Subject: Dow Brook Dam

Subject: Site Visit and Dam Condition
Dow Brook Reservoir Dam
Ipswich, Massachusetts

**Commonwealth of Massachusetts
Department of Conservation and Recreation
Office of Dam Safety Poor and Unsafe Condition Dam Follow-up Inspection Form**

Dam Name: Dow Brook Reservoir Dam
Dam Owner: Town of Ipswich
Nat. ID Number: MA00165
Hazard Potential: Significant
Location of Dam (town): Ipswich, Massachusetts
Coordinate location (lat,long): 42°41.9' N, 70°52.3' W
Date of Inspection: 25 April 2018
Weather: Light Rain, 50s

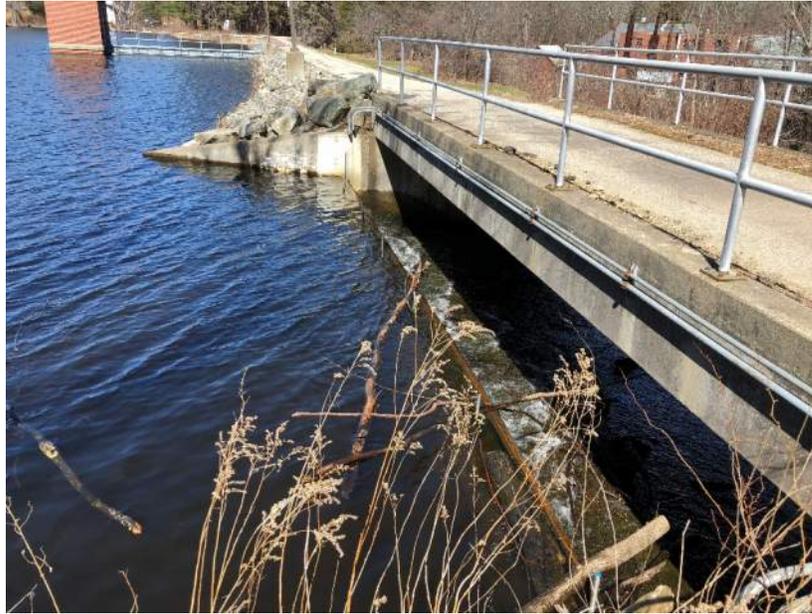
We understand site personnel noticed seepage on the downstream slope/toe of the dam on 4 April 2018. Denis Bell visited on 10 April 2018 and observed the seepage. During the site visit the water level within Dow Brook Reservoir was recorded at El. 33.3, about 4.2 ft below the concrete curb on the bridge, and 2.8 ft above the spillway slab invert. A site plan dated 17 April 1981 includes the top of concrete curb on the bridge at El. 37.5.

Photo 1
Spillway with Water at El. 33.3

We recommend the water level be lowered within the next day. To start, lower the water 1 ft, to El. 32.3 (1.8 ft above the spillway slab invert) and the monitor the seeps. If the seeps continue, the water level should be lowered to a level where the seeps stop.

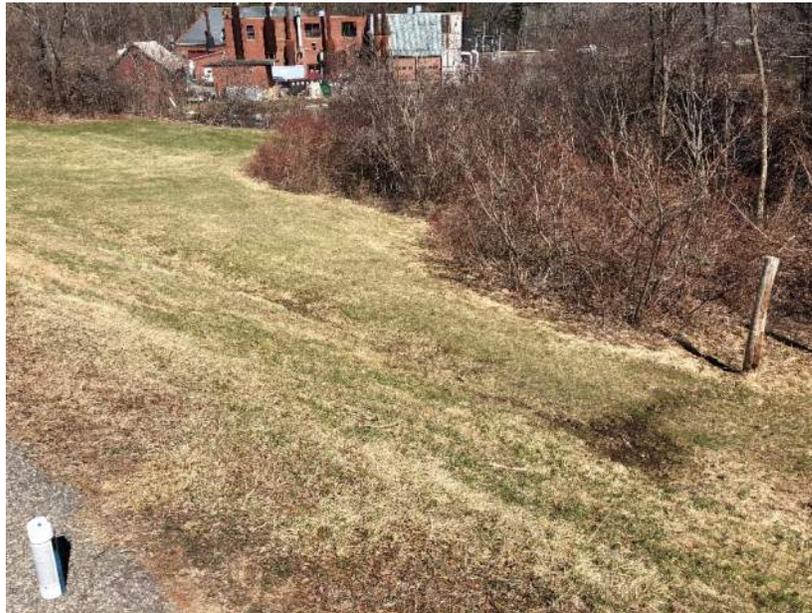
The observed seep measured about 11 ft on the downstream slope, perpendicular to the dam axis, and 8 ft wide, along the dam axis. The seep was actively producing water during the site visit; however, the water was visually clear and causing minor damage to the grass vegetation on the slope. Two additional

seeps were observed 8 to 12 ft north of the main seep on the downstream slope. The additional seeps were 3 to 4 ft in diameter and at about El. 26. The seeps were located about 73 to 90 ft north of the bridge.

Photo 2
Area of Seeps on Downstream Slope

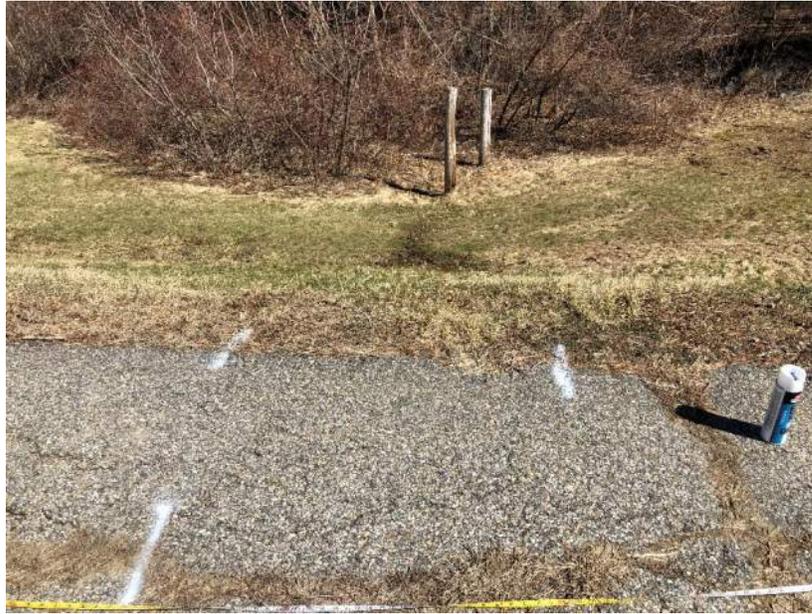
Photo 3
Area of Seep, 73 ft from Bridge

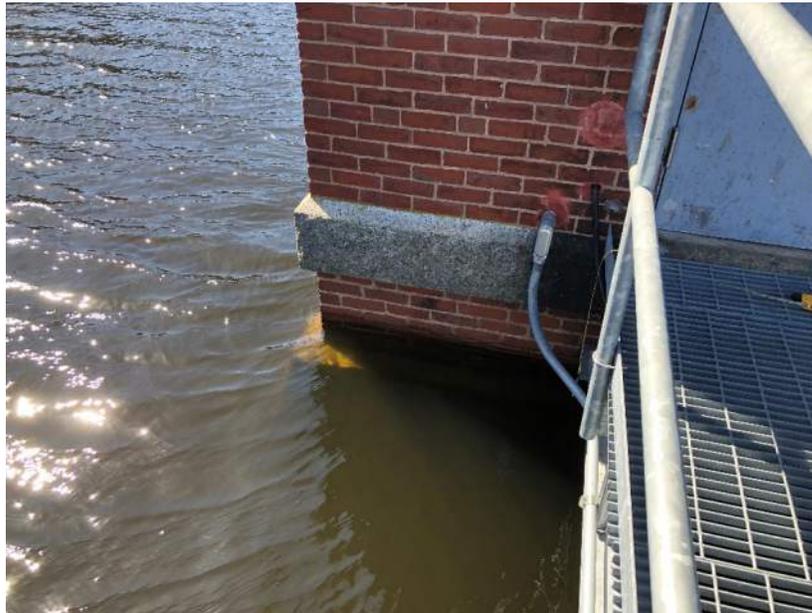
The observed seeps are likely caused by high water levels in the reservoir. The water is 1.3 ft above the top of the corewall. This condition is causing water to flow over the corewall and 'daylight' on the downstream slope, causing seeps. The seeps will get worse with time and compromise the dam if the water level is not lowered.

Photo 4
Water Level at El. 33.3 at the Gatehouse

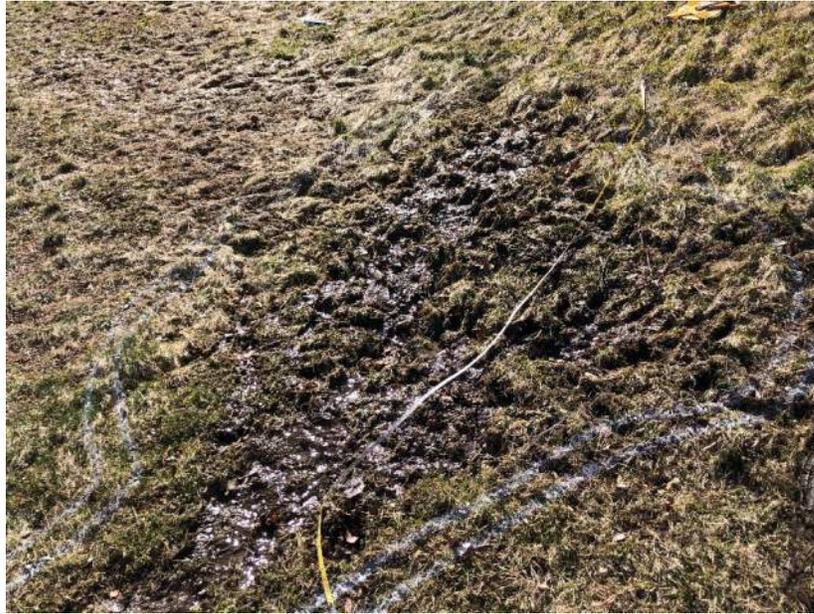
Photo 5
Seep at Dam

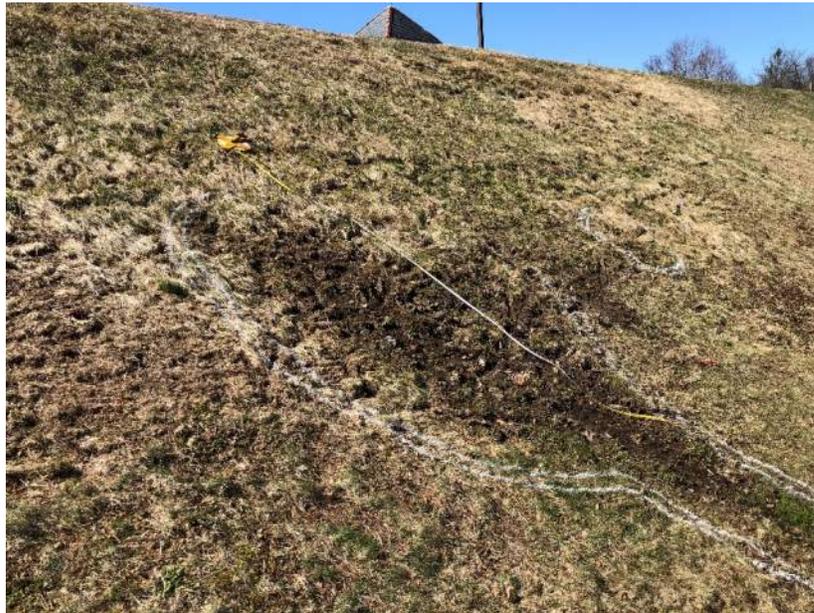
Photo 6
Seep at Dam, about 11 ft by 8 ft

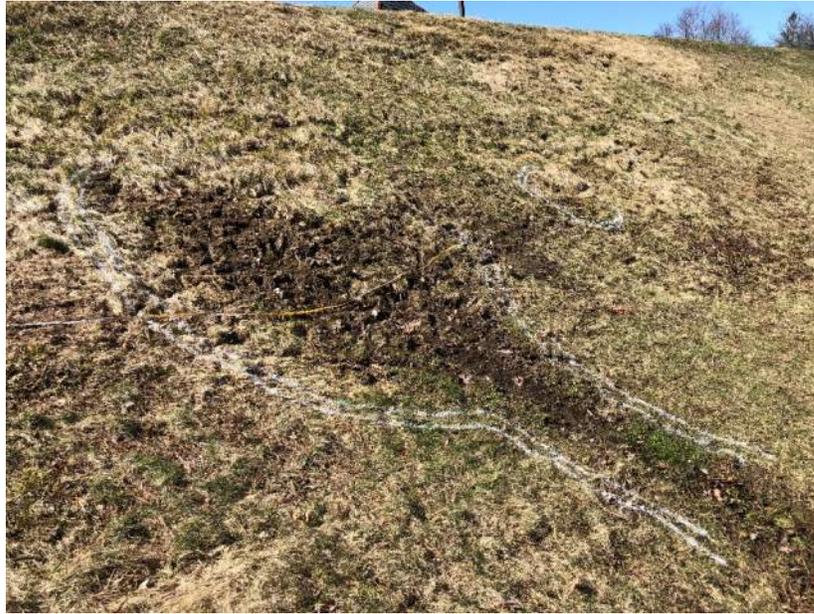
Photo 7
Seep at Dam

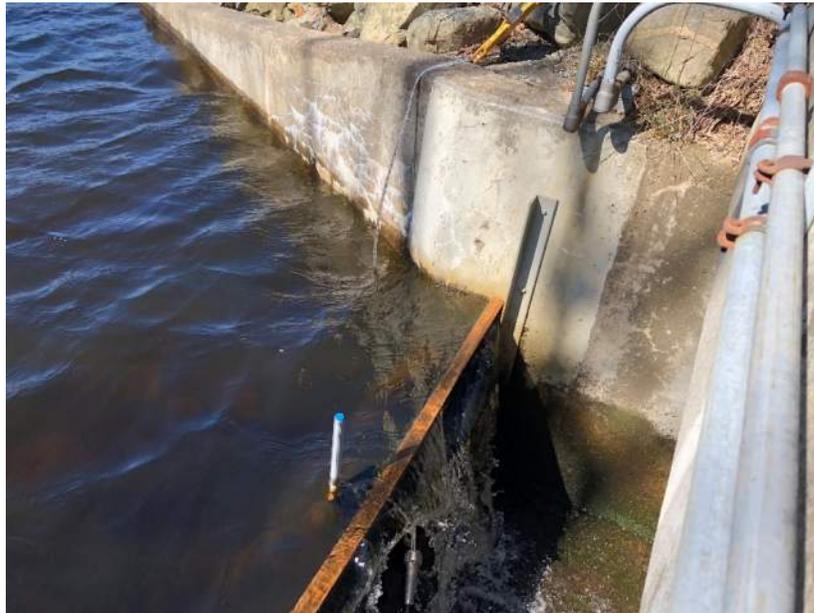
Photo 8
Flashboards at El. 33.3

As requested by H&A, the water level in the Dow Brook Reservoir was lowered to the spillway invert level, about 2-feet lower than the level on April 10th. This was accomplished by cutting and removing sections of the wooden flashboards within the dam spillway. The water level and seepage area are monitored daily by staff. With the level now lowered, the seepage is still present but no longer actively flowing. H&A returned for a follow-up site visit on April 25th with a representative from the Massachusetts Office of Dam Safety. The current status of the dam is stable, but unsafe. The water level must remain at or below its currently position to prevent further damage to the dam. The Office of Dam Safety will be issuing the Town an order to repair the dam (April 26th H&A letter to Office of Dam Safety attached).

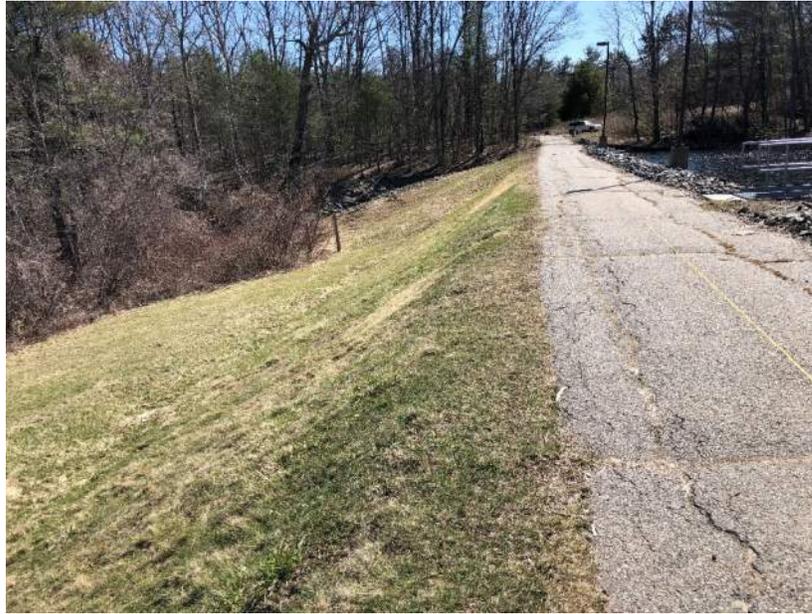
Photo 9
Right Downstream Slope

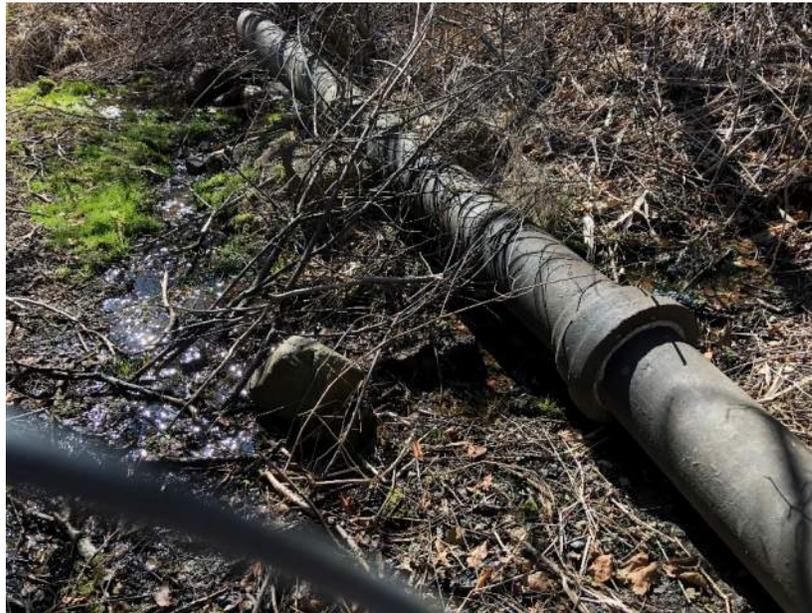
In addition to the seeps on the main dam, seepage was also observed at the left abutment contact. Seepage at this location has been observed since the 1980s and records indicate the seep was historically estimated at 5 gallons per minute, the seep was clear and damage was not reported.

Seepage at the left abutment during this site visit was different, and larger, than the seepage reported since the 1980s. Seepage observed on 10 April 2018 occurred over a 30 ft long area and visually estimated at 30 to 40 gallons per minute. Minor erosion was observed at the left abutment, including gullies, less than 2 in. in depth.

Photo 10
Seeps at Downstream Toe of Left Abutment

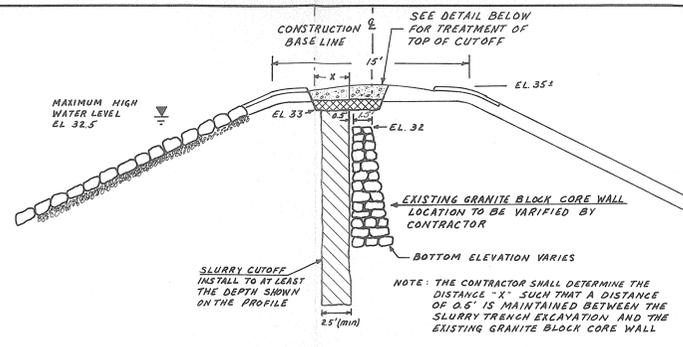
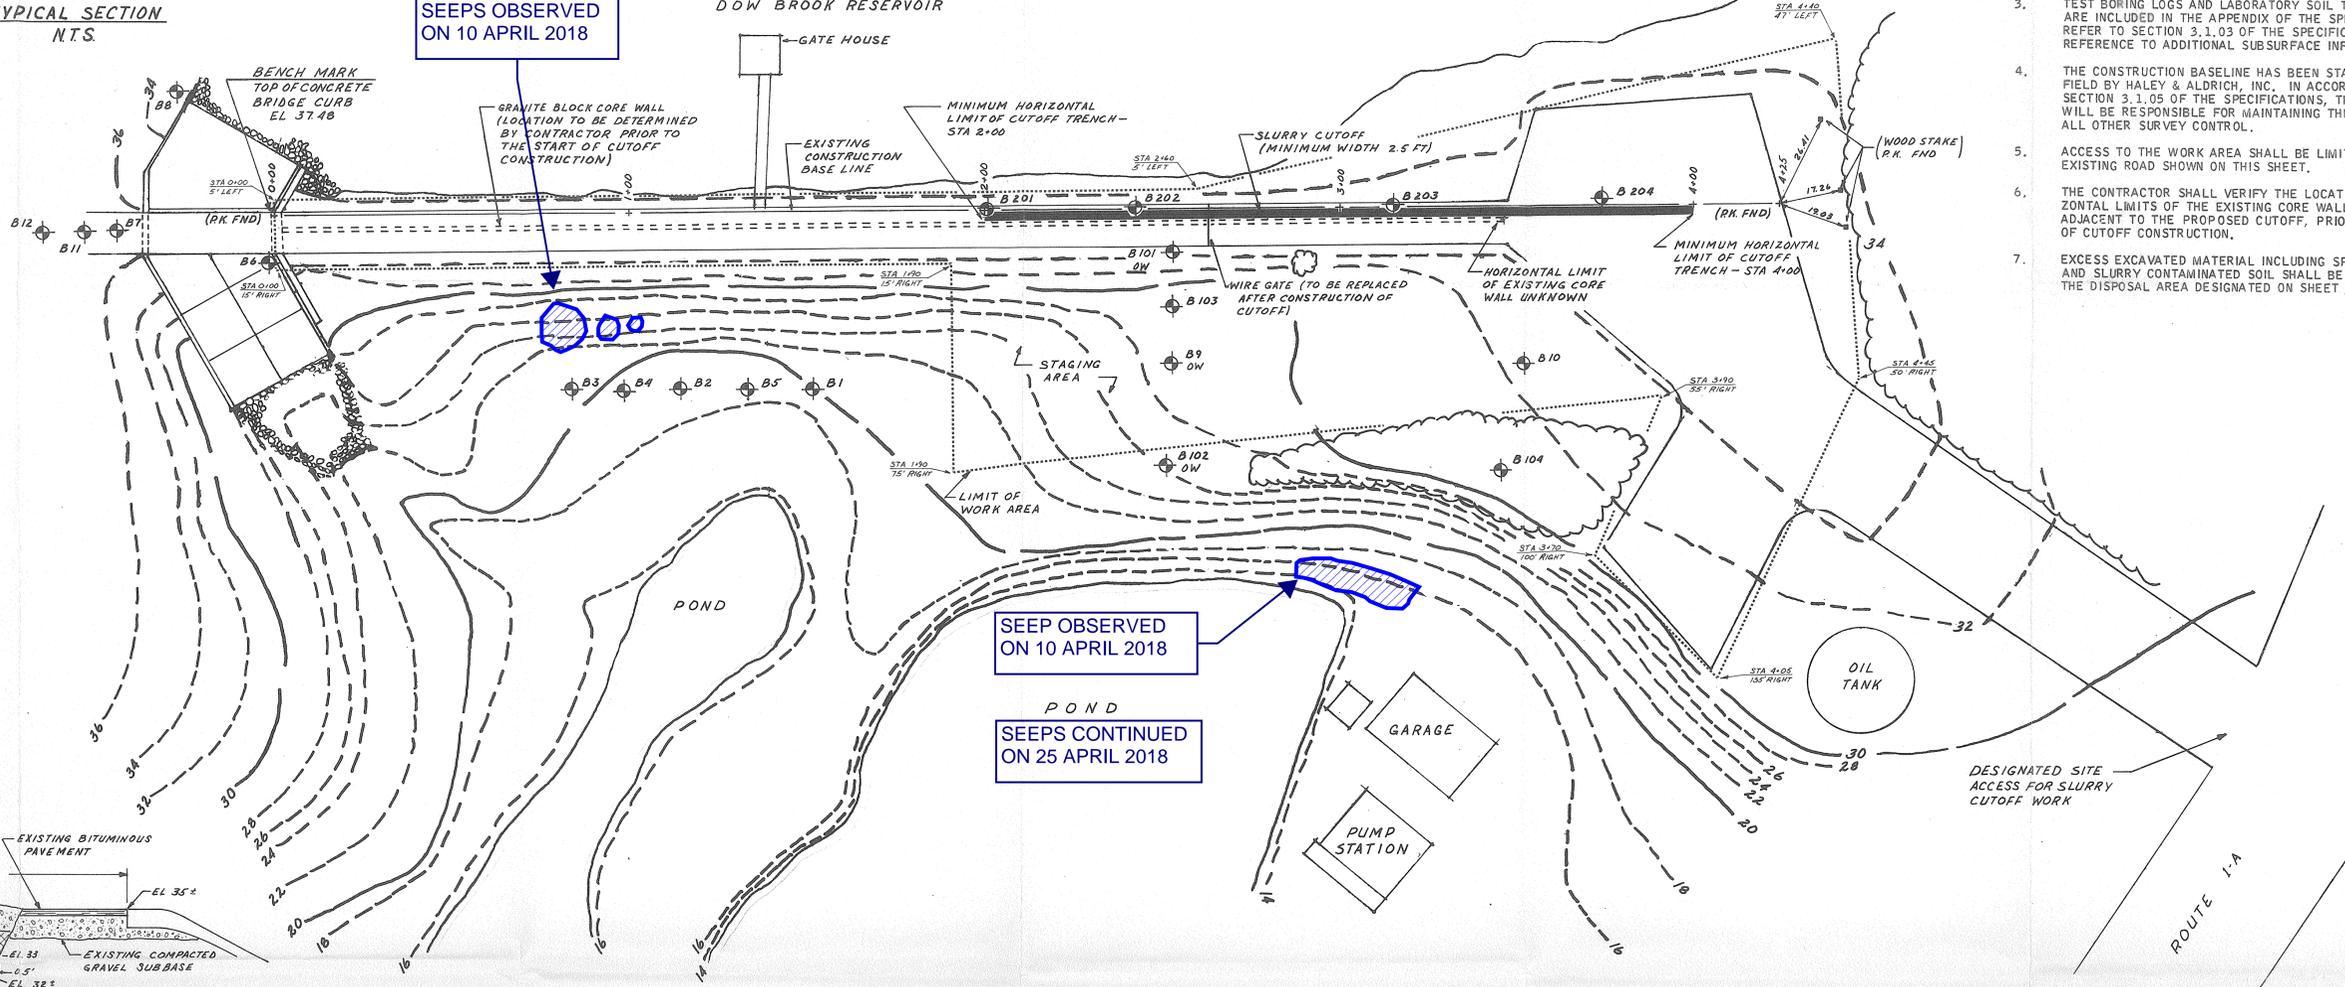
SKETCH OF SEEP AREAS

25 APRIL 2018
SEEP AREA WAS SATURATED,
NOT FLOWING

SEEPS CONTINUED
ON 24 APRIL 2018

SEEPS OBSERVED
ON 10 APRIL 2018

SEEP OBSERVED
ON 10 APRIL 2018

SEEPS CONTINUED
ON 25 APRIL 2018

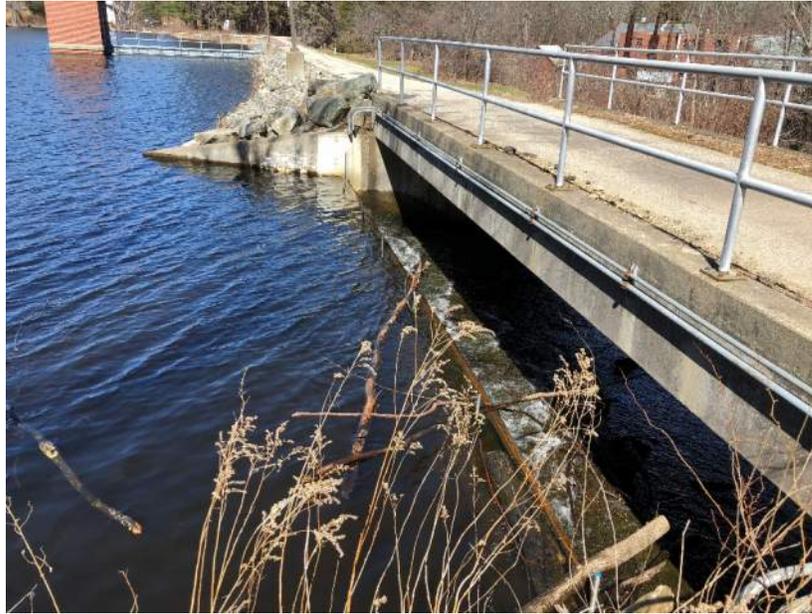
Photo 1
Spillway with Water at El. 33.3
4/10/2018

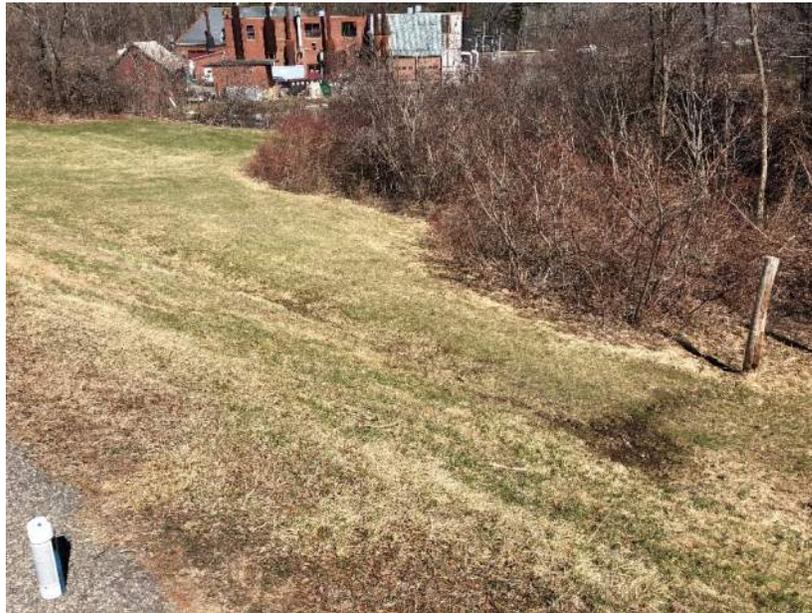
Seeps have developed on the downstream toe of the dam at the right side. The observed seep measured about 11 ft on the downstream slope, perpendicular to the dam axis, and 8 ft wide, along the dam axis. The seep was actively producing water on the site visit on 10 April 2018; however, the water was visually clear and causing minor damage to the grass vegetation on the slope. Two additional seeps were observed 8 to 12 ft north of the main seep on the downstream slope. The additional seeps were 3 to 4 ft in diameter and at about El. 26. The seeps were located about 73 to 90 ft north of the bridge.

Photo 2
Area of Seeps on Downstream Slope
4/10/2018

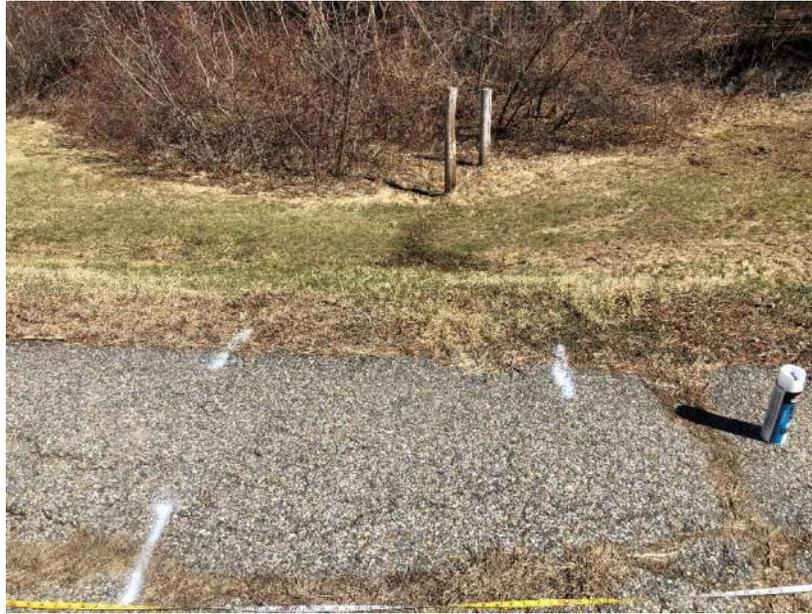
Photo 3
Area of Seep, 73 ft from Bridge
4/10/2018

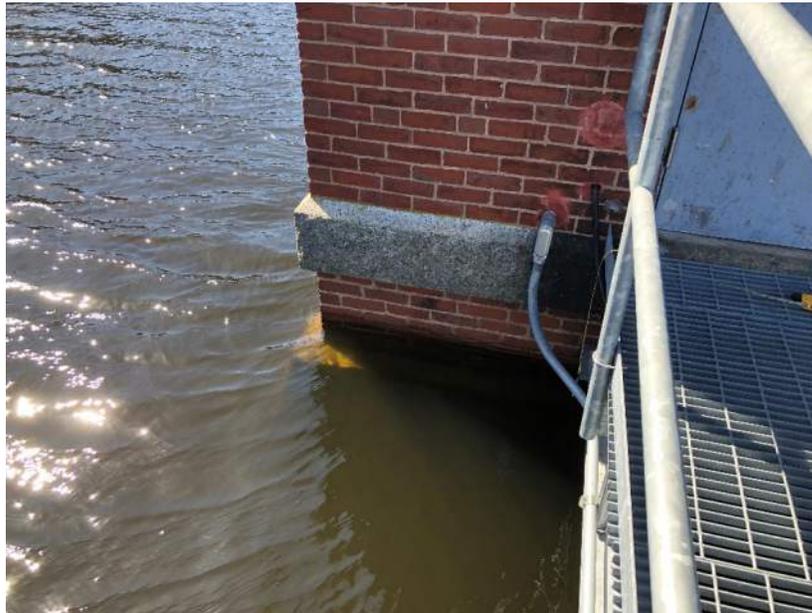
Photo 4
Water Level at El. 33.3 at the Gatehouse
4/10/2018

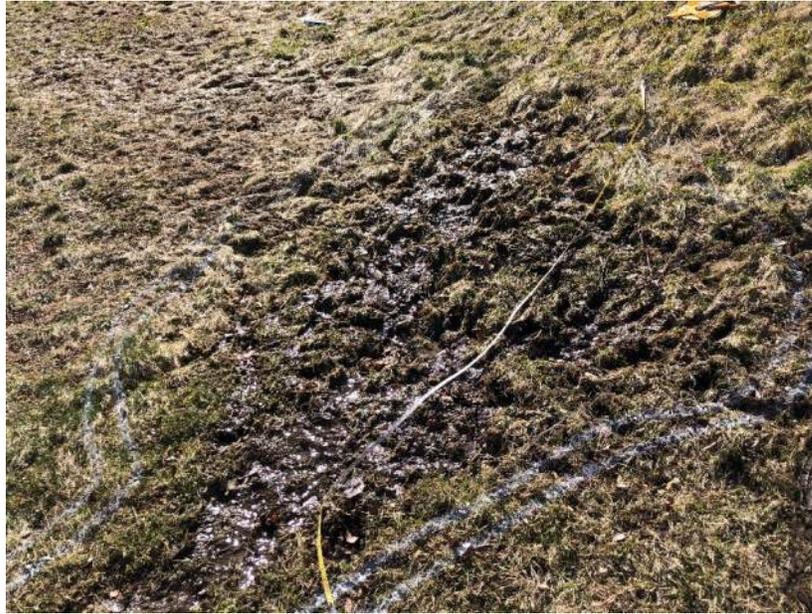
Photo 5
Seep at Dam
4/10/2018

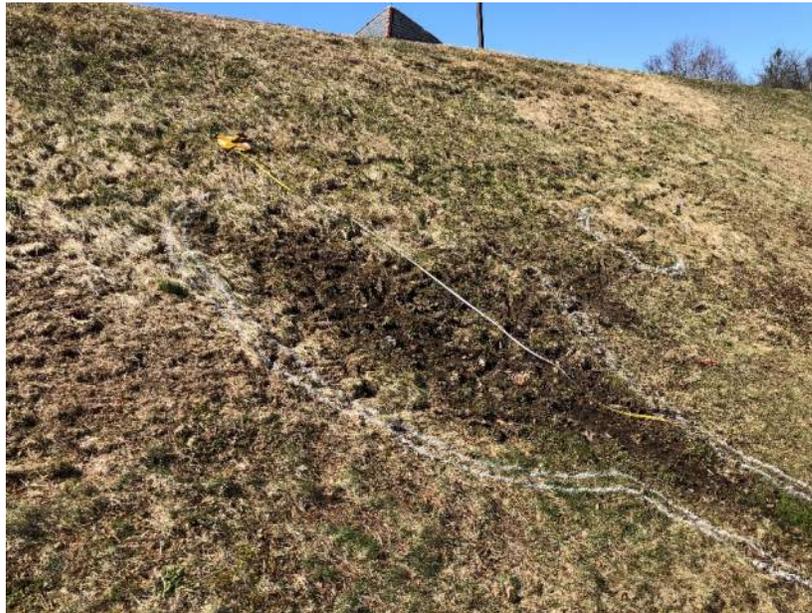
The observed seep on 10 April 2018 measured about 11 ft on the downstream slope, perpendicular to the dam axis, and 8 ft wide, along the dam axis. The seep was actively producing water during the site visit; however, the water was visually clear and causing minor damage to the grass vegetation on the slope.

Photo 6
Seep at Dam, about 11 ft by 8 ft
4/10/2018

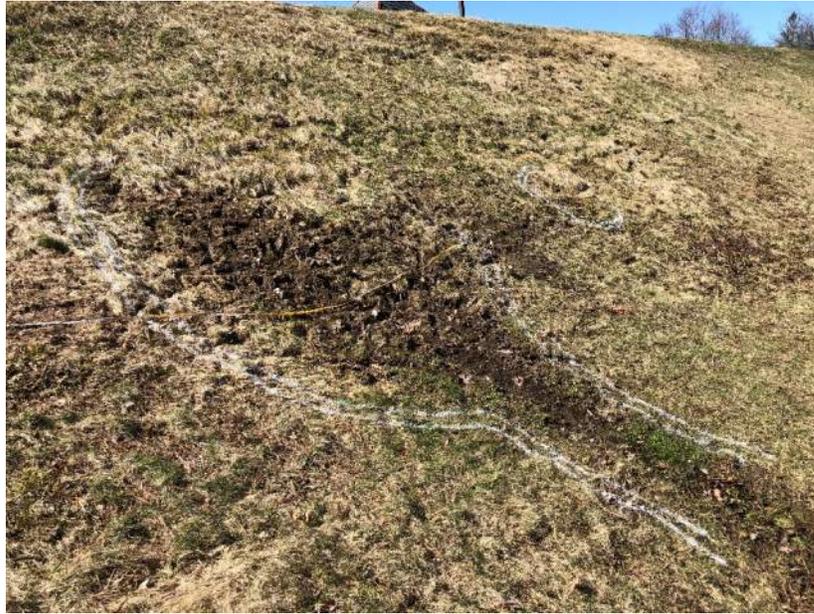
Photo 7
Seep at Dam
4/10/2018

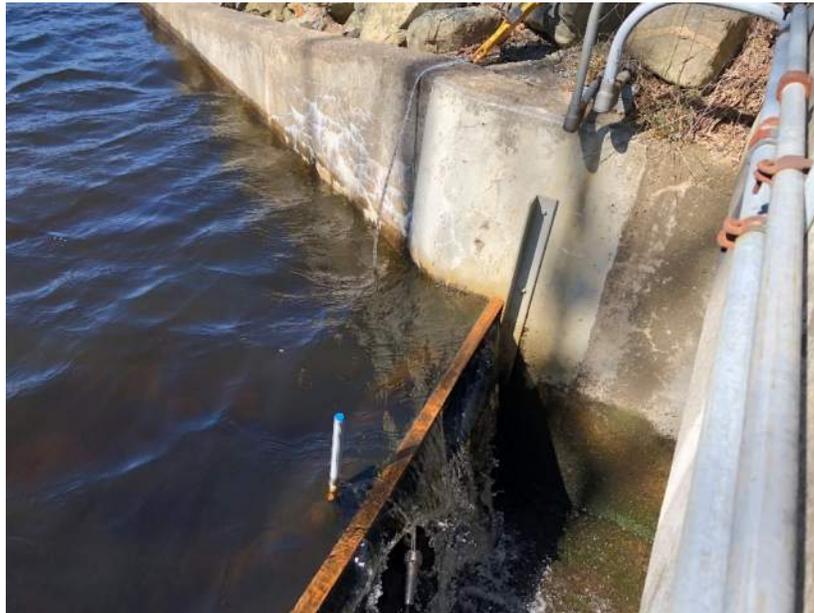
Photo 8
Flashboards at El. 33.3
4/10/2018

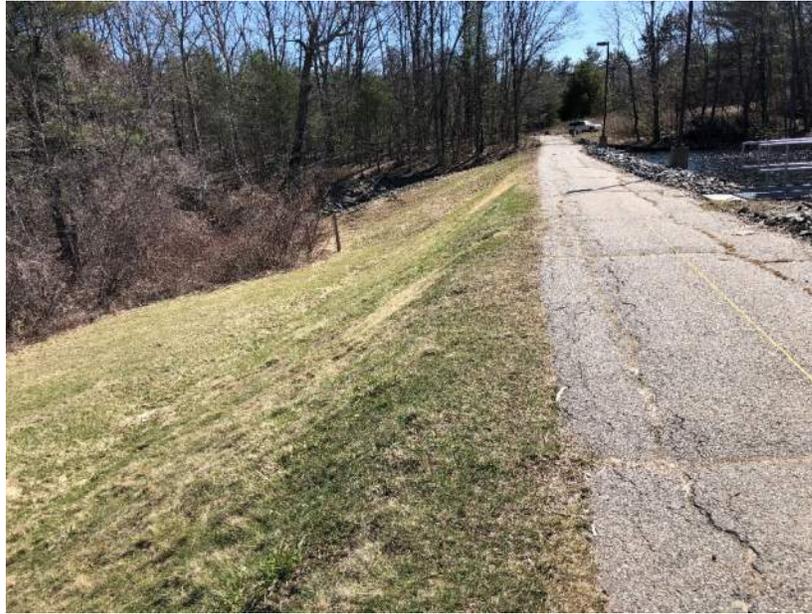
Photo 9
Right Downstream Slope
4/10/2018

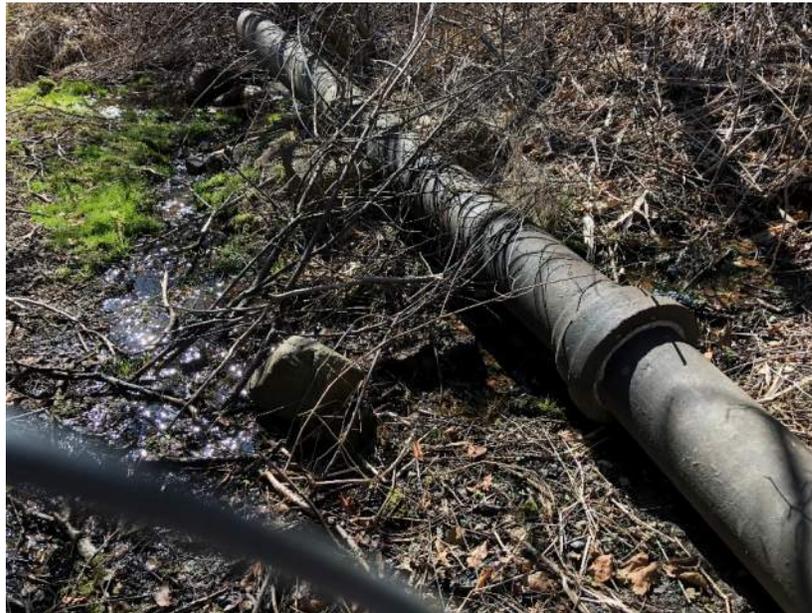
Seepage at the left abutment on 10 April 2018 was different, and larger, than the seepage reported since the 1980s. Seepage observed on 10 April 2018 occurred over a 30 ft long area and visually estimated at 30 to 40 gallons per minute. Minor erosion was observed at the left abutment, including gullies, less than 2 in. in depth.

The seep at the left abutment has increased to over a 30 to 40 ft length of the dam.

Photo 10
Seeps at Downstream Toe of Left Abutment
4/10/2018

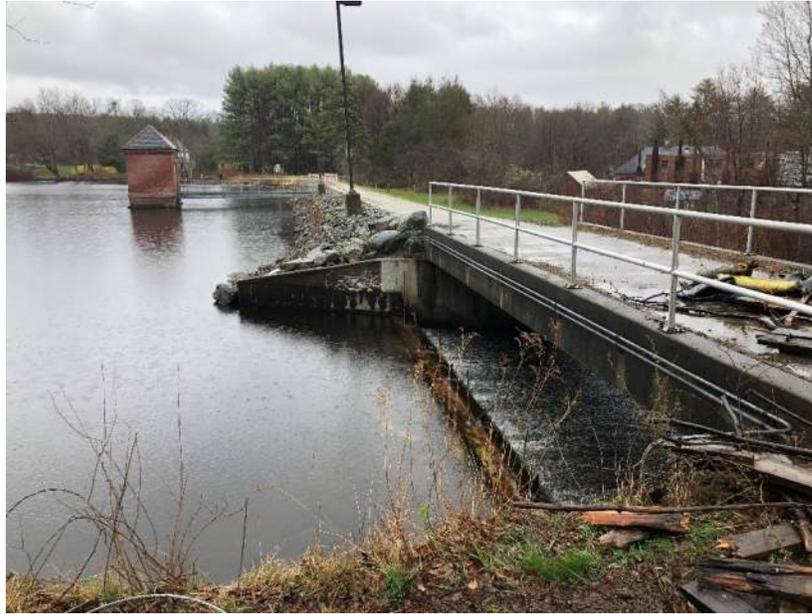
On 25 April 2018, Mr. Bell completed an additional site visit and contacted Massachusetts Office of Dam Safety and informed them of the conditions. On 25 April 2018, the water level was at spillway invert level, about 2 ft lower than on 10 April 2018. The seepage areas were saturated and thinly vegetated. The seeps were not actively flowing on 25 April 2018.

Photo 1
Spillway with Water at El. 31.3
4/25/2018

We recommend the water level be maintained at, or below, spillway invert elevation until repairs can be made to bring the dam into compliance with Massachusetts Dam Safety Regulations.

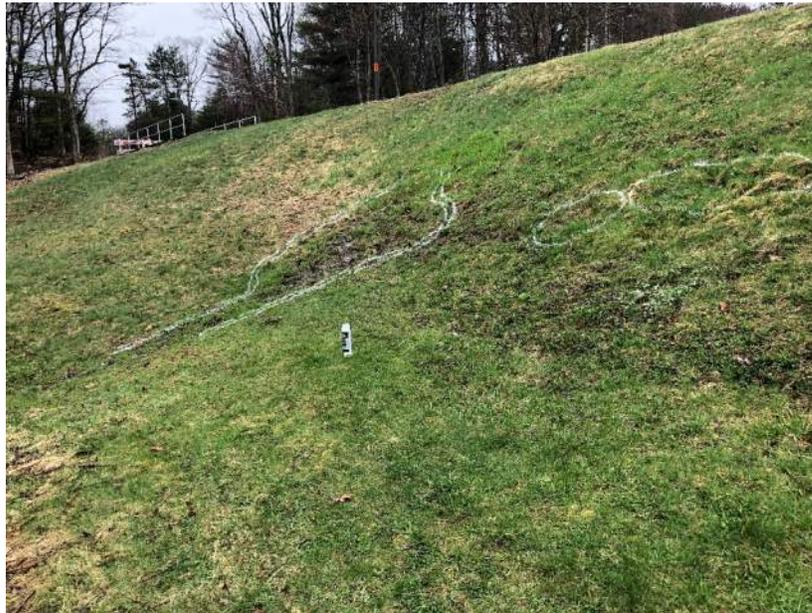
On 25 April 2018, with the reservoir water level about 3 ft lower than 10 April 2018, the seep area of concern was wet and saturated with standing puddles, however, water was not observed to be actively flowing.

Photo 2
Area of Seeps on Downstream Slope
4/25/2018

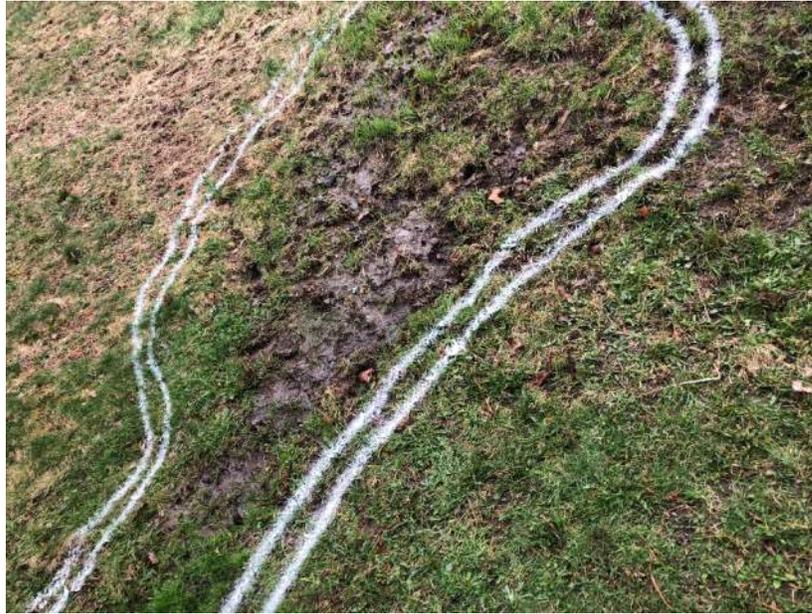
Photo 3
Area of Seep, 73 ft from Bridge
4/25/2018

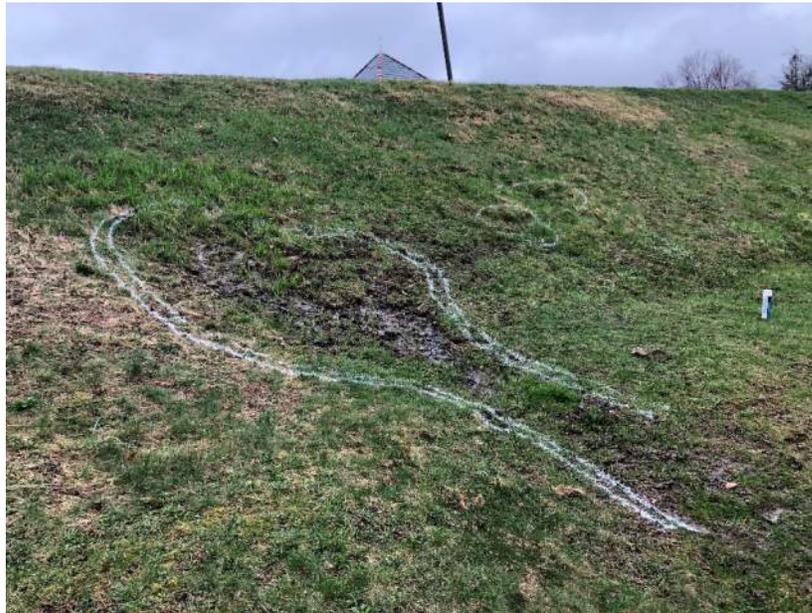
Photo 4
Seep
4/25/2018

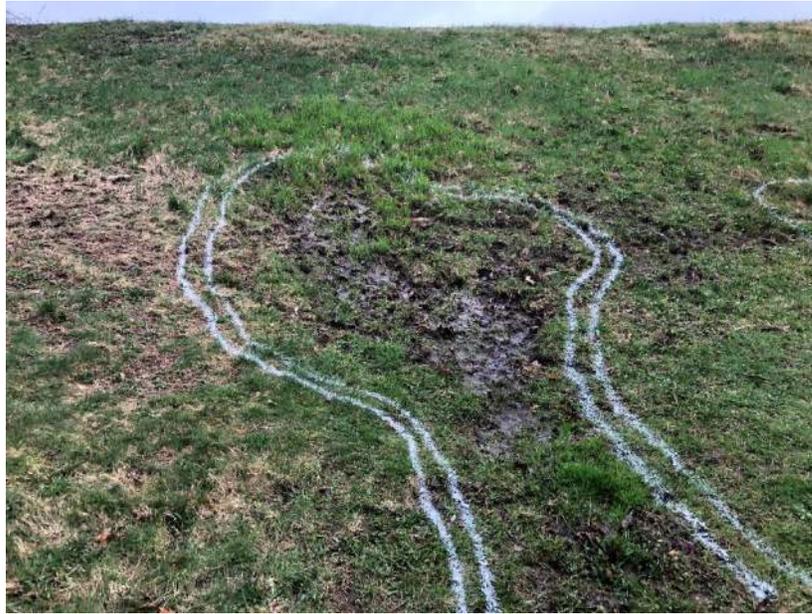
Photo 5
Seep at Dam
4/25/2018

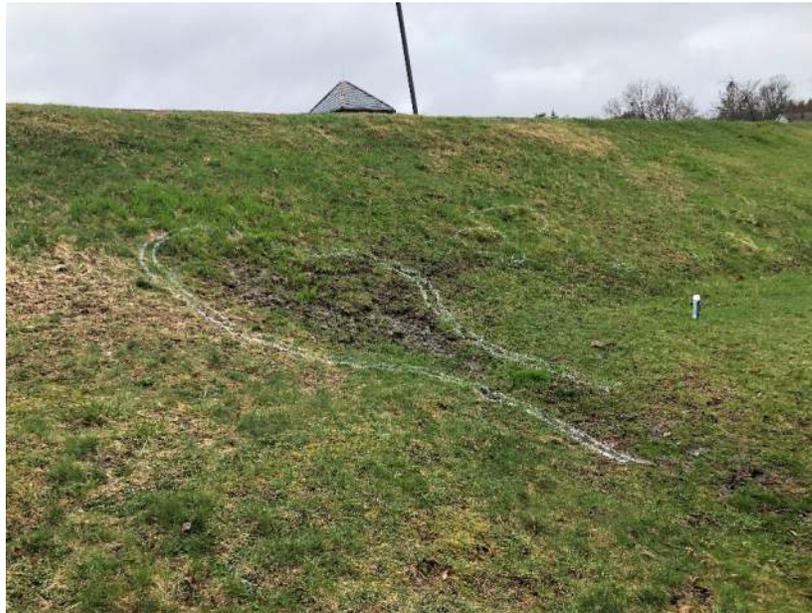
Photo 6
Seep at Dam, about 11 ft by 8 ft
4/25/2018

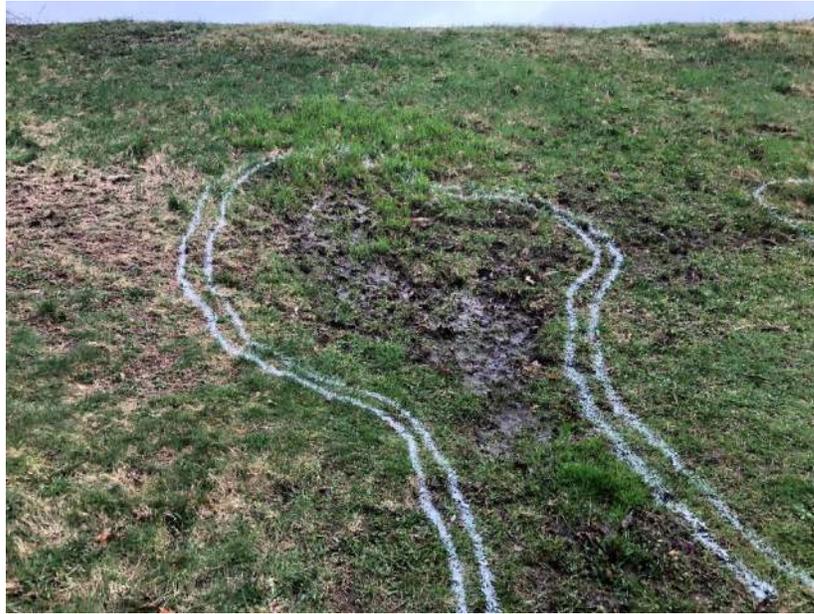
Photo 7
Seep at Dam
4/25/2018

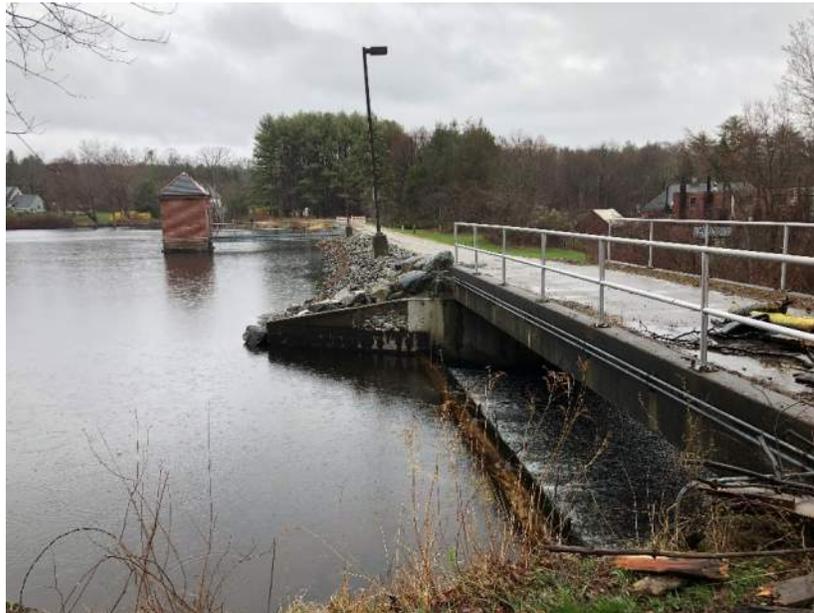
Photo 8
Flashboards Removed, Spillway Invert about El. 31.3
4/25/2018

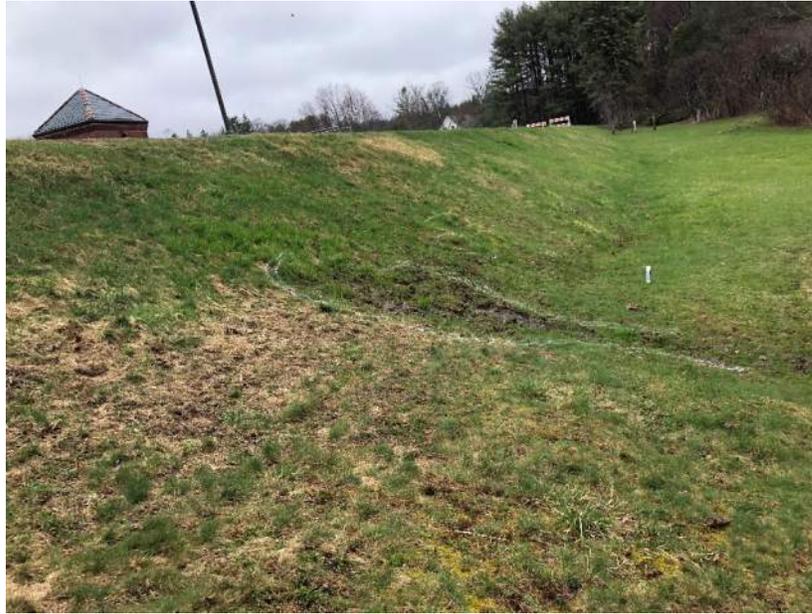
Photo 9
Downstream Slope
4/25/2018

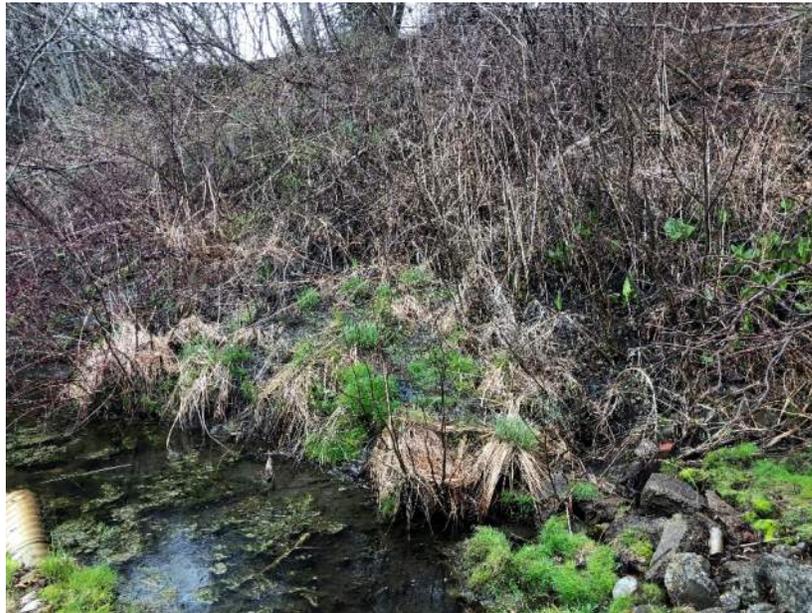
Photo 10
Seeps at Downstream Toe of Left Abutment
4/25/2018

1. The reservoir level should be maintained at the Spillway Invert Elevation, or lower, until repairs are completed to bring the dam into compliance with Massachusetts Dam Safety Regulations.
2. The condition of the dam should be monitored daily for signs of additional seepage and deterioration.
3. The dam should be repaired to prevent seepage and bring the dam into compliance with dam safety regulations.
