TOWN OF IPSWICH

April 17, 2019

Re: Ipswich Sewer Interceptor Rehabilitation and Siphon Replacement Project
EEA File #16003

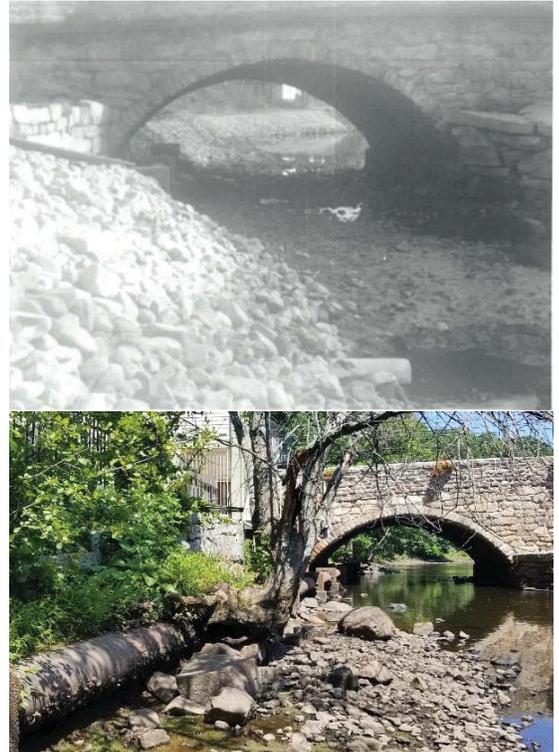
The area of the interceptor under evaluation was originally covered and protected with at least one foot of stone fill. A stone on the river side of the pipe was indicated as "stone tailings" and at a very steep 1:1 slope. However, over time this stone armoring and interceptor protection has washed away, leaving the interceptor and its support piers exposed to the elements, increasing the potential for deterioration. The earth along the river bank has eroded, and the bank is partially supported in many areas by the interceptor (a loading condition that was likely not anticipated when the interceptor was originally designed/constructed). Additionally, there are multiple trees with roots growing around the interceptor. Figure 1 depicts the interceptor as it was in 1965 and how it looks at present day.

Figure 1-1. 1965 and 2018 Photos of Interceptor with and without revetment stone coverage.

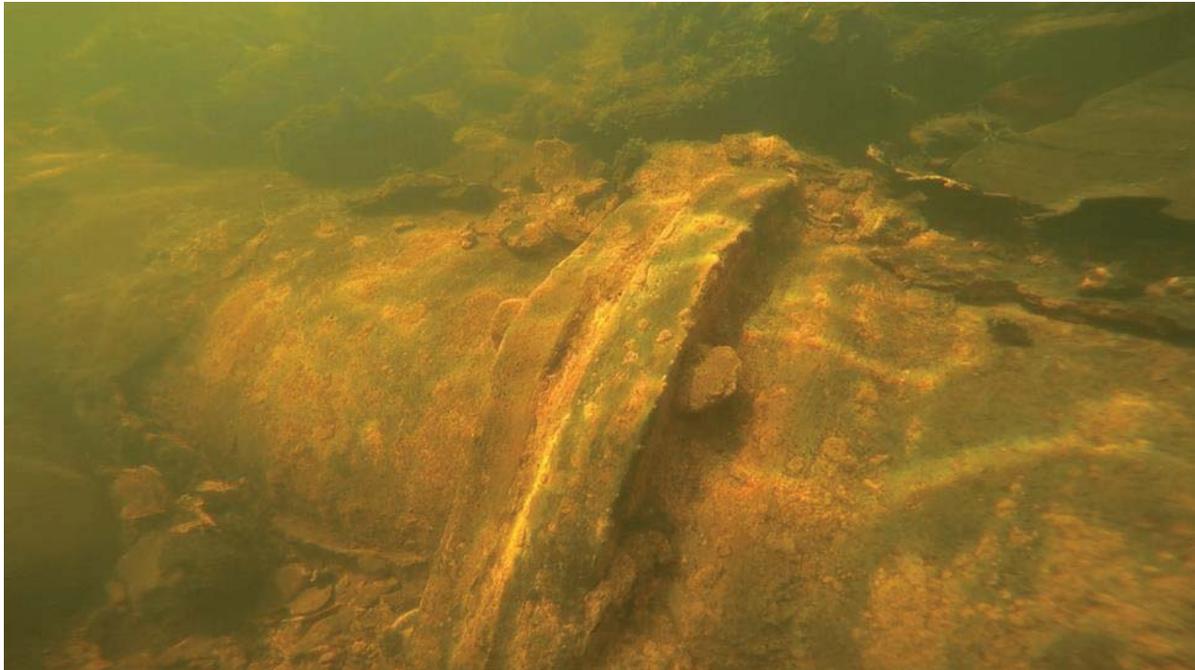
Photo 2-1. Bolted connection on exposed siphon pipe (after corrosion byproduct removal).

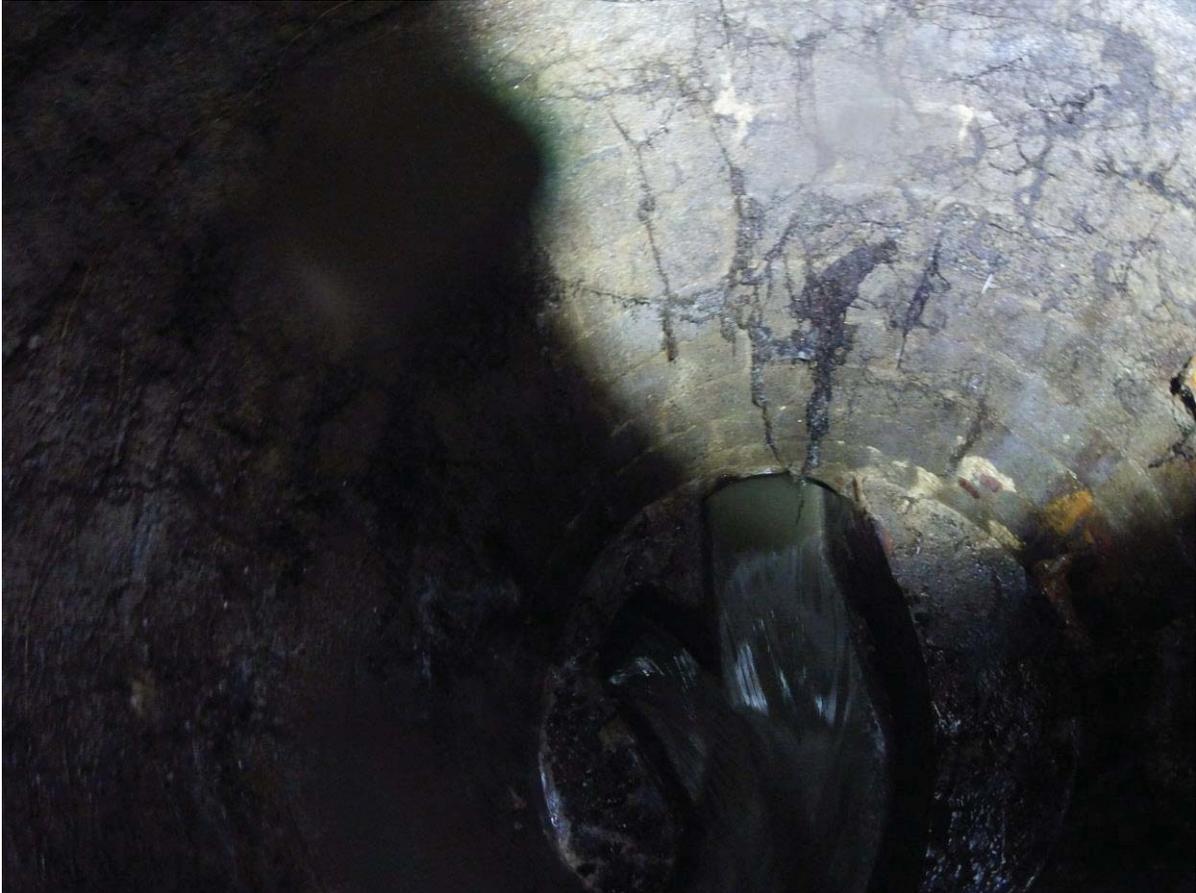
The scope of work included 2 key access manholes along the Siphon, SMHs 18 and 34. This conclusion was supported by multiple surface site investigations. SMH 34 is in good condition and does not show evidence of failure. However, due to its proximity to the river, this manhole should have a flood proof hatch and therefore requires attention. SMH 18 requires attention because roots were observed entering SMH 18. This creates the potential for infiltration to enter this manhole through the same path through which the roots enter the structure. Please see below a photo of SMH 18 showing where roots are entering the structure.

Photo 2-2. Roots visible from surface growing within SMH 18.

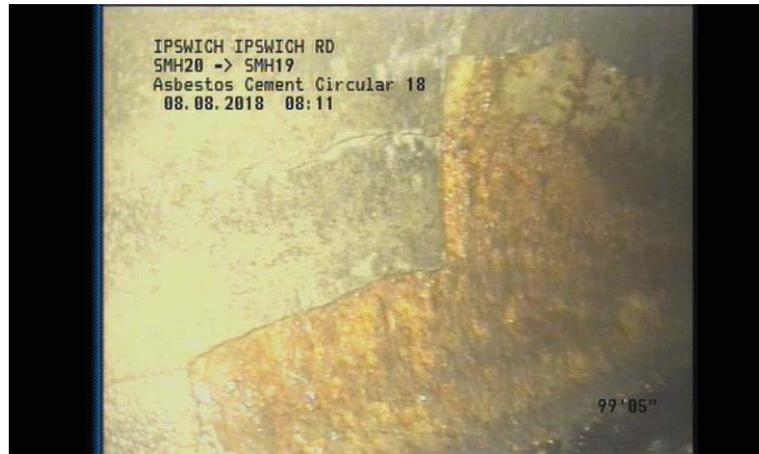
deterioration over time to the point where the surface lost its smooth interior. The cracking can be seen in Photo 2-1. In addition, some grease deposition was observed in the interceptor, similar to the siphon.

Photo 4-1. Multiple Cracks in Interceptor at 100 ft.

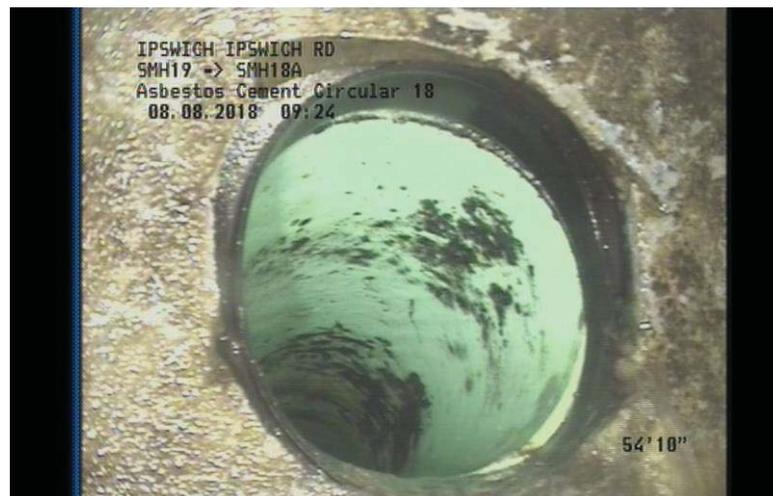
One area to note is a defective tap break-in occurring 55 feet downstream of SMH 19. A defective tap break in is when a tap for a service is made on the sewer main after installation. If not done carefully, infiltration can occur at the joint where the new service is tied into the main. While concerning, this is not a major area of concern as the interceptor has plenty of capacity to handle this excess flow. If this added flow contributed to backups in the interceptor, this would need to be dealt with immediately. In this case, the infiltration is negligible from a capacity standpoint. Please see photo below of defective tap break in.

Photo 4-2. Defective Tap Break In

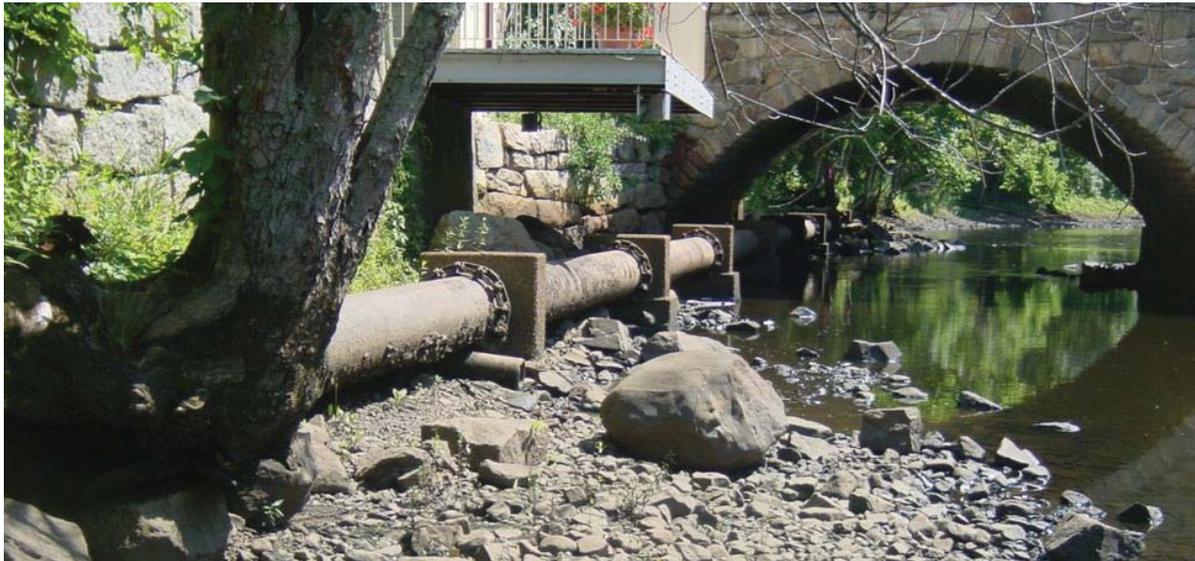
Photo 4-3. Overview of interceptor pipe running parallel to river and under the bridge.

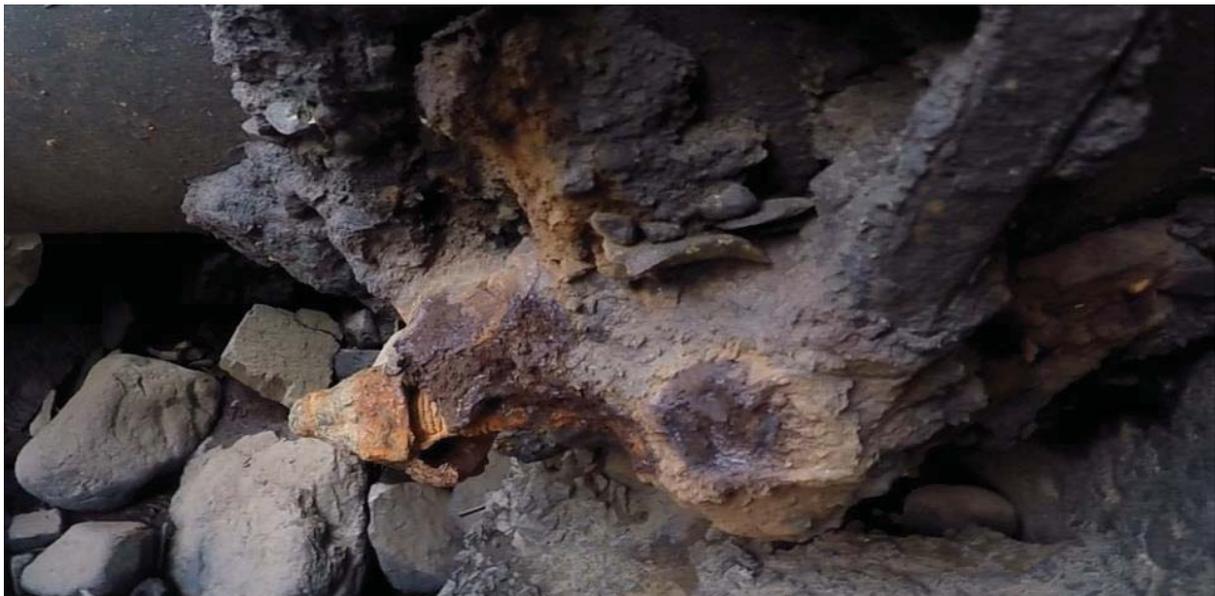
Photo 4-5. Typical corrosion of the bottom bolts on the interceptor pipe joints. In this instance, the coupling flanges are also corroding to the point of failure.

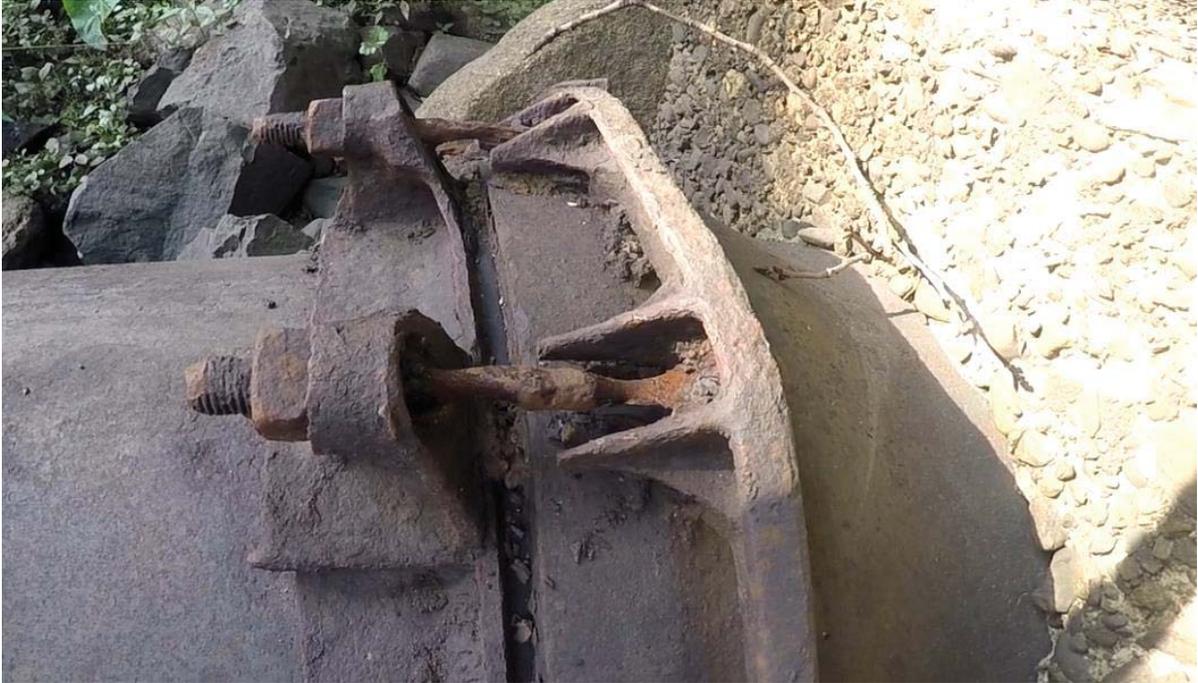
Photo 4-6. Typical corrosion of the top bolts of the interceptor joints. The Bell Joint Leak Clamps are generally still structurally intact, but the bolts have lost enough diameter that they may no longer be providing restraint. Because these bolts have lost enough diameter, these clamps do not provide much support.

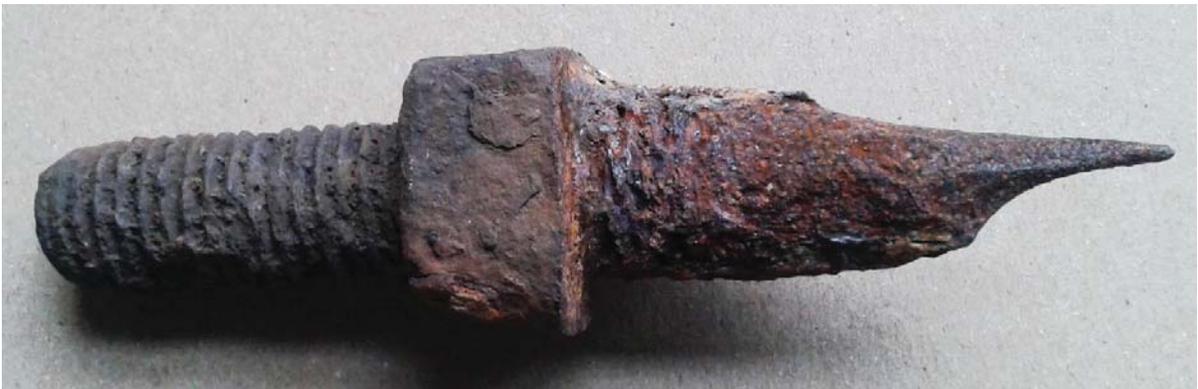
Photo 4-7. Corrosion of failed bolt.

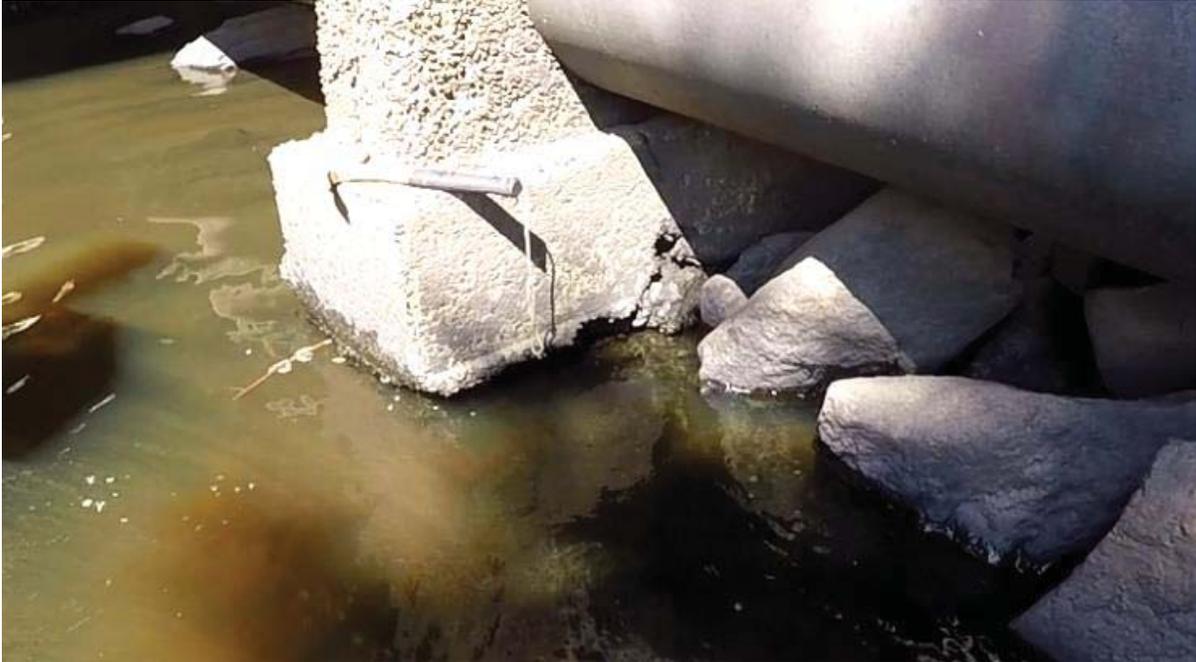
Photo 4-8. Scour hole under concrete pier supporting the interceptor pipe just to the east of the bridge.

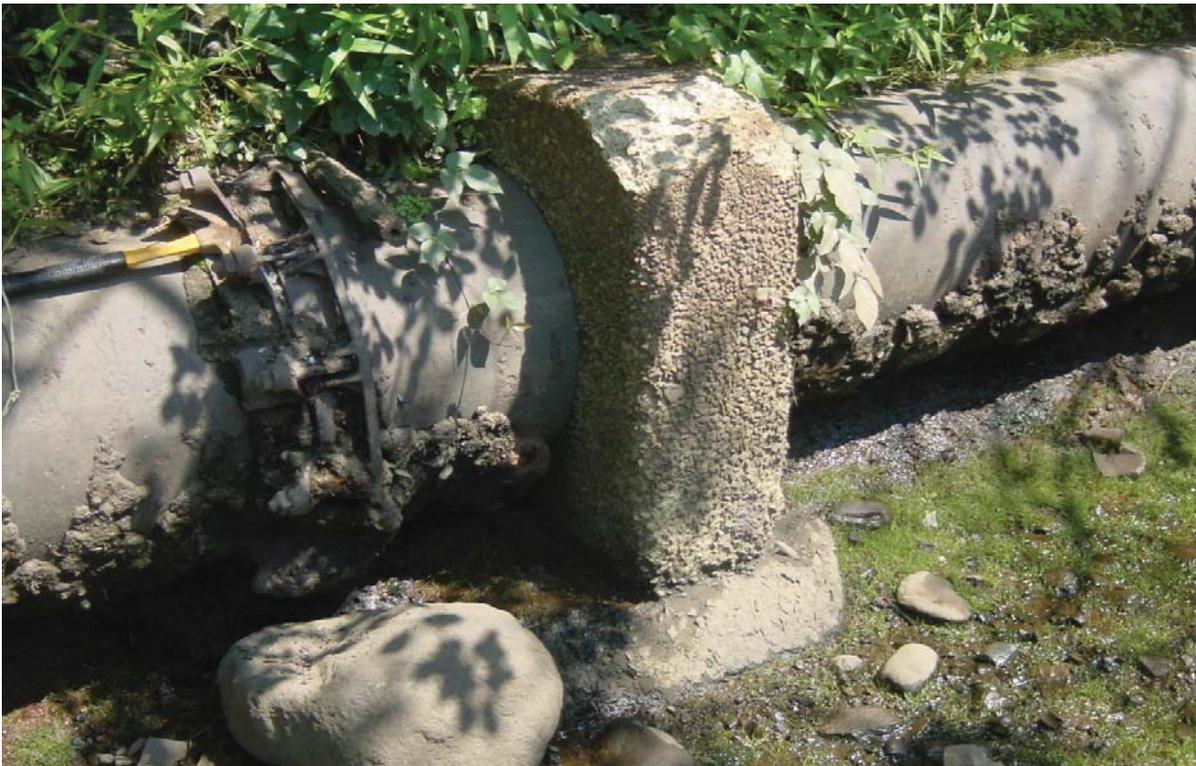
Photo 4-9. Concrete damage on a support pier for the interceptor pipe.

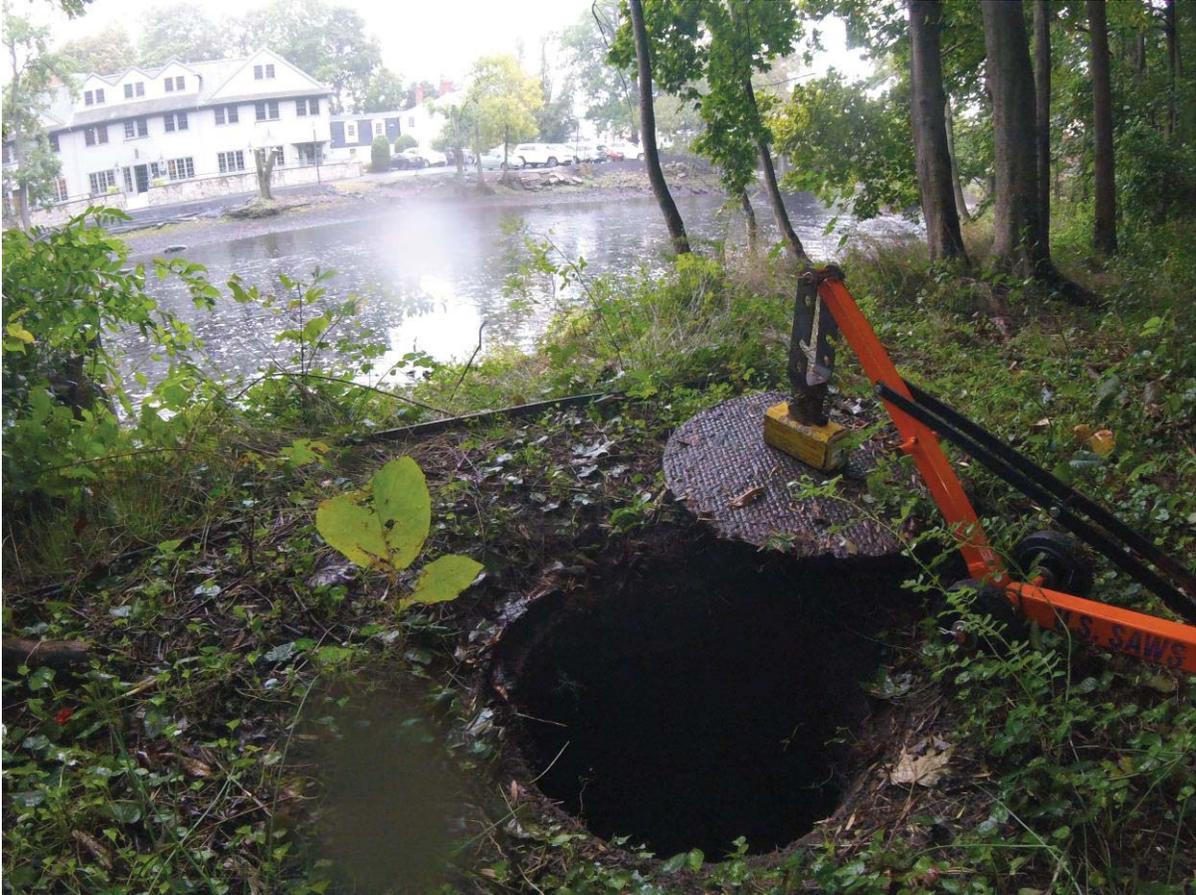
SMH 19 had an issue with surrounding vegetation growing in through the rim. This prevents the rim from fully closing creating a void for debris to fall in. This is an easy fix, as this vegetation can be cleared from the cover area. Please see image below:

Photo 4-12. Vegetation surrounding cover of SMH 19.

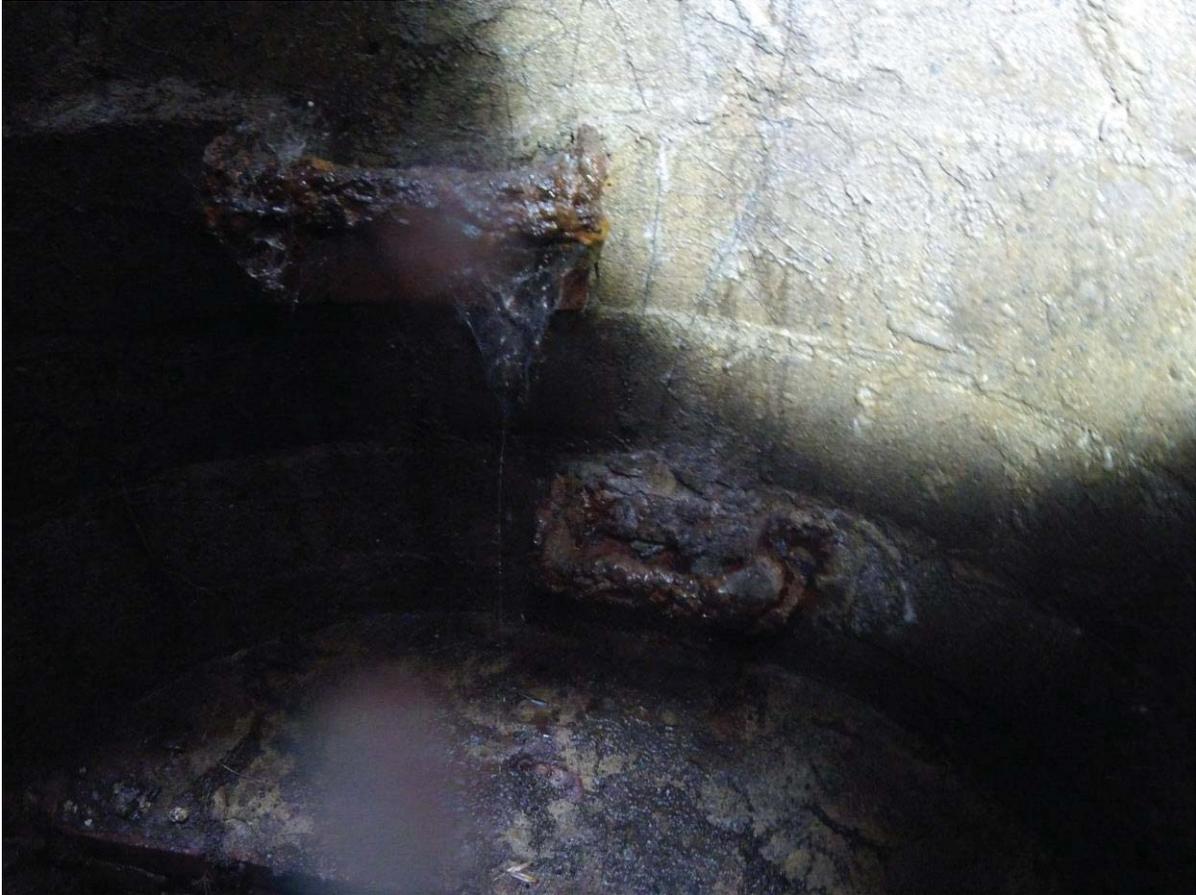
Rusted rungs were also observed within SMH 19, as shown in Photo 4-13.

Photo 4-13. Corroded access rungs in SMH 19.

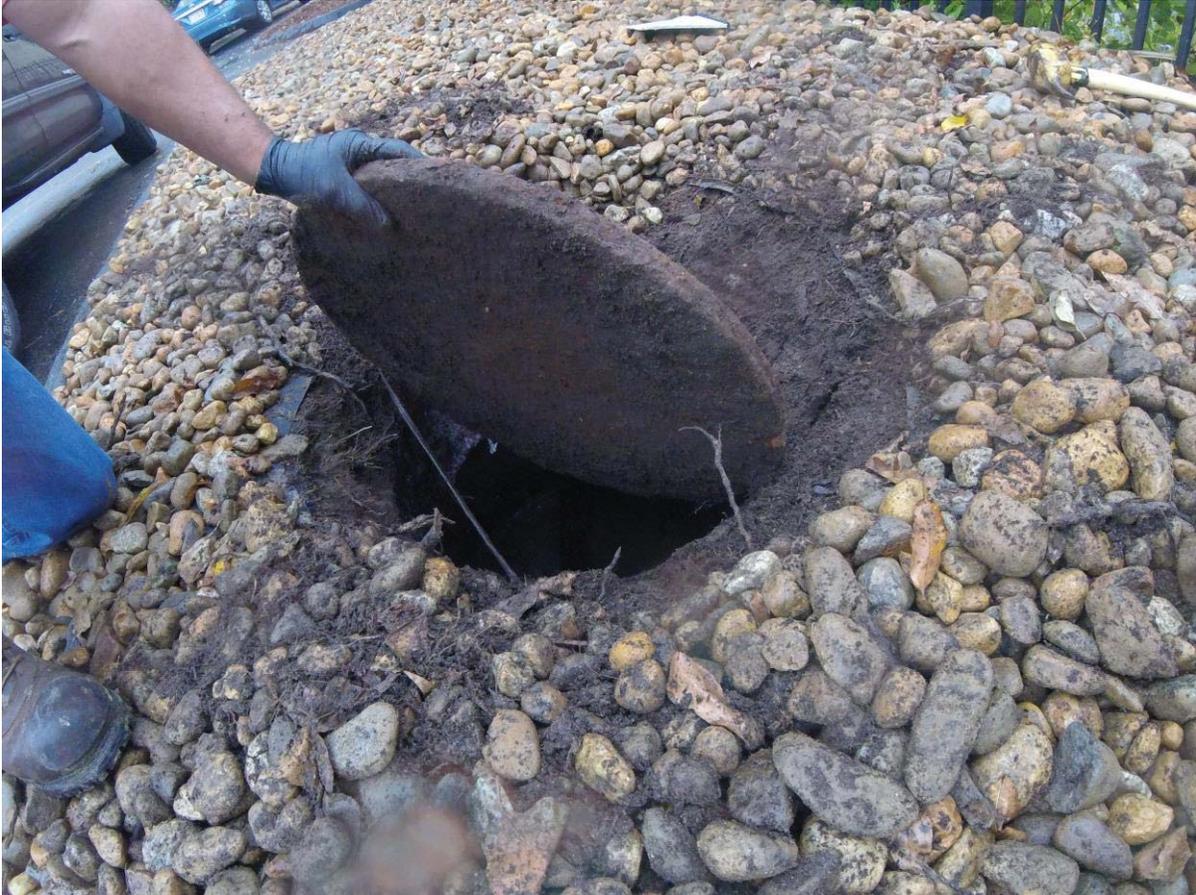
At SMH 20, there is a low voltage wire surrounding the MH which creates an unsafe environment. The origin of this wire is unknown, however to speculate this could be some type of lighting or power for a surrounding neighbor. This does not appear to be a major wire, and therefore should be relatively easy to reroute. The manhole is also in a rock garden, and rocks can potentially fall into the manhole when the cover is removed. To remedy this issue, an additional row of bricks should be added underneath the frame. This will raise the cover of the manhole above the grade line of stone, eliminating the risk of rock from falling in.

Photo 4-14. Wire and rock garden creating access issue to SMH 20.

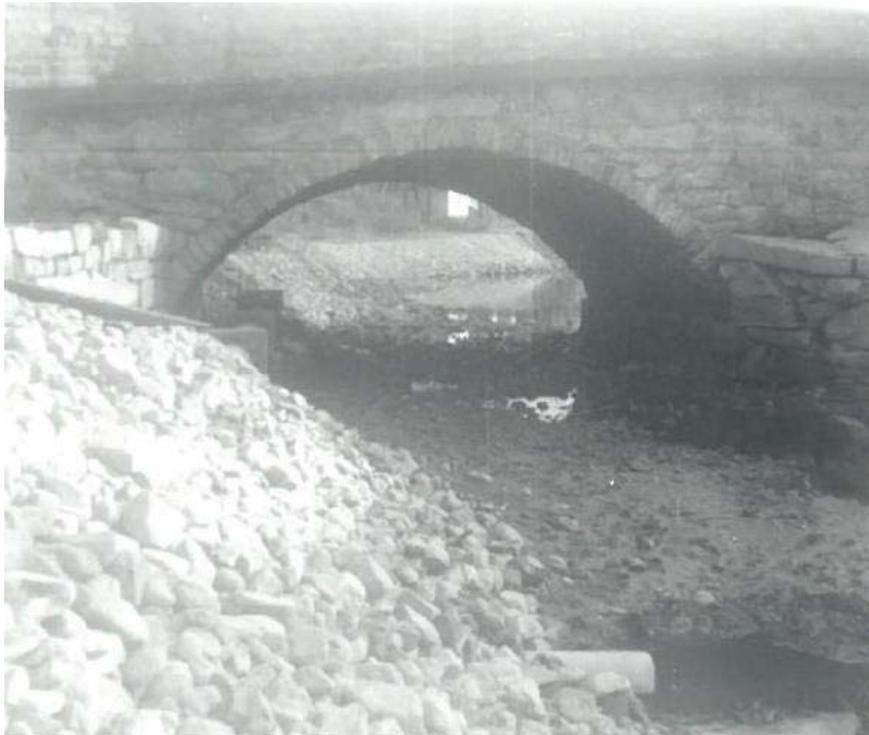
The bank along the north side of the Ipswich River, to the east of the South Main Street bridge, is eroding and the original stone fill pipe covering is mostly missing. The original 1958 interceptor was designed as an 18" cast iron pipe supported by 3' diameter concrete caissons spaced 18' on center (matching pipe section lengths). This original structure was protected circa 1965 with 1:1 rock fill revetment slope upriver and downriver of the Choate Bridge. Some of the trees along the top of the bank have grown around the interceptor and appear to be falling into the river with the potential to damage the pipe. Please see below photo of existing rip rap located over the Interceptor to protect the pipe facing West under Choate Bridge.

Photo 4-15. Existing Rip Rap Protecting Interceptor facing West

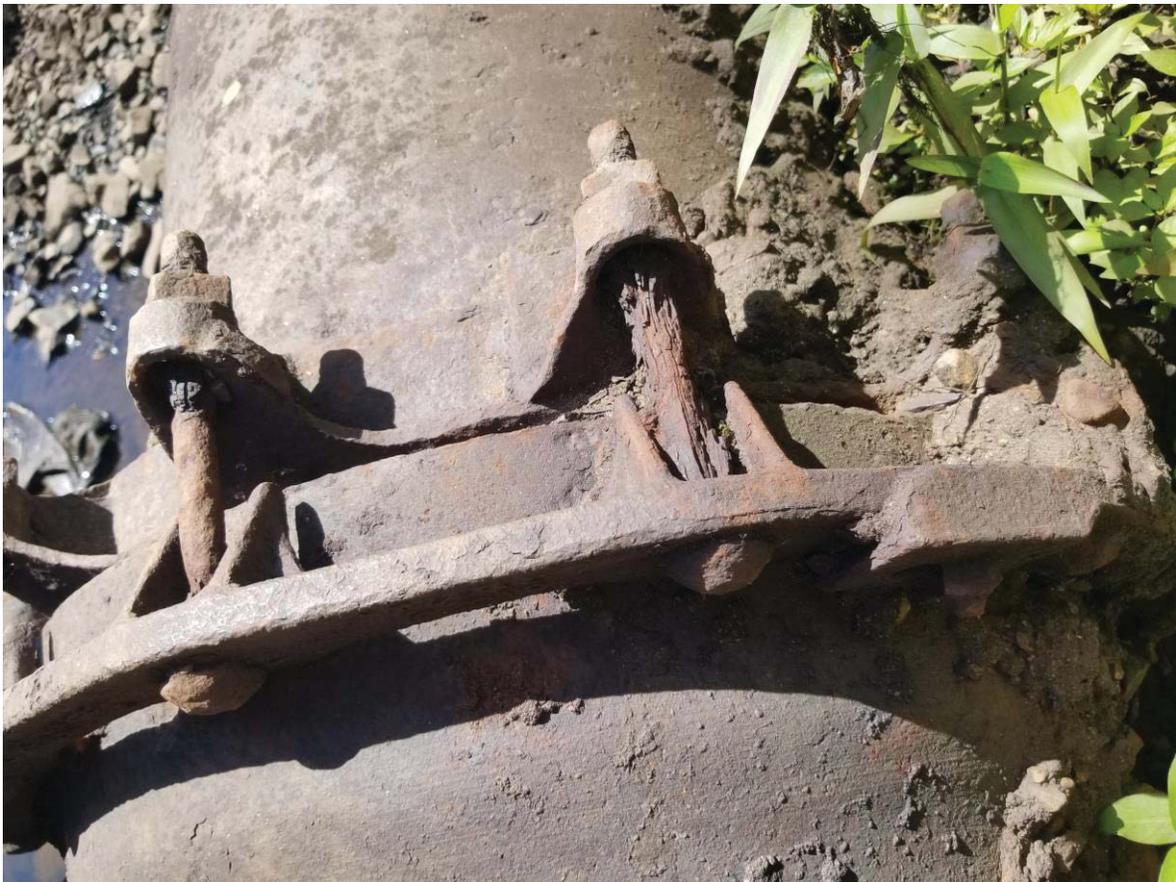
Over time, the threaded rod of the existing bell joint leak clamps has corroded and lost its structural purpose. Some may appear to be in good condition, but most are very brittle and barely still intact. Please see pictures below of discussed corrosion.

Photo 5-1. Existing Bell Joint Leak Clamp on Interceptor.

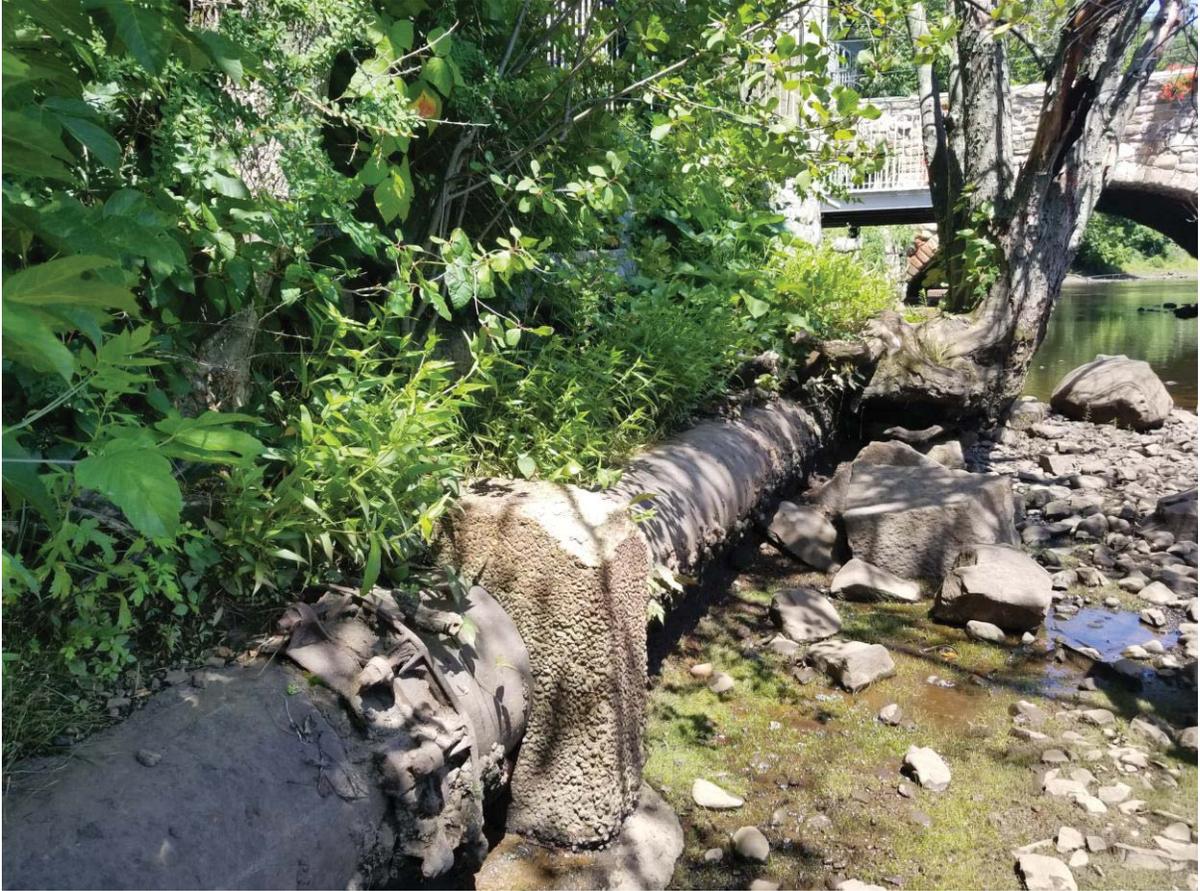
Photo 5-2. Existing Bell Joint Leak Clamp and concrete caisson.

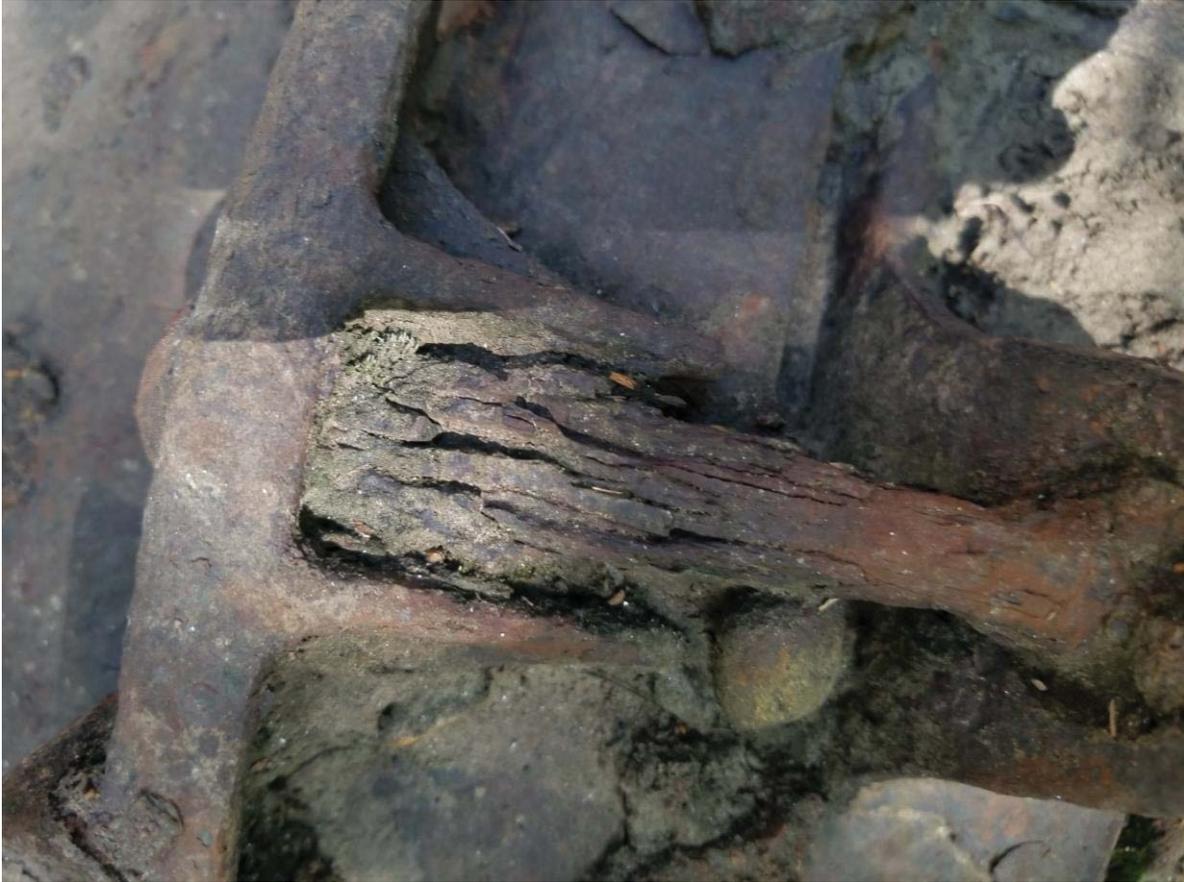
Photo 5-3. Corroded bolt of existing Bell Joint Leak Clamp.

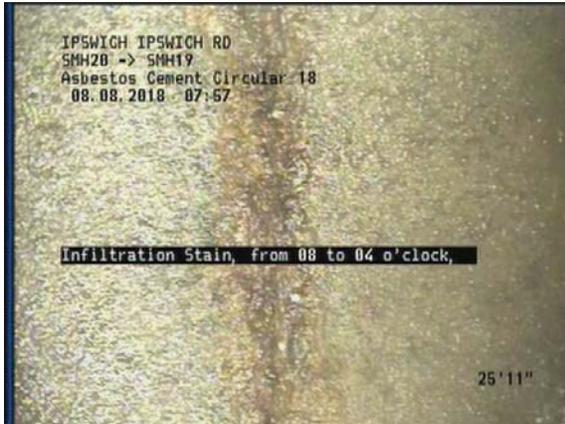
Photo: SMH20-SMH19-08202018-IS-25.9198-160828.jpg
25.92FT, Infiltration Stain, from 08 to 04 o'clock, within 8 inches of joint: YES

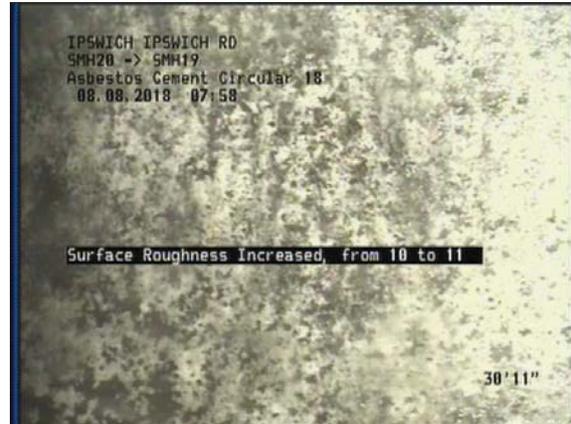
Photo: SMH20-SMH19-08202018-SRI-30.9237-160838.jpg
30.92FT, Surface Roughness Increased, from 10 to 11 o'clock, within 8 inches of joint: YES, Start

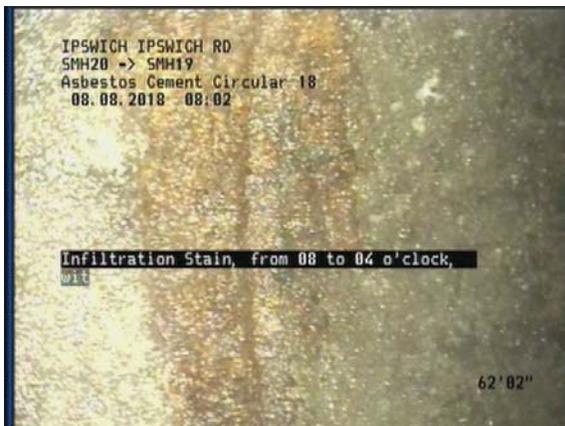
Photo: SMH20-SMH19-08202018-IS-62.1476-161049.jpg
62.15FT, Infiltration Stain, from 08 to 04 o'clock, within 8 inches of joint: YES

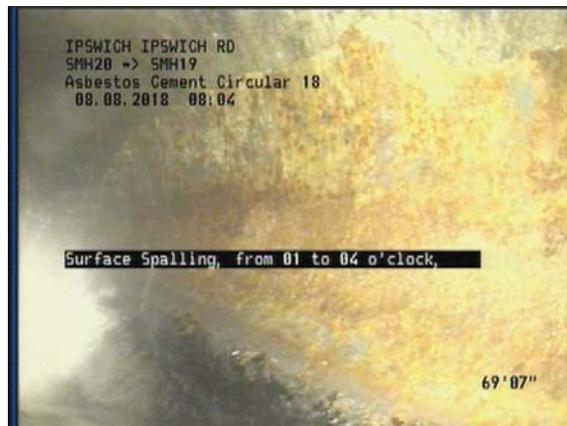
Photo: SMH20-SMH19-08202018-SSS-69.5533-161135.jpg
69.55FT, Surface Spalling, from 01 to 04 o'clock, within 8 inches of joint: YES

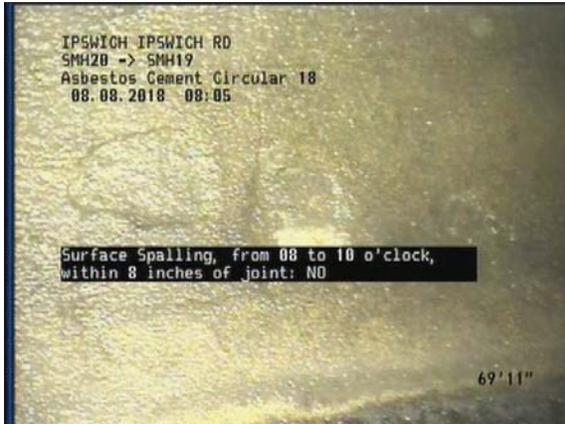
Photo: SMH20-SMH19-08202018-SSS-69.9536-161207.jpg
69.95FT, Surface Spalling, from 08 to 10 o'clock, within 8 inches of joint: NO

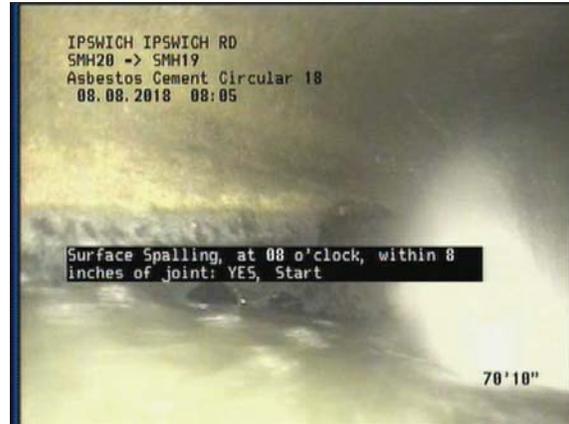
Photo: SMH20-SMH19-08202018-SSS-70.8543-161256.jpg
70.85FT, Surface Spalling, at 08 o'clock, within 8 inches of joint: YES, Start

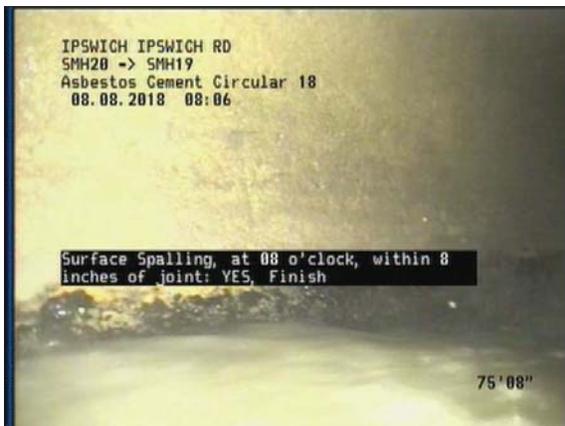
Photo: SMH20-SMH19-08202018-SSS-75.6579-161428.jpg
75.66FT, Surface Spalling, at 08 o'clock, within 8 inches of joint: YES, Finish

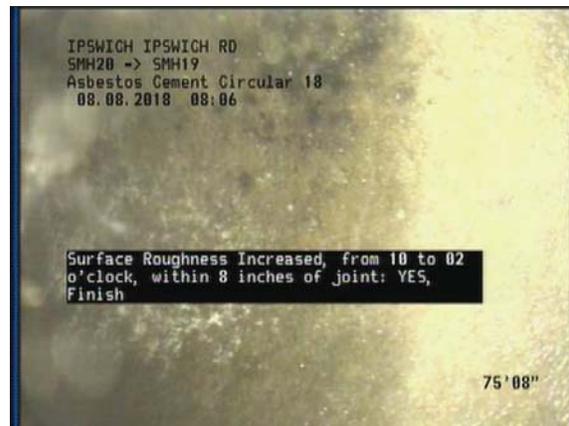
Photo: SMH20-SMH19-08202018-SRI-75.6579-161327.jpg
75.66FT, Surface Roughness Increased, from 10 to 02 o'clock, within 8 inches of joint: YES, Finish

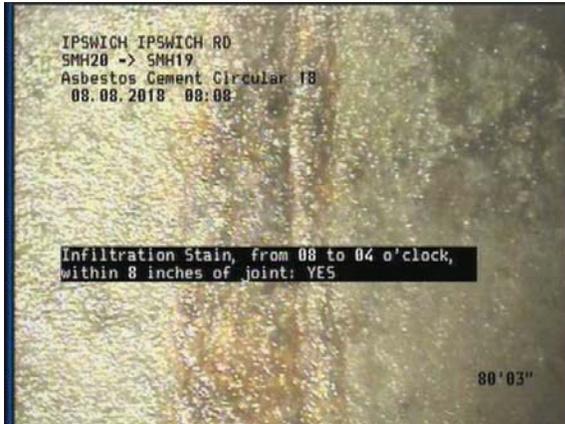
Photo: SMH20-SMH19-08202018-IS-80.2615-161523.jpg
80.26FT, Infiltration Stain, from 08 to 04 o'clock, within 8 inches of joint: YES

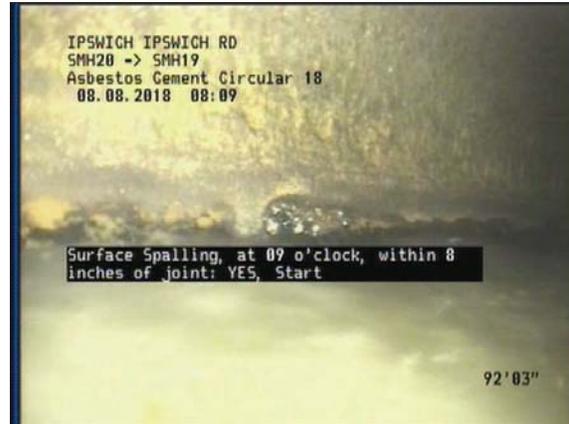
Photo: SMH20-SMH19-08202018-SSS-92.2707-161553.jpg
92.27FT, Surface Spalling, at 09 o'clock, within 8 inches of joint: YES, Start

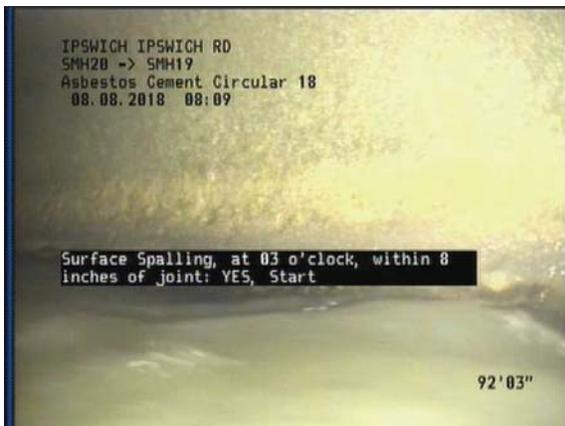
Photo: SMH20-SMH19-08202018-SSS-92.2707-161611.jpg
92.27FT, Surface Spalling, at 03 o'clock, within 8 inches of joint: YES, Start

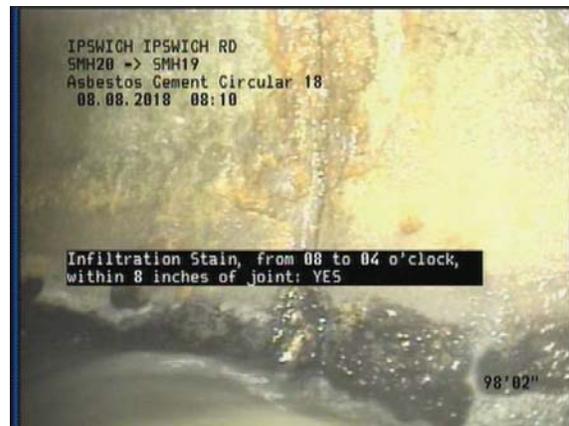
Photo: SMH20-SMH19-08202018-IS-98.1752-161803.jpg
98.18FT, Infiltration Stain, from 08 to 04 o'clock, within 8 inches of joint: YES

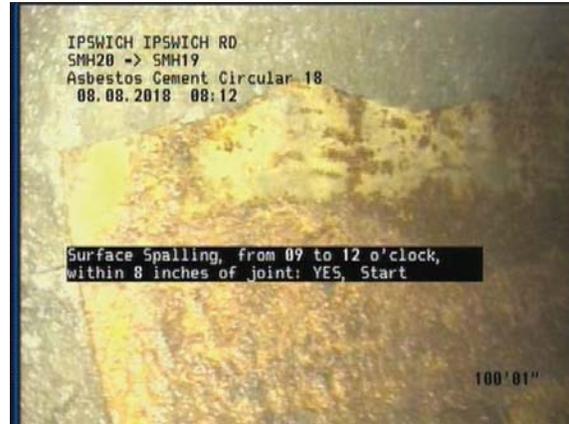
Photo: SMH20-SMH19-08202018-SSS-100.0766-161935.jpg
100.08FT, Surface Spalling, from 09 to 12 o'clock, within 8 inches of joint: YES, Start

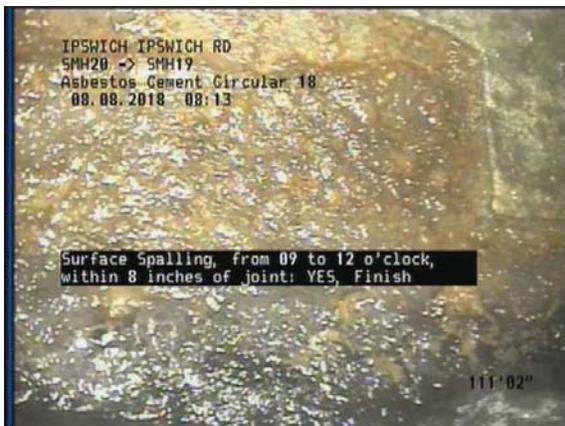
Photo: SMH20-SMH19-08202018-SSS-111.1851-162004.jpg
111.19FT, Surface Spalling, from 09 to 12 o'clock, within 8 inches of joint: YES, Finish

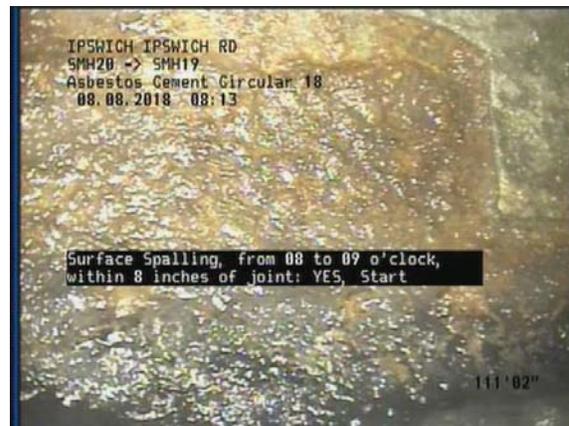
Photo: SMH20-SMH19-08202018-SSS-111.1851-162154.jpg
111.19FT, Surface Spalling, from 08 to 09 o'clock, within 8 inches of joint: YES, Start

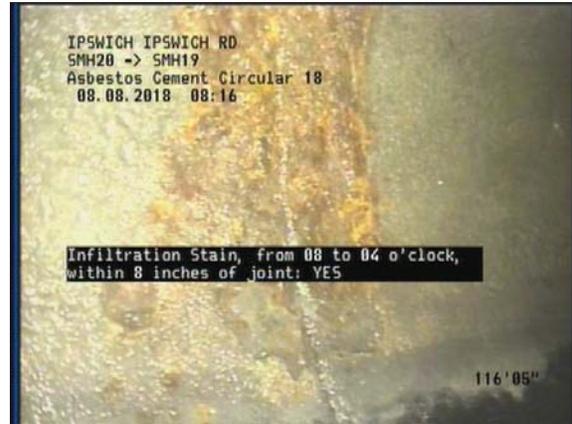
Photo: SMH20-SMH19-08202018-IS-116.3891-163428.jpg
116.39FT, Infiltration Stain, from 08 to 04 o'clock, within 8 inches of joint: YES

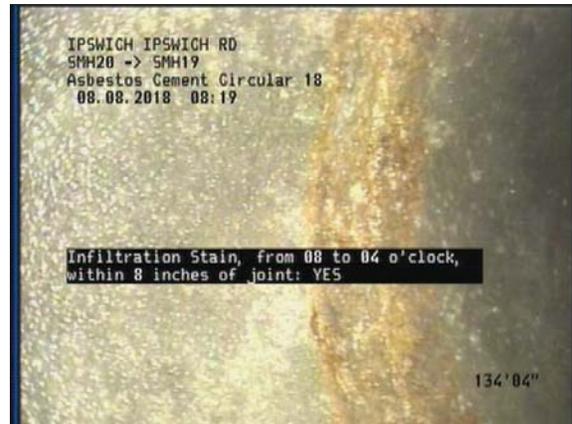
Photo: SMH20-SMH19-08202018-IS-134.3028-163451.jpg
134.3FT, Infiltration Stain, from 08 to 04 o'clock, within 8 inches of joint: YES

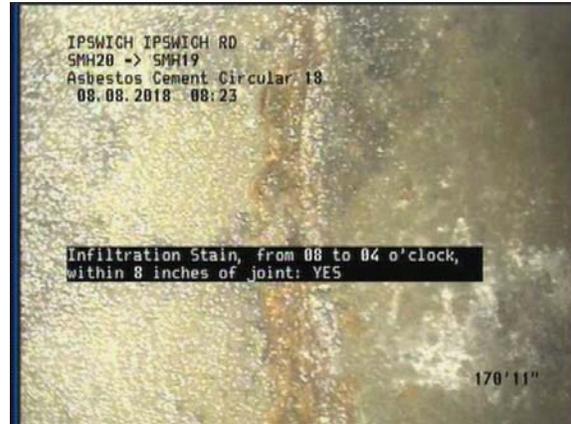
Photo: SMH20-SMH19-08202018-IS-170.9309-163611.jpg
170.93FT, Infiltration Stain, from 08 to 04 o'clock, within 8 inches of joint: YES

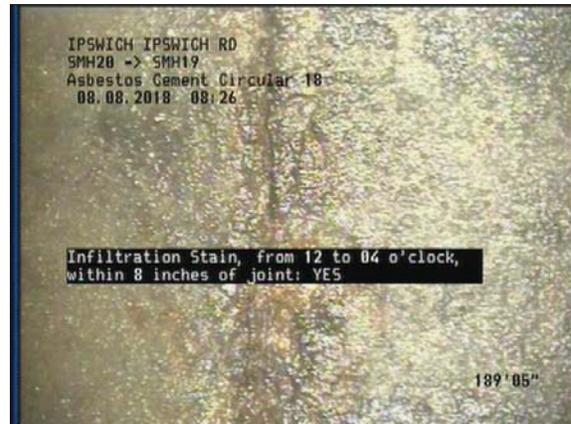
Photo: SMH20-SMH19-08202018-IS-189.4451-163713.jpg
189.45FT, Infiltration Stain, from 12 to 04 o'clock, within 8 inches of joint: YES

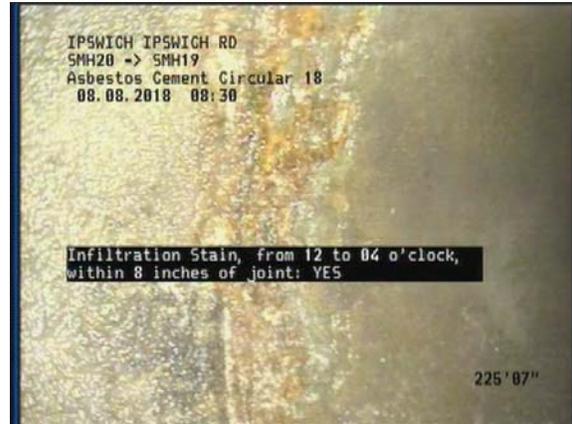
Photo: SMH20-SMH19-08202018-IS-225.5727-163758.jpg
225.57FT, Infiltration Stain, from 12 to 04 o'clock, within 8 inches of joint: YES

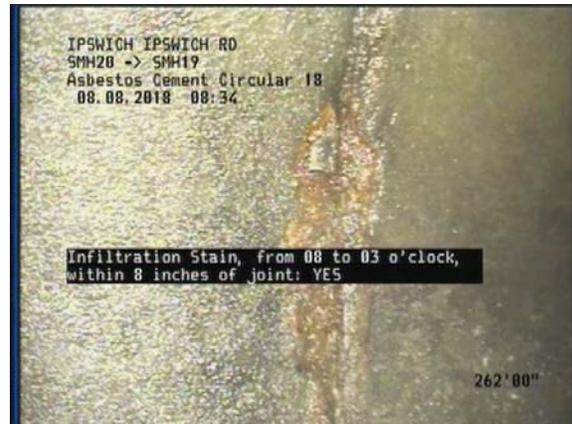
Photo: SMH20-SMH19-08202018-IS-262.0006-163859.jpg
262FT, Infiltration Stain, from 08 to 03 o'clock, within 8 inches of joint: YES

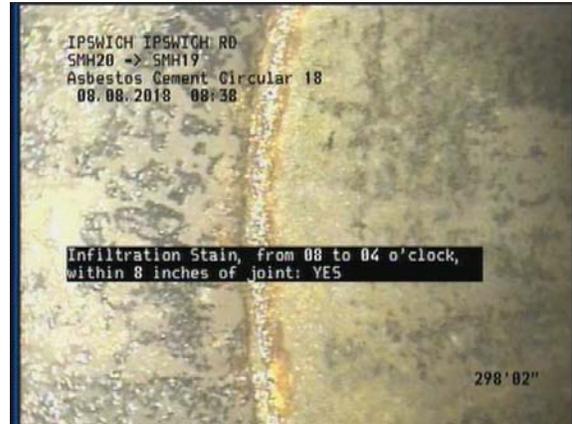
Photo: SMH20-SMH19-08202018-IS-298.1283-164037.jpg
298.13FT, Infiltration Stain, from 08 to 04 o'clock, within 8 inches of joint: YES

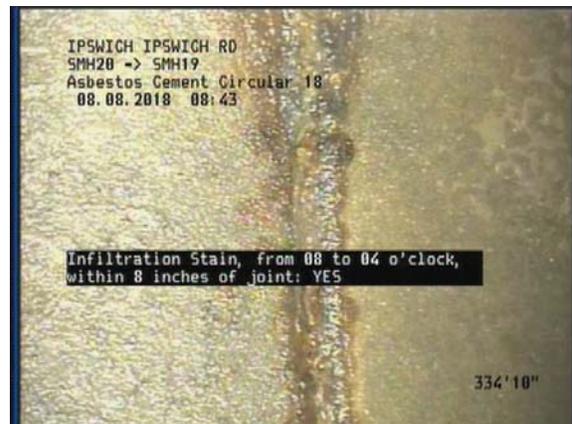
Photo: SMH20-SMH19-08202018-IS-334.8564-164153.jpg
334.86FT, Infiltration Stain, from 08 to 04 o'clock, within 8 inches of joint: YES

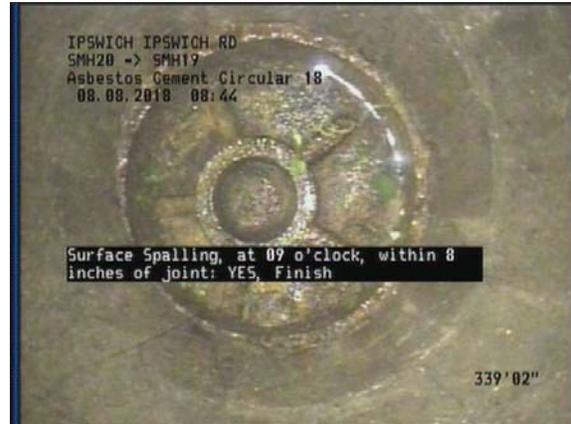
Photo: SMH20-SMH19-08202018-SSS-339.1597-164236.jpg
339.16FT, Surface Spalling, at 09 o'clock, within 8 inches of joint: YES, Finish

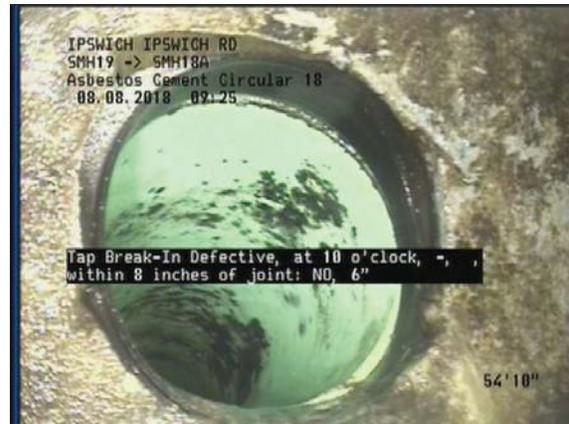
Photo: SMH19-SMH18-08202018-TBD-54.842-164440.jpg
54.84FT, Tap Break-In Defective, at 10 o'clock, -, within 8 inches of joint: NO, 6"
