TOWN OF IPSWICH

April 17, 2019

Re: Ipswich Sewer Interceptor Rehabilitation and Siphon Replacement Project
EEA File #16003

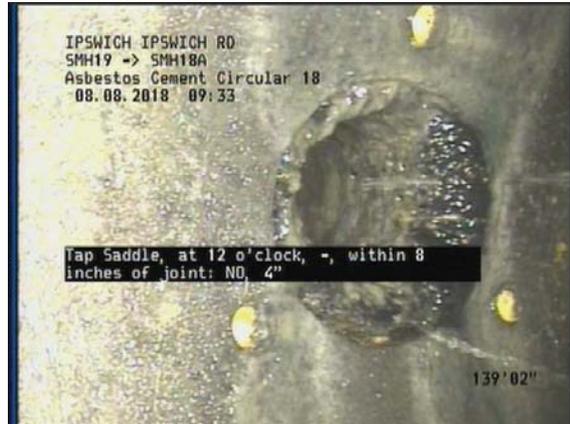
Photo: SMH19-SMH18-08202018-TS-139.2066-164533.jpg
139.21FT, Tap Saddle, at 12 o'clock, -, within 8 inches of joint: NO, 4"
