FACILITY CONDITION ASSESSMENT

Town of Ipswich

FACILITY CONDITION ASSESSMENT
OF
TOWN OF IPSWICH / MUNICIPAL BUILDINGS
MULTIPLE ADDRESSES
IPSWICH, MASSACHUSETTS 01938

June 30, 2019

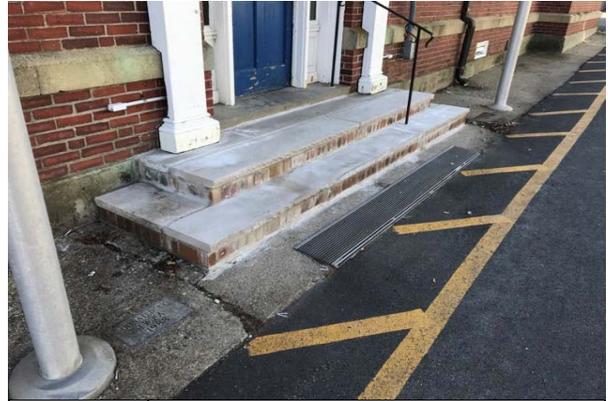
#7	EXTERIOR STAIRS, CONCRETE, REPAIR
----	-----------------------------------
