Subject: Dow Brook Dam

Subject: Site Visit and Dam Condition
Dow Brook Reservoir Dam
Ipswich, Massachusetts

**Commonwealth of Massachusetts
Department of Conservation and Recreation
Office of Dam Safety Poor and Unsafe Condition Dam Follow-up Inspection Form**

Dam Name: Dow Brook Reservoir Dam
Dam Owner: Town of Ipswich
Nat. ID Number: MA00165
Hazard Potential: Significant
Location of Dam (town): Ipswich, Massachusetts
Coordinate location (lat,long): 42°41.9' N, 70°52.3' W
Date of Inspection: 25 April 2018
Weather: Light Rain, 50s

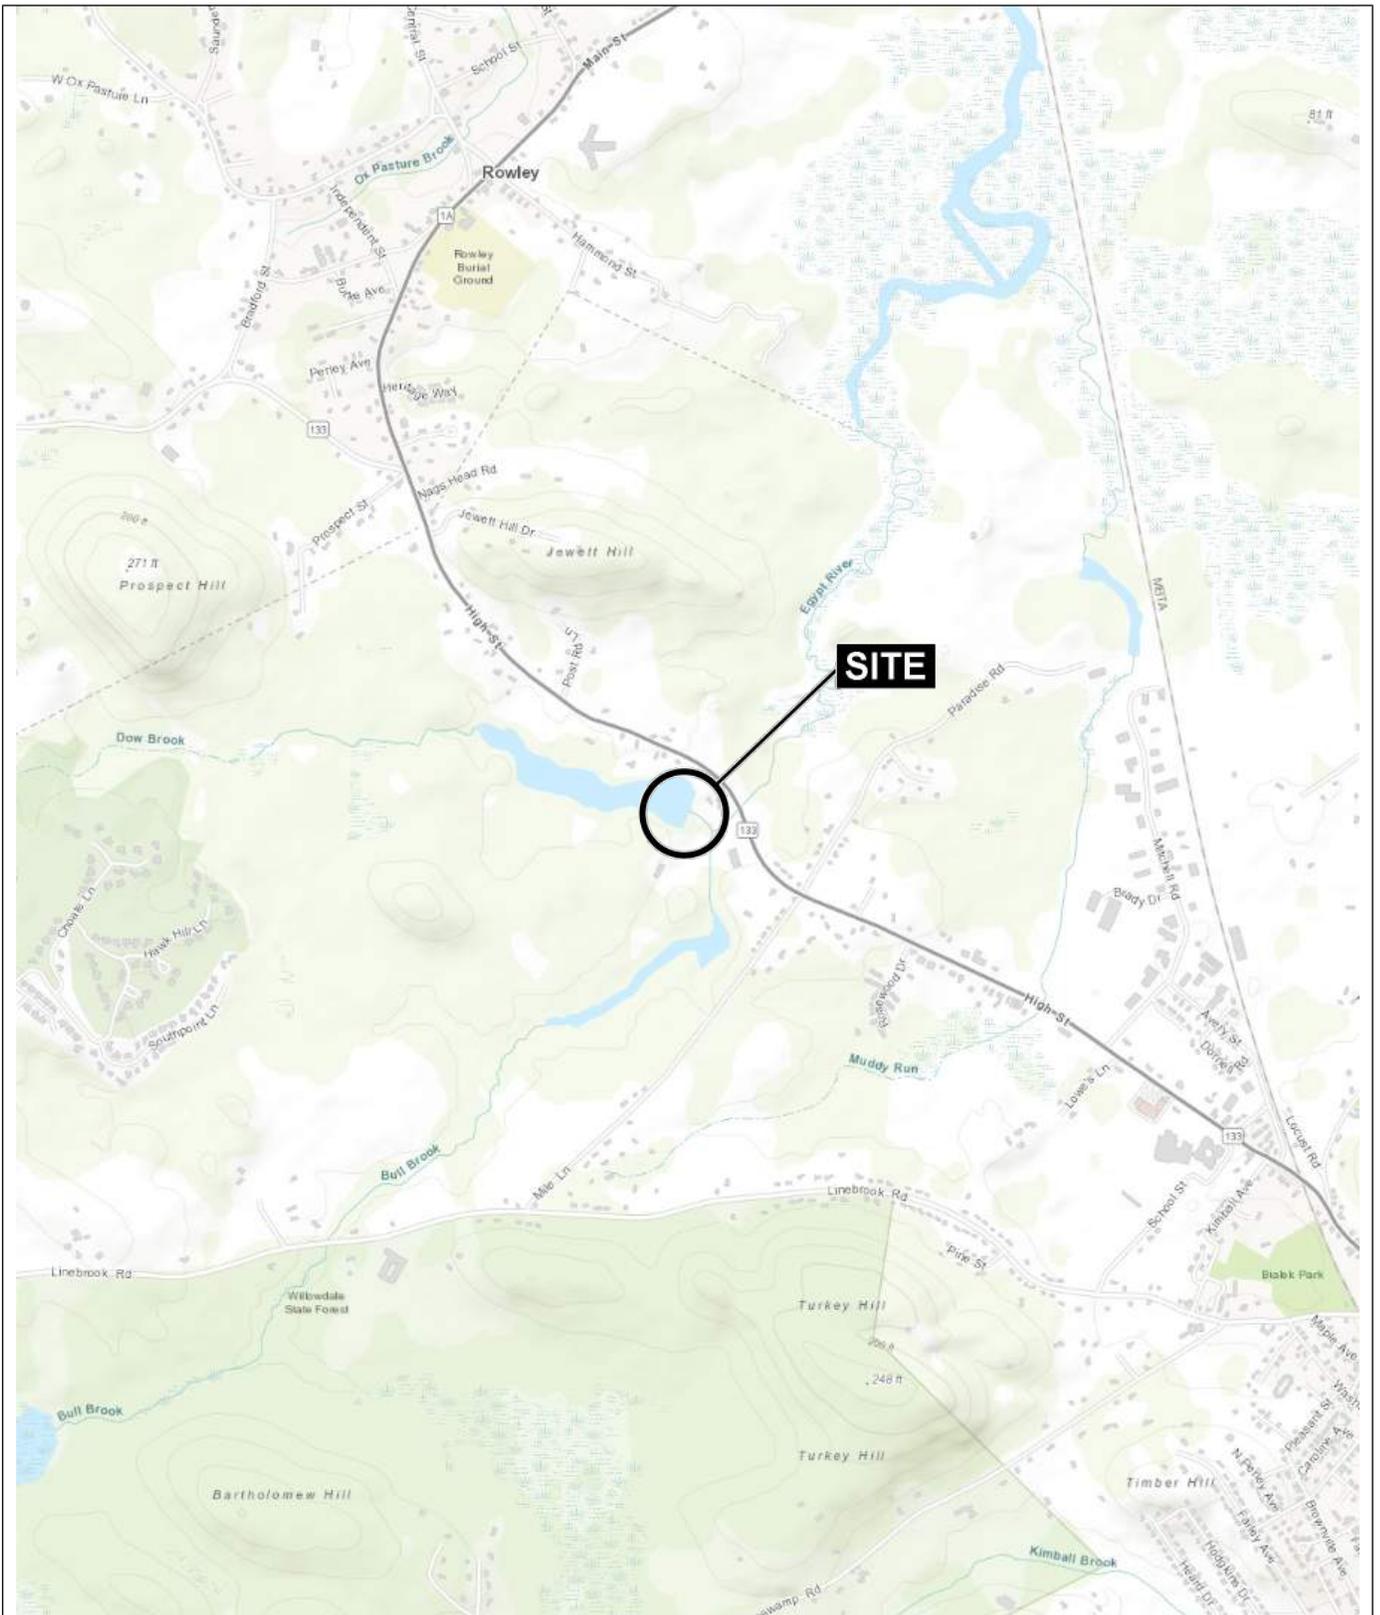
Seeps have developed on the downstream toe of the dam at the right side. The observed seep measured about 11 ft on the downstream slope, perpendicular to the dam axis, and 8 ft wide, along the dam axis. The seep was actively producing water on the site visit on 10 April 2018; however, the water was visually clear and causing minor damage to the grass vegetation on the slope. Two additional seeps were observed 8 to 12 ft north of the main seep on the downstream slope. The additional seeps were 3 to 4 ft in diameter and at about El. 26. The seeps were located about 73 to 90 ft north of the bridge.

SEEPS OBSERVED
ON 10 APRIL 2018

SEEP OBSERVED
ON 10 APRIL 2018

1. The reservoir level should be maintained at the Spillway Invert Elevation, or lower, until repairs are completed to bring the dam into compliance with Massachusetts Dam Safety Regulations.
2. The condition of the dam should be monitored daily for signs of additional seepage and deterioration.
3. The dam should be repaired to prevent seepage and bring the dam into compliance with dam safety regulations.
