TOWN OF IPSWICH

April 17, 2019

Re: Ipswich Sewer Interceptor Rehabilitation and Siphon Replacement Project
EEA File #16003

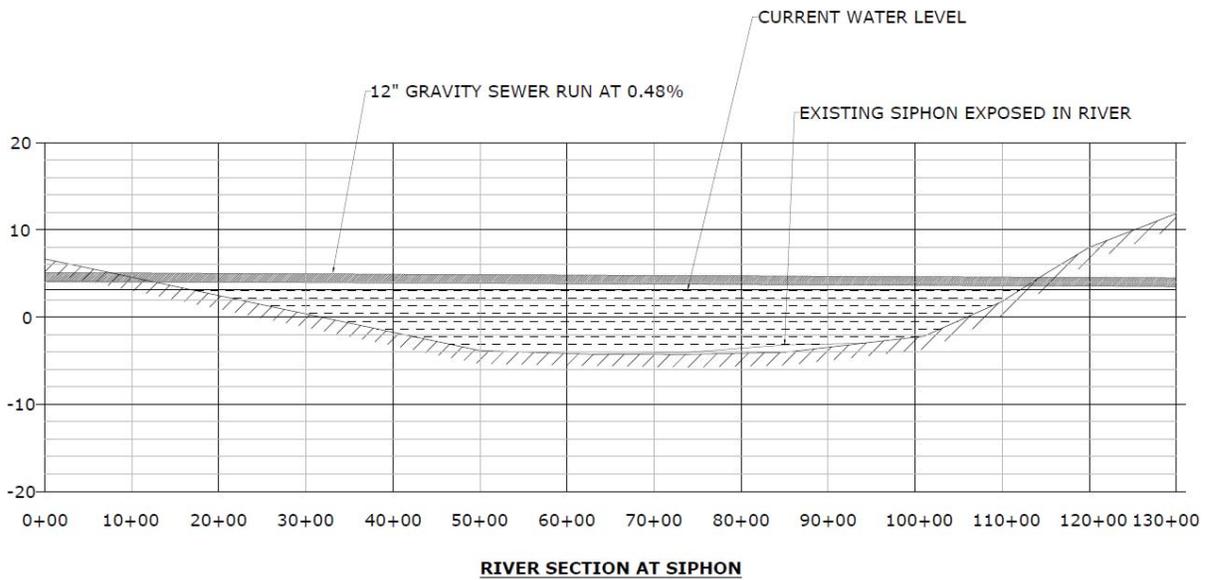
Figure 3-3. Profile View of Deep Gravity Sewer

This sewer would need to be installed above the river bed on piers in order to maintain the required continuous slope between the existing inverts on each side of the river. In fact, during some periods the sewer main would be above the river water level. Figure 3-3 displays the current water elevation versus the realistic 12" gravity sewer elevation.

This alternative was not considered further because the Ipswich River is a navigable water and obstructions such as this are not allowed within navigable waters.

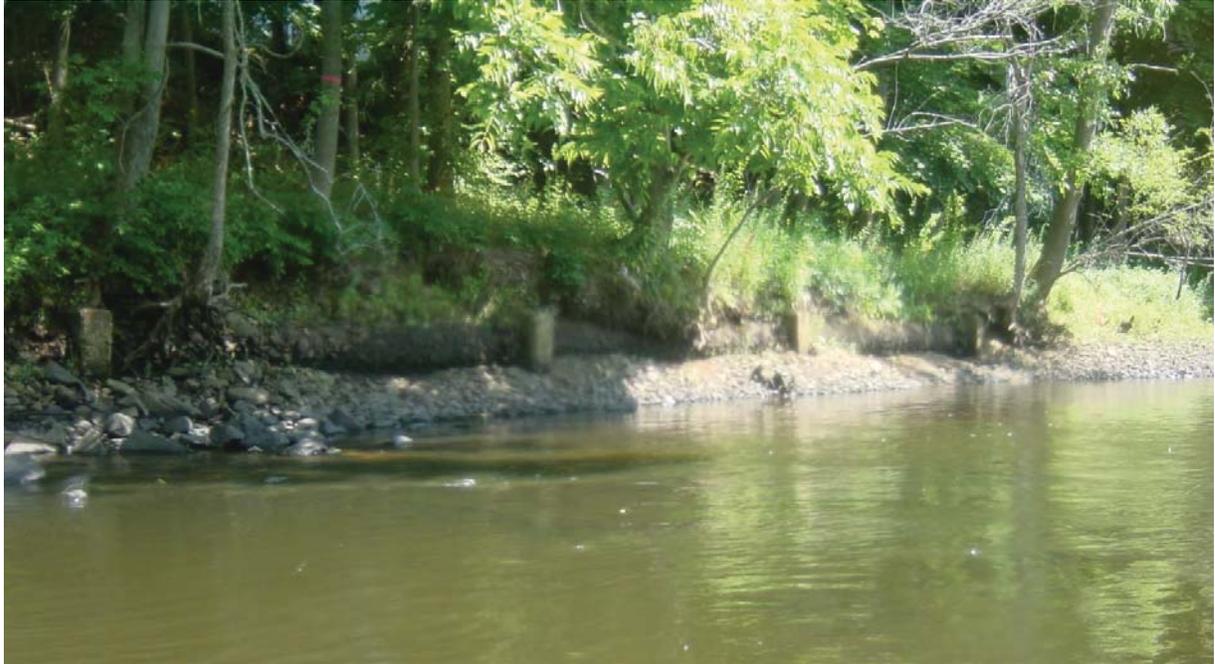
Photo 4-4. Bank erosion around the interceptor pipe. It appears this section of pipe was originally buried, but scour from the river has exposed the pipe over time.

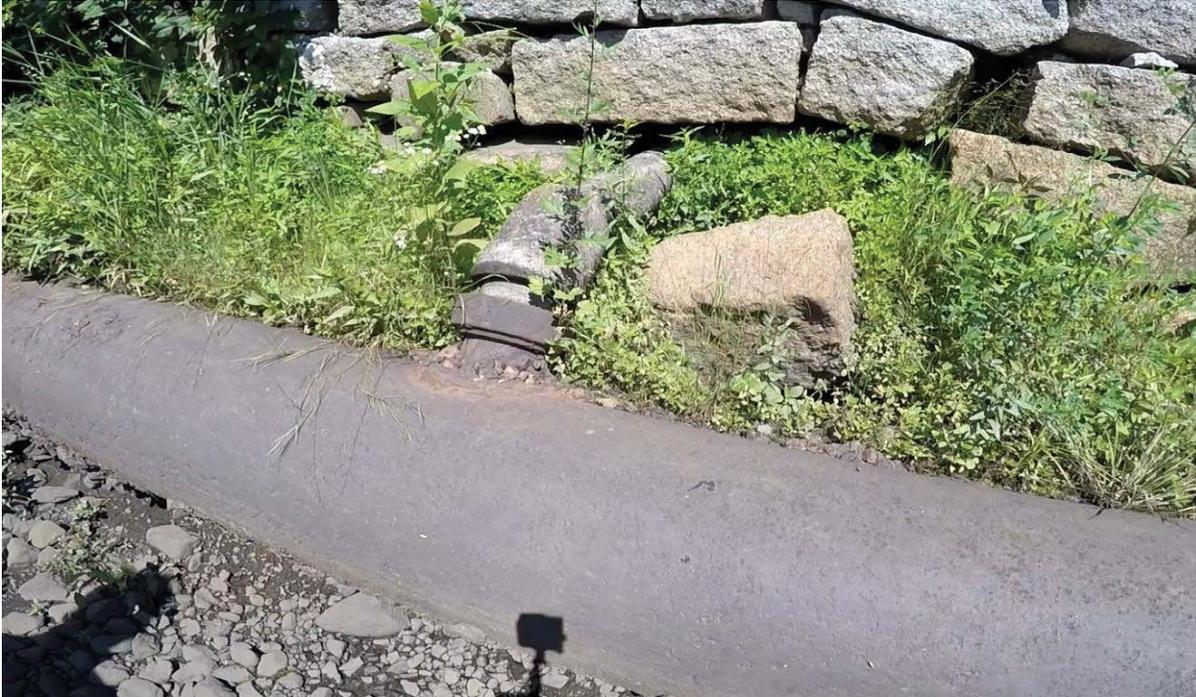
Photo 4-10. Connection into the interceptor pipe at the retaining wall to the west of the South Main Street bridge.

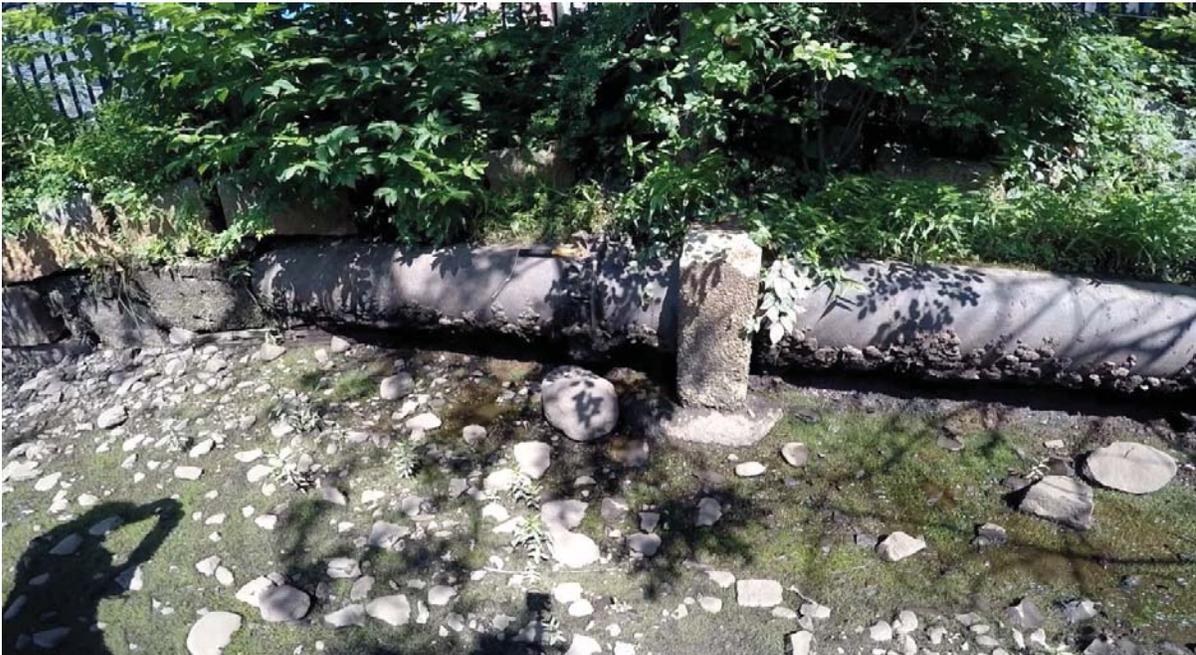
Photo 4-11. West end of the exposed section of the interceptor.

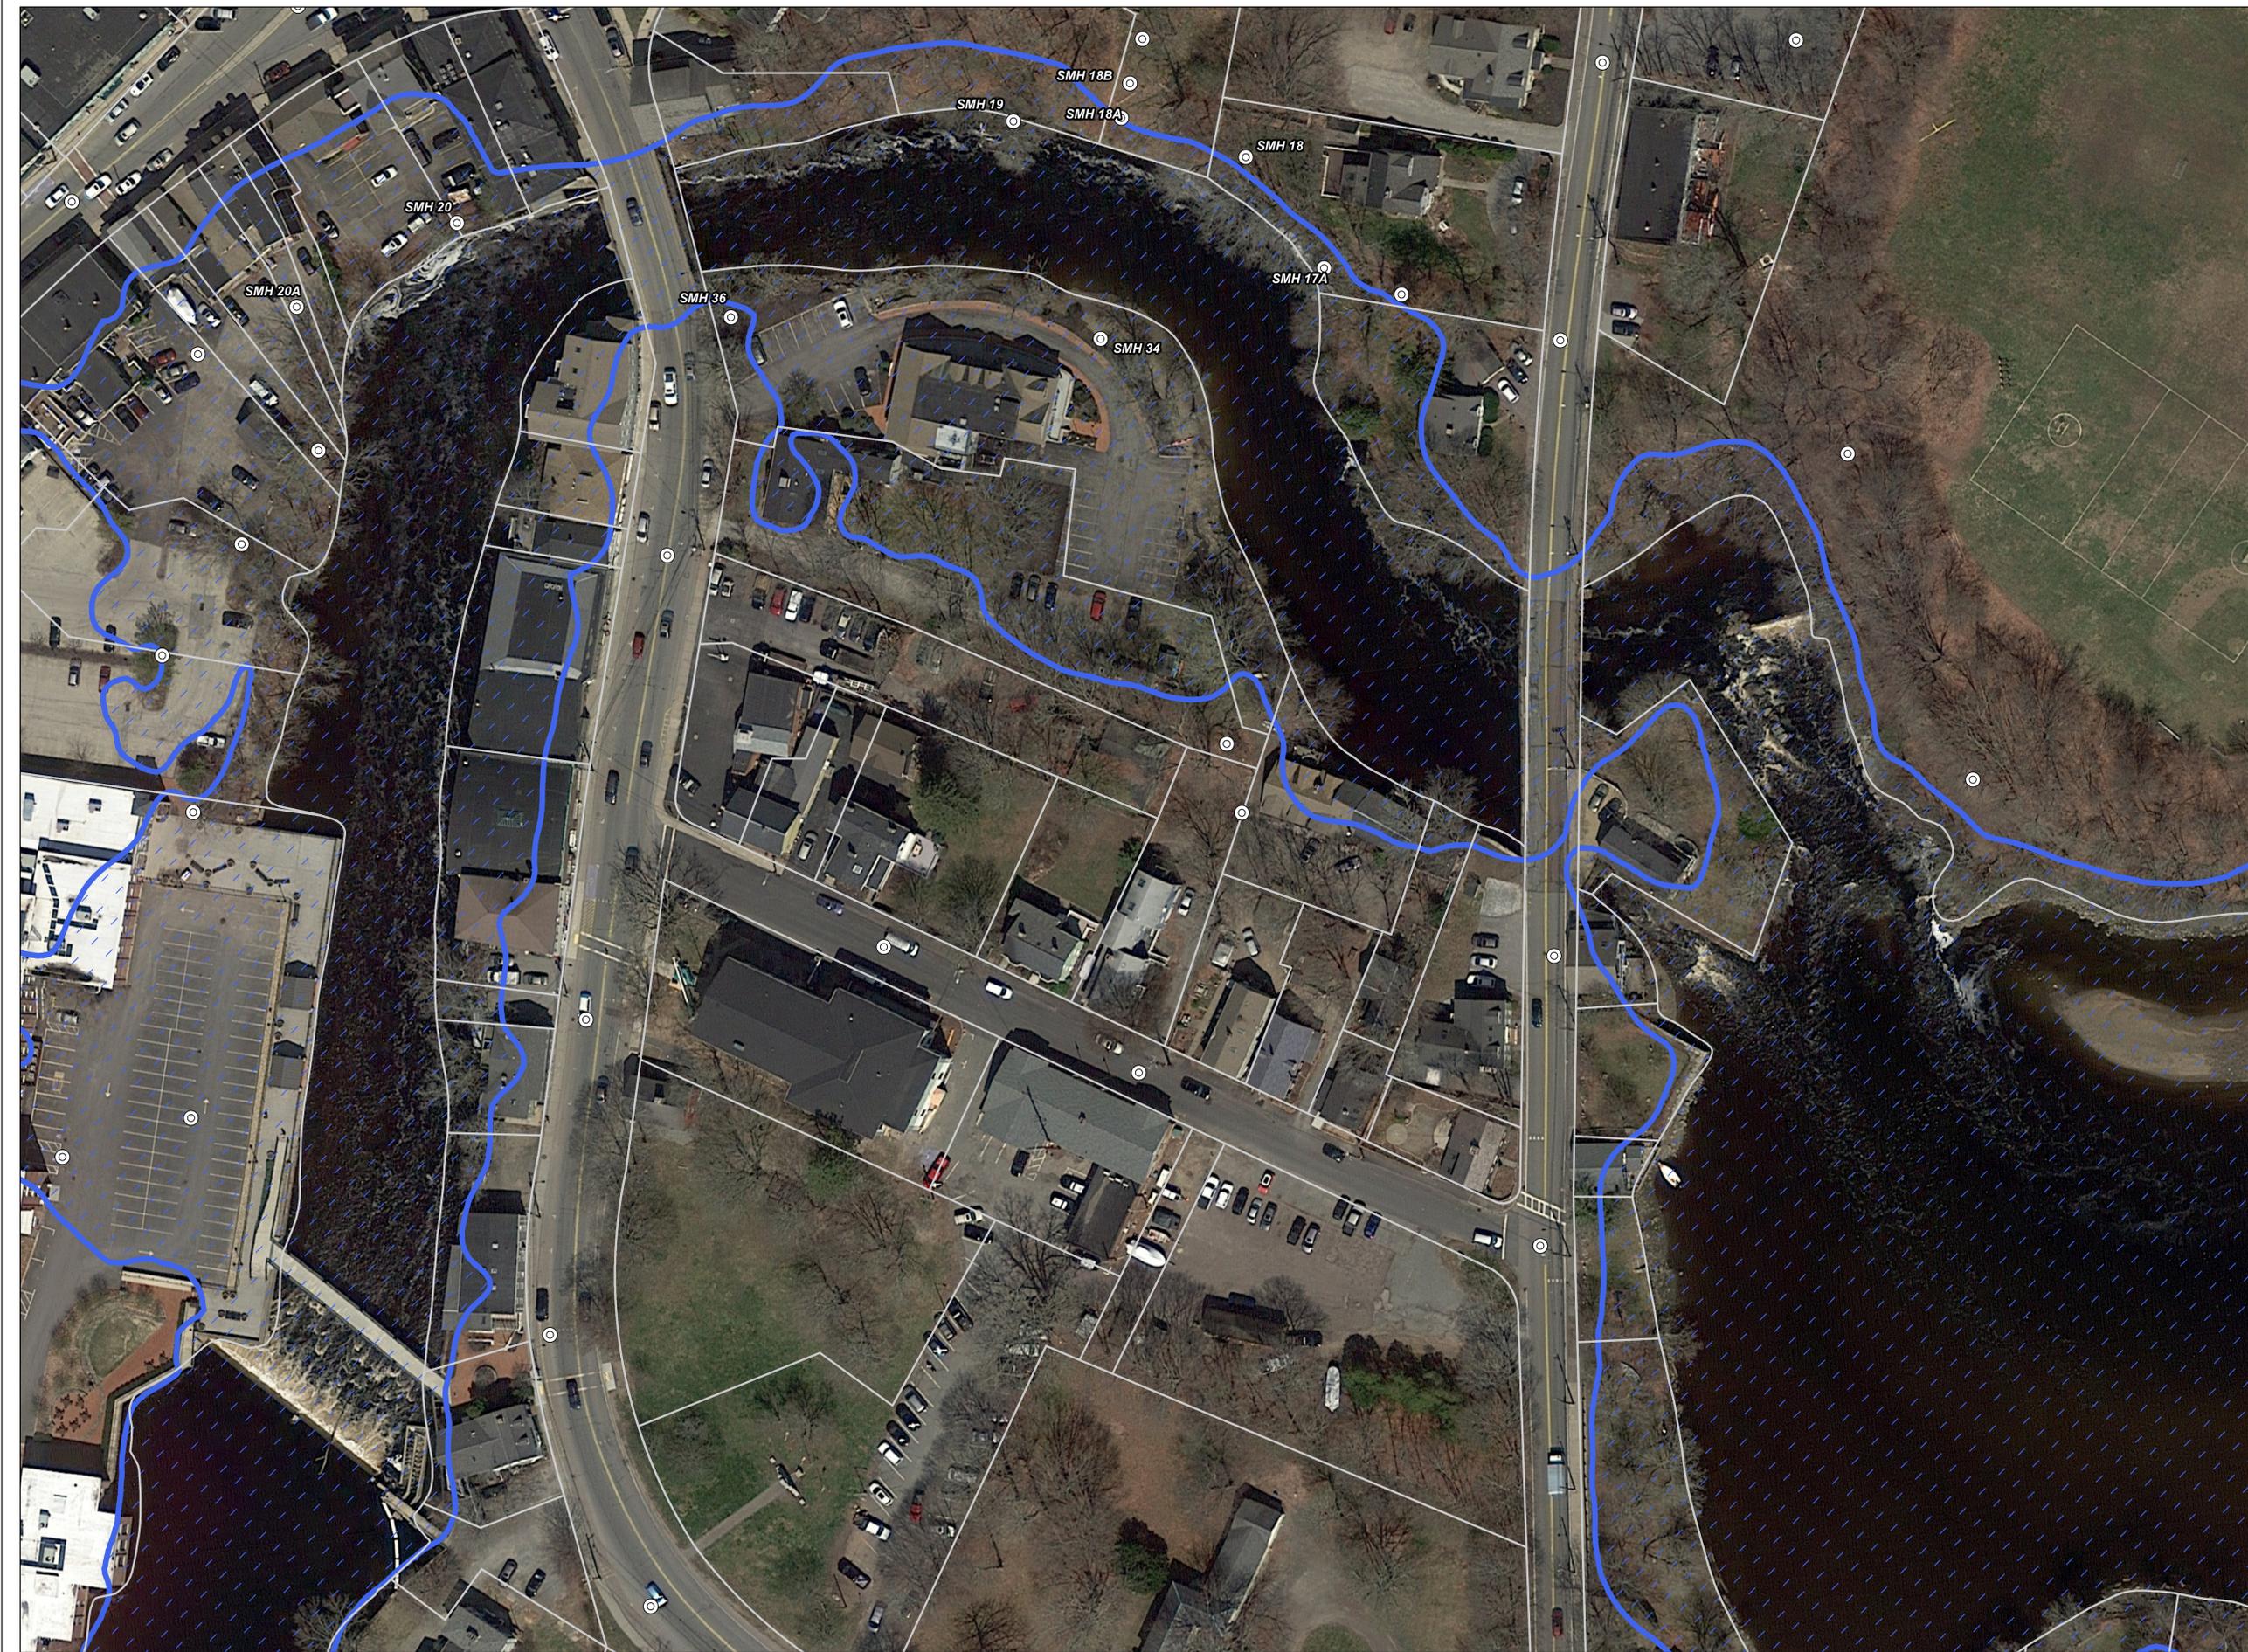
**FIGURE 4-1
100 YEAR
FLOOD ZONE**

Based on a review of Flood Insurance Study and FIRM Mapping of the area, the interceptor and the siphon inlet and outlet structures are subject to flooding during the 100-year flood. The 100-year flood elevation boundaries are shown on Figure 2-1.

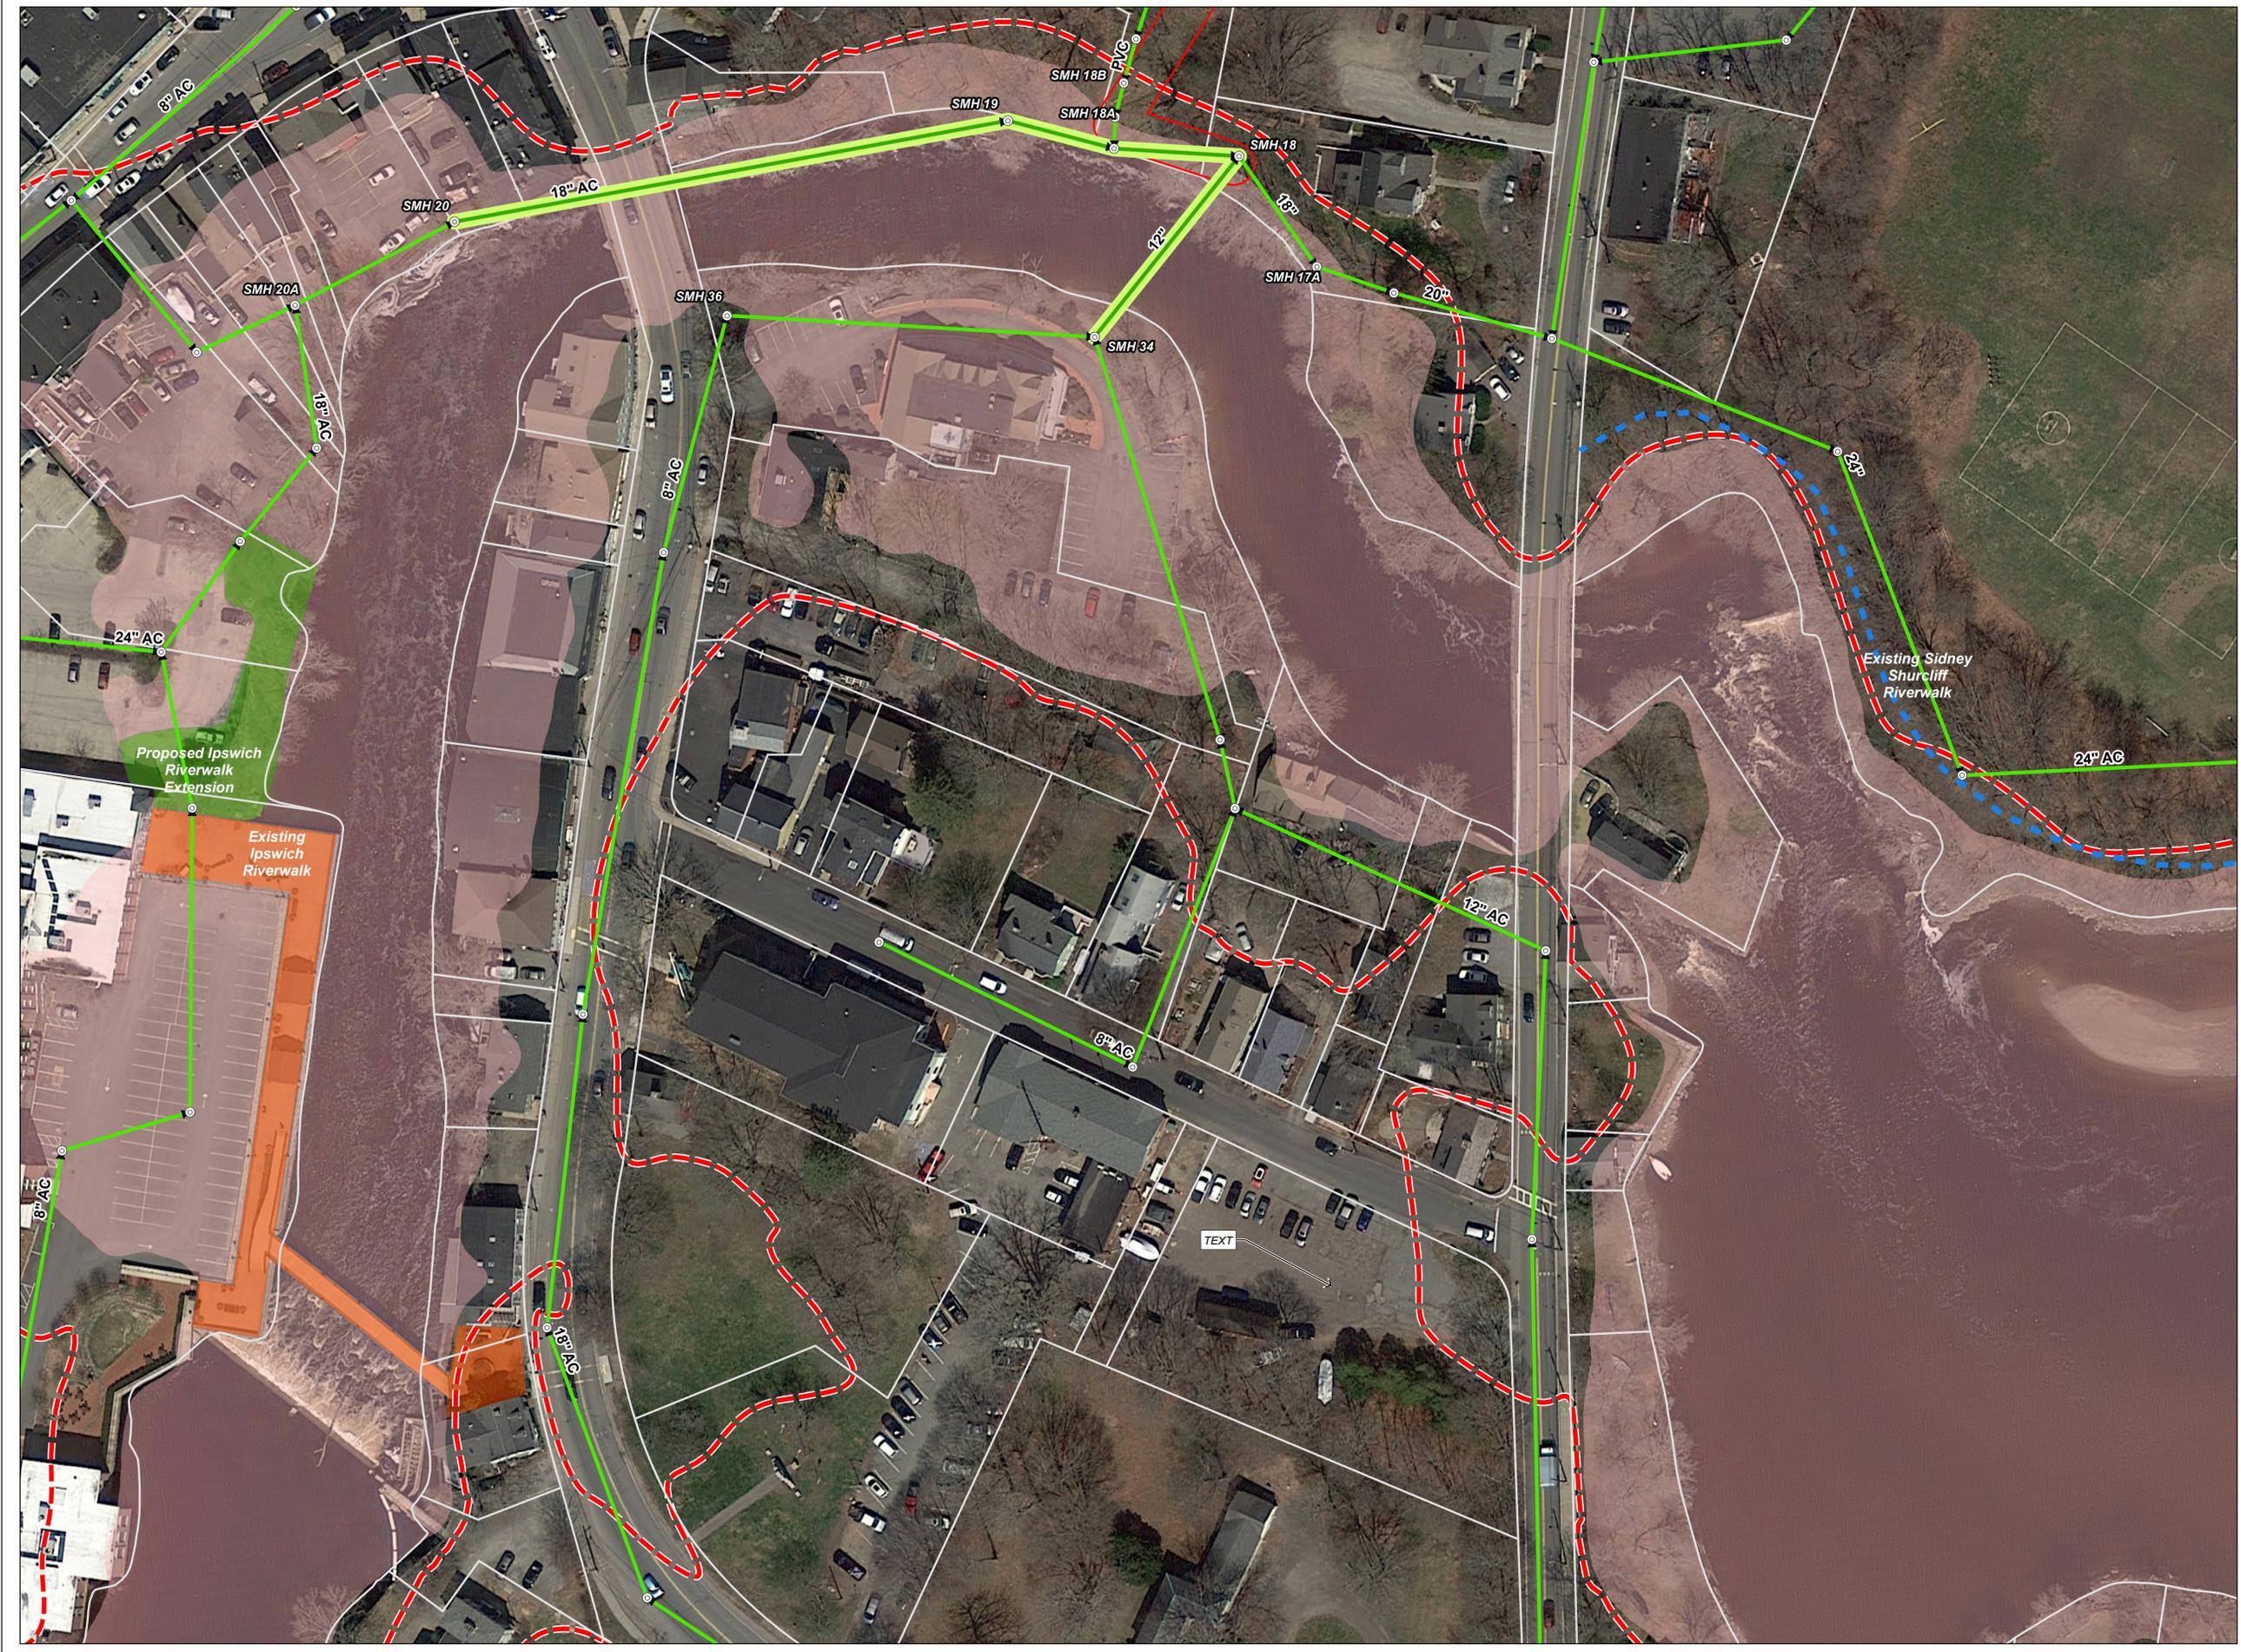
**FIGURE 4-2
MANHOLES WITHIN
100 YEAR FLOOD AND
TR 16 ZONE**

These flood zones conflict with the elevation of many structures in this area. Please see Table 2-7 and Figure 4-2 below displaying these results.

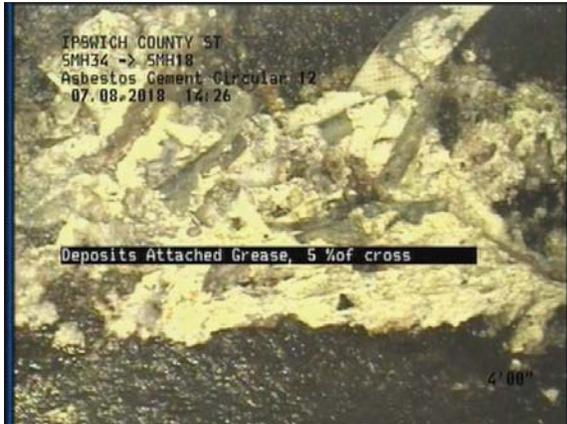
Photo: SMH34-SMH18-08202018-DAGS-4.0031-155652.jpg
4FT, Deposits Attached Grease, 5 %of cross sectional area, at 12 o'clock, , within 8 inches of joint: YES, Start

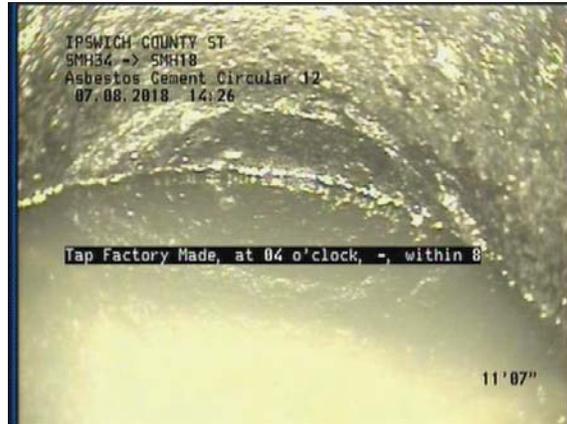
Photo: SMH34-SMH18-08202018-TF-11.6089-155726.jpg
11.61FT, Tap Factory Made, at 04 o'clock, -, within 8 inches of joint: NO, 6"

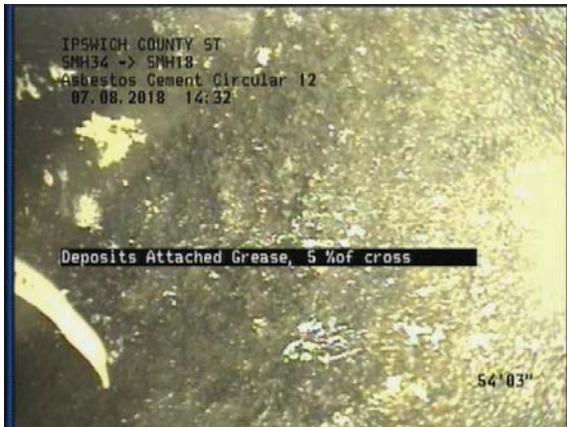
Photo: SMH34-SMH18-08202018-DAGS-54.2415-155752.jpg
54.24FT, Deposits Attached Grease, 5 %of cross sectional area, at 12 o'clock, , within 8 inches of joint: YES, Finish

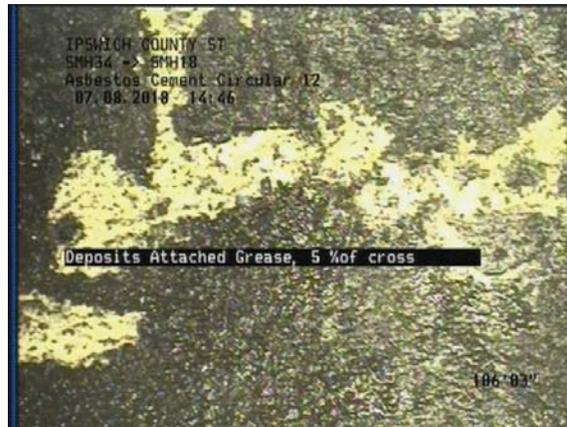
Photo: SMH34-SMH18-08202018-DAGS-106.2814-155812.jpg
106.28FT, Deposits Attached Grease, 5 %of cross sectional area, at 12 o'clock, , within 8 inches of joint: YES, Start

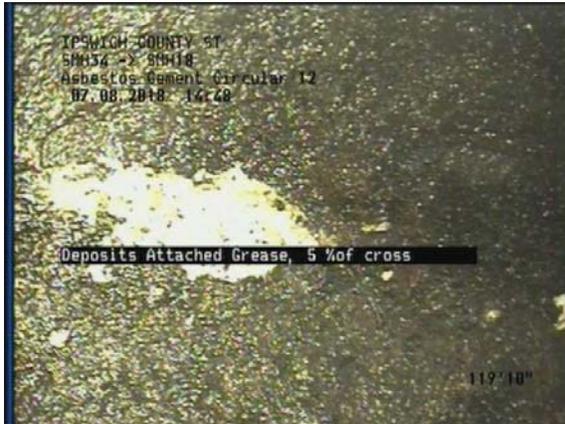
Photo: SMH34-SMH18-08202018-DAGS-119.7917-155847.jpg
119.79FT, Deposits Attached Grease, 5 %of cross sectional area, at 12 o'clock, , within 8 inches of joint: YES, Finish

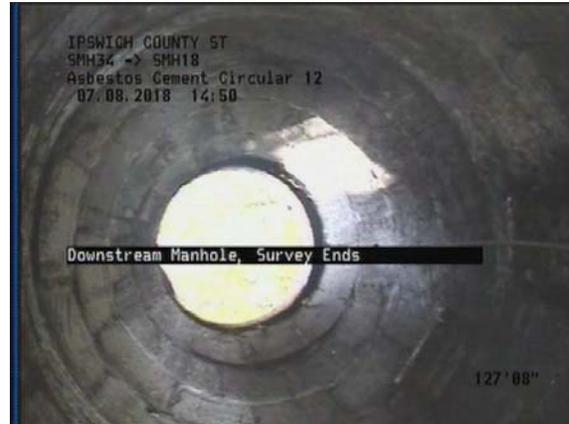
Photo: SMH34-SMH18-08202018-AMH-127.6978-155859.jpg
127.7FT, Downstream Manhole, Survey Ends

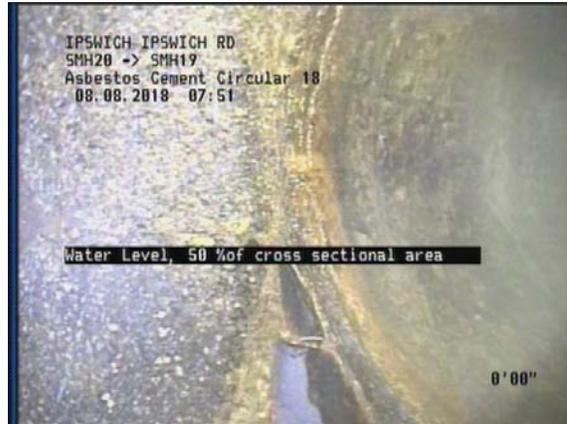
Photo: SMH20-SMH19-08202018-MWL-0-160629.jpg
0FT, Water Level, 50 %of cross sectional area

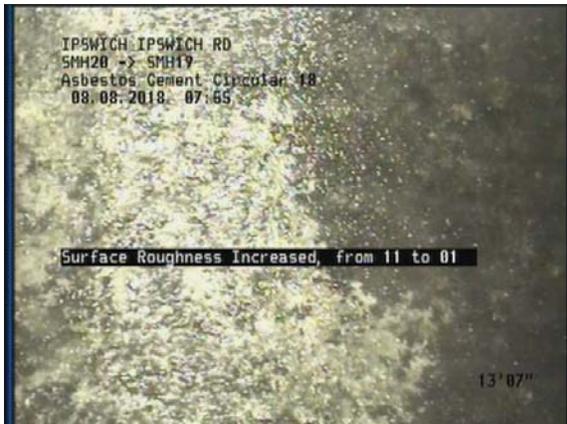
Photo: SMH20-SMH19-08202018-SRI-13.6104-160715.jpg
13.61FT, Surface Roughness Increased, from 11 to 01
o'clock, within 8 inches of joint: YES, Start

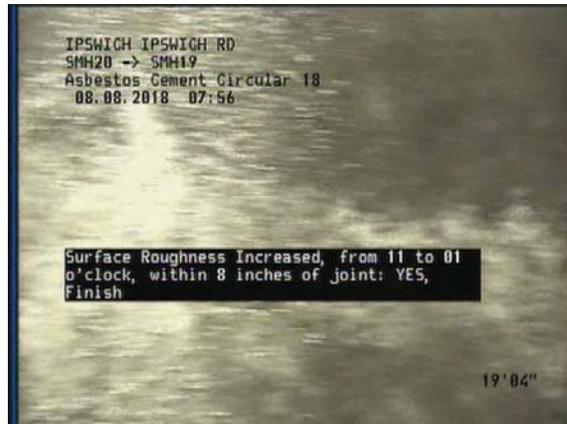
Photo: SMH20-SMH19-08202018-SRI-19.3148-160728.jpg
19.31FT, Surface Roughness Increased, from 11 to 01
o'clock, within 8 inches of joint: YES, Finish

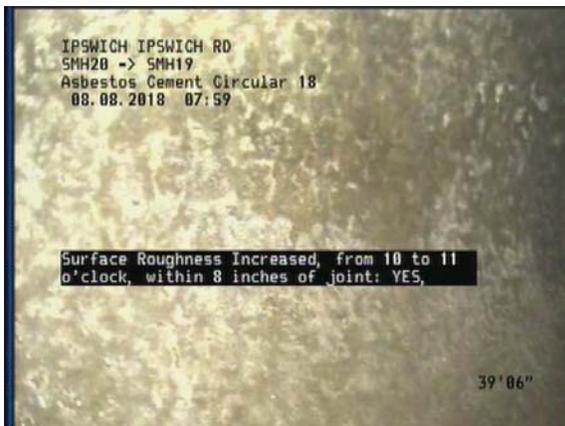
Photo: SMH20-SMH19-08202018-SRI-39.5303-160930.jpg
39.53FT, Surface Roughness Increased, from 10 to 11 o'clock, within 8 inches of joint: YES, Finish

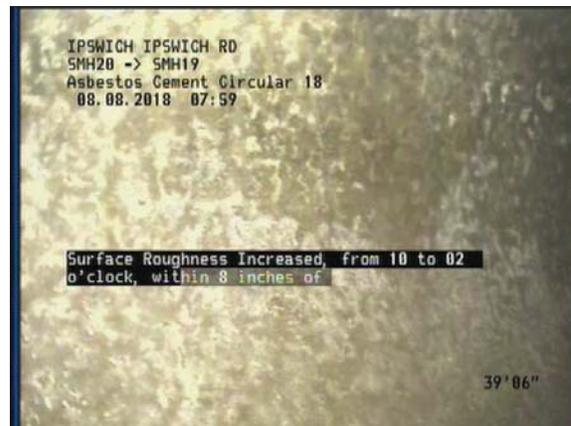
Photo: SMH20-SMH19-08202018-SRI-39.5303-160939.jpg
39.53FT, Surface Roughness Increased, from 10 to 02 o'clock, within 8 inches of joint: YES, Start

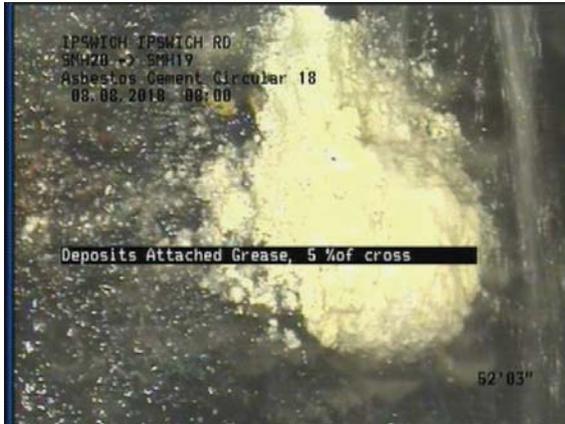
Photo: SMH20-SMH19-08202018-DAGS-52.24-161007.jpg
52.24FT, Deposits Attached Grease, 5 %of cross sectional area, at 08 o'clock, , within 8 inches of joint: YES

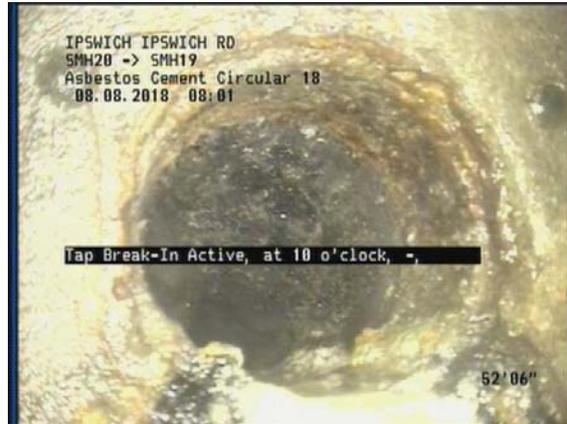
Photo: SMH20-SMH19-08202018-TBA-52.5402-161034.jpg
52.54FT, Tap Break-In Active, at 10 o'clock, -, within 8 inches of joint: NO, 4"

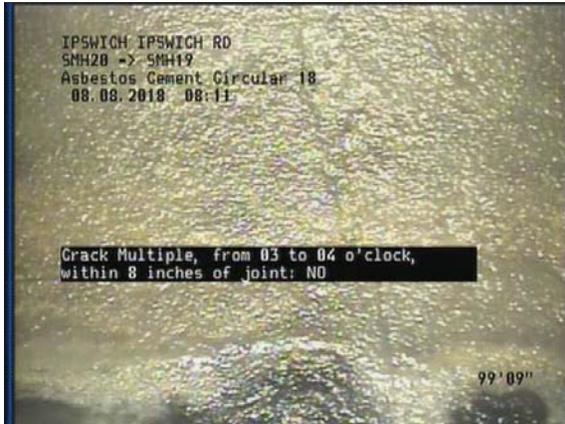
Photo: SMH20-SMH19-08202018-CM-99.7764-161705.jpg
99.78FT, Crack Multiple, from 03 to 04 o'clock, within 8 inches of joint: NO

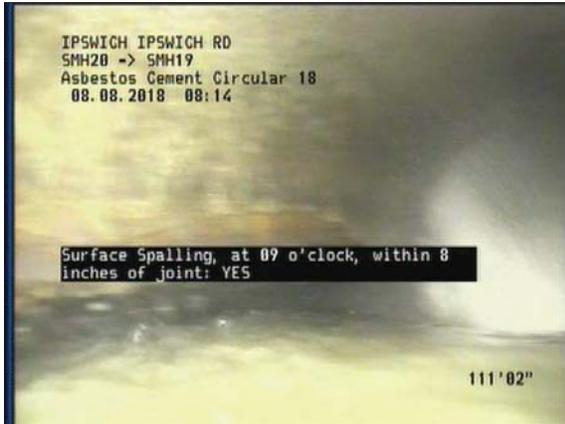
Photo: SMH20-SMH19-08202018-SSS-111.1851-162033.jpg
111.19FT, Surface Spalling, at 09 o'clock, within 8 inches of joint: YES

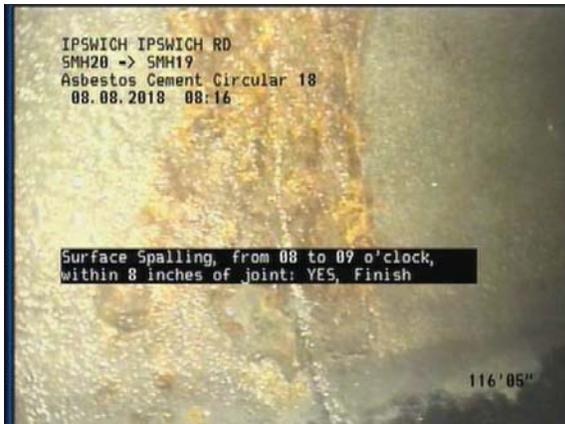
Photo: SMH20-SMH19-08202018-SSS-116.3891-163441.jpg
116.39FT, Surface Spalling, from 08 to 09 o'clock, within 8 inches of joint: YES, Finish

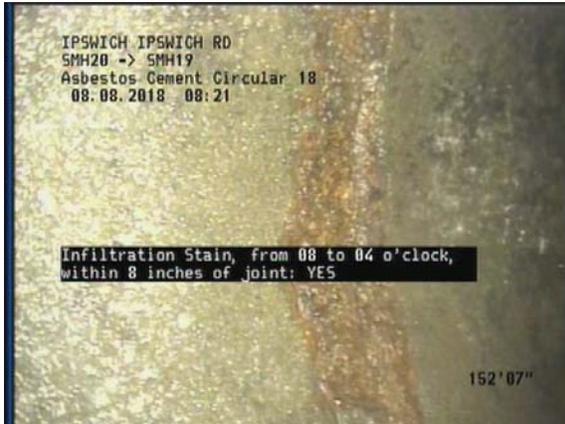
Photo: SMH20-SMH19-08202018-IS-152.6169-163510.jpg
152.62FT, Infiltration Stain, from 08 to 04 o'clock, within 8 inches of joint: YES

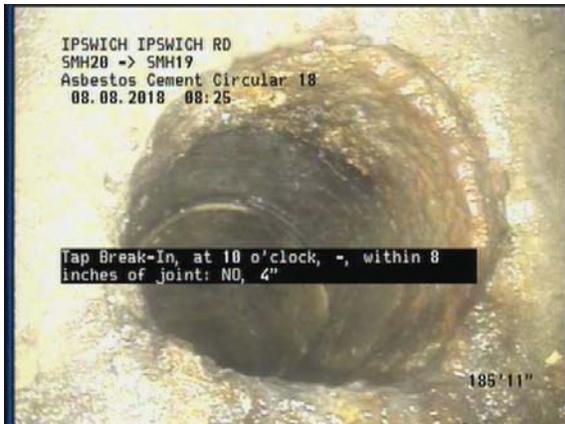
Photo: SMH20-SMH19-08202018-TB-185.9424-163643.jpg
185.94FT, Tap Break-In, at 10 o'clock, -, within 8 inches of joint: NO, 4"

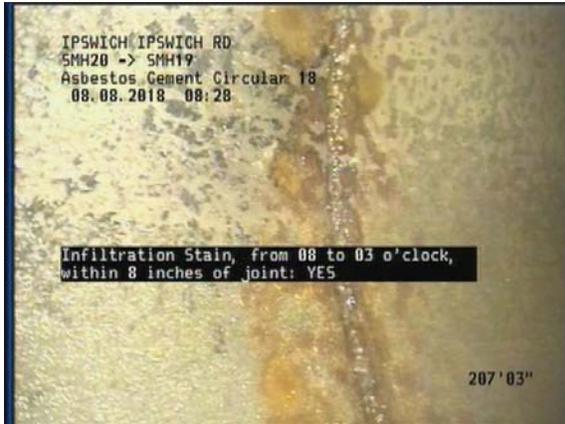
1:270	Position	Code	Observation	Rate
	<u>207.26</u>	IS	Infiltration Stain, from 08 to 03 o'clock, within 8 inches of joint: YES	
	<u>225.57</u>	IS	Infiltration Stain, from 12 to 04 o'clock, within 8 inches of joint: YES	
	<u>243.49</u>	IS	Infiltration Stain, from 12 to 03 o'clock, within 8 inches of joint: YES	
	<u>262.00</u>	IS	Infiltration Stain, from 08 to 03 o'clock, within 8 inches of joint: YES	
	<u>280.01</u>	IS	Infiltration Stain, from 02 to 04 o'clock, within 8 inches of joint: YES	
	<u>298.13</u>	IS	Infiltration Stain, from 08 to 04 o'clock, within 8 inches of joint: YES	
	<u>316.44</u>	IS	Infiltration Stain, from 08 to 04 o'clock, within 8 inches of joint: YES	
	<u>334.86</u>	IS	Infiltration Stain, from 08 to 04 o'clock, within 8 inches of joint: YES	
	<u>339.16</u>	F6	SSS Surface Spalling, at 03 o'clock, within 8 inches of joint: YES, Finish	S 2
	<u>339.16</u>	F5	SSS Surface Spalling, at 09 o'clock, within 8 inches of joint: YES, Finish	S 2

Photo: SMH20-SMH19-08202018-IS-207.2587-163744.jpg
207.26FT, Infiltration Stain, from 08 to 03 o'clock, within 8 inches of joint: YES

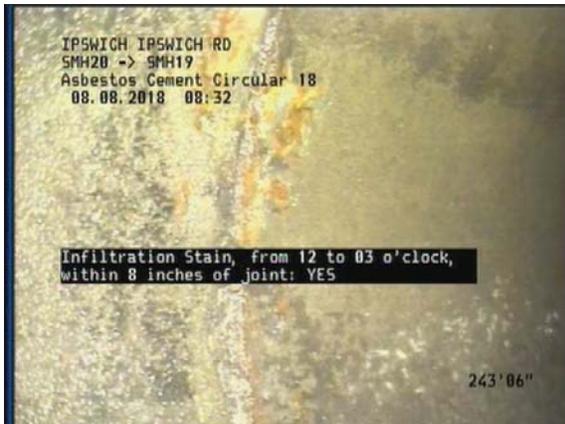
Photo: SMH20-SMH19-08202018-IS-243.4865-163818.jpg
243.49FT, Infiltration Stain, from 12 to 03 o'clock, within 8 inches of joint: YES

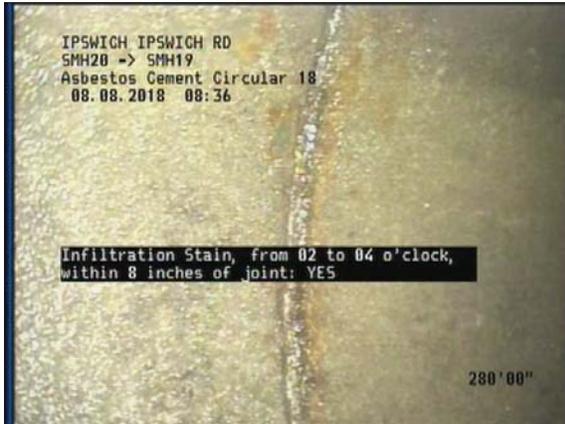
Photo: SMH20-SMH19-08202018-IS-280.0144-164005.jpg
280.01FT, Infiltration Stain, from 02 to 04 o'clock, within 8 inches of joint: YES

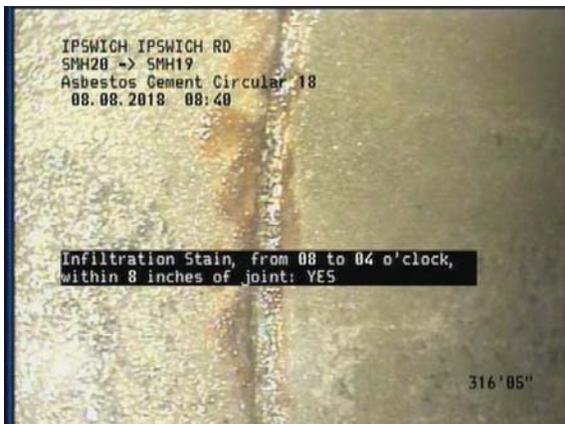
Photo: SMH20-SMH19-08202018-IS-316.4423-164129.jpg
316.44FT, Infiltration Stain, from 08 to 04 o'clock, within 8 inches of joint: YES

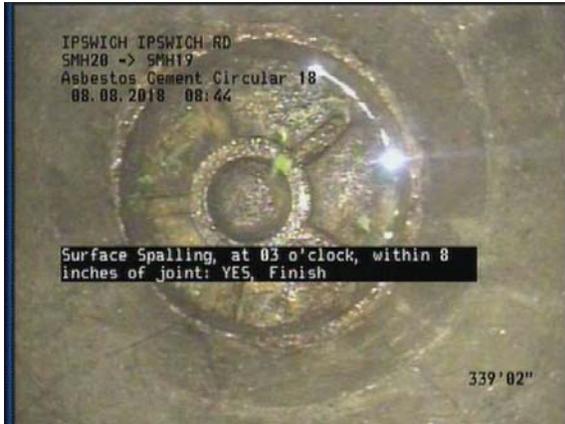
Photo: SMH20-SMH19-08202018-SSS-339.1597-164227.jpg
339.16FT, Surface Spalling, at 03 o'clock, within 8 inches of joint: YES, Finish

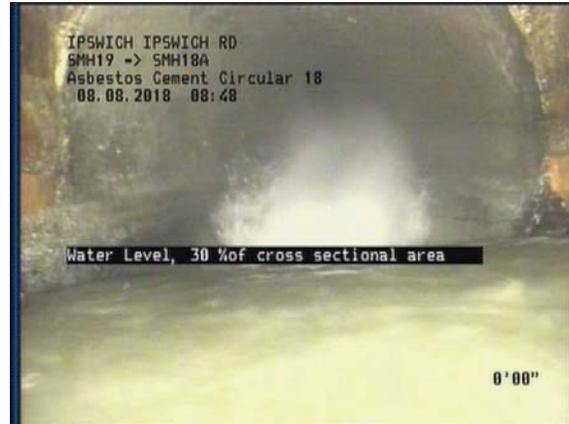
Photo: SMH19-SMH18-08202018-MWL-0-164356.jpg
0FT, Water Level, 30 %of cross sectional area

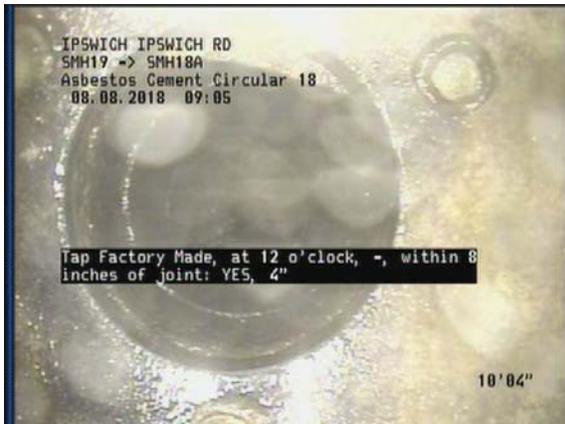
Photo: SMH19-SMH18-08202018-TF-10.3079-164420.jpg
10.31FT, Tap Factory Made, at 12 o'clock, -, within 8 inches of joint: YES, 4"

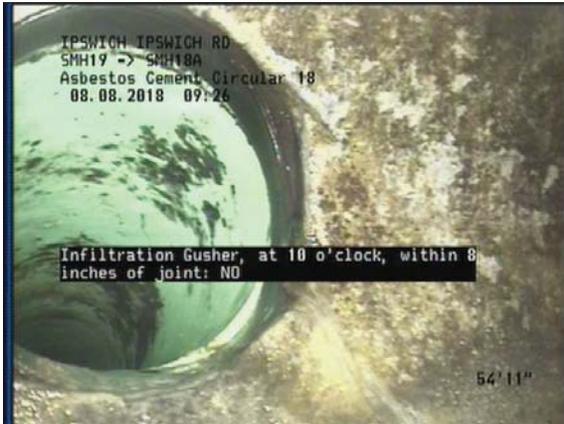
Photo: SMH19-SMH18-08202018-IG-54.9421-164511.jpg
54.94FT, Infiltration Gusher, at 10 o'clock, within 8 inches of joint: NO
