TOWN OF IPSWICH

April 17, 2019

Re: Ipswich Sewer Interceptor Rehabilitation and Siphon Replacement Project
EEA File #16003

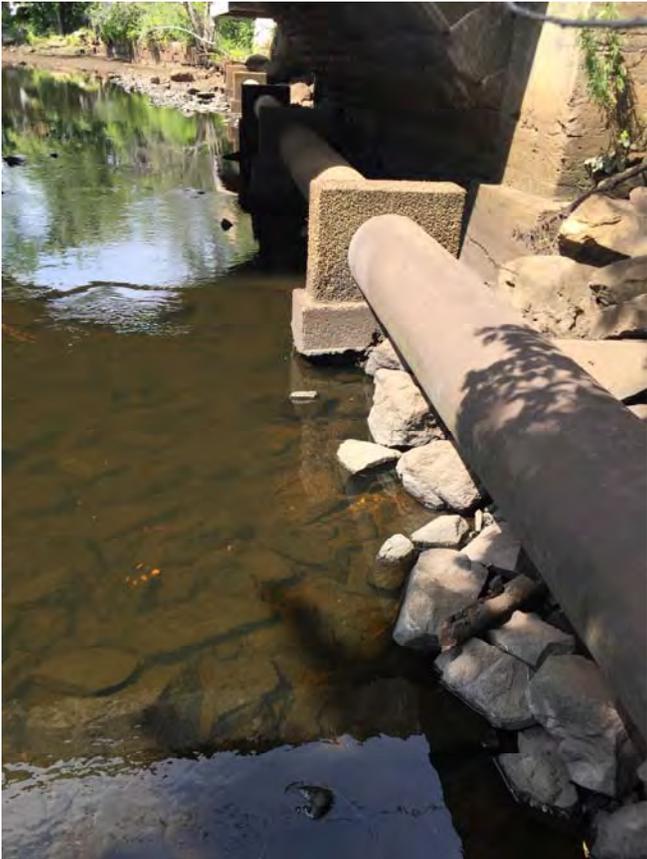
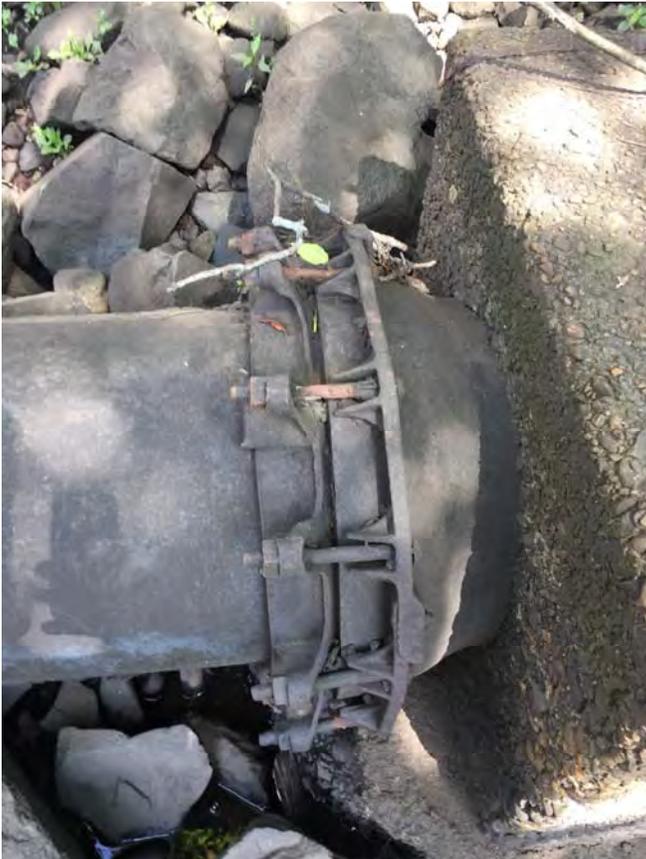
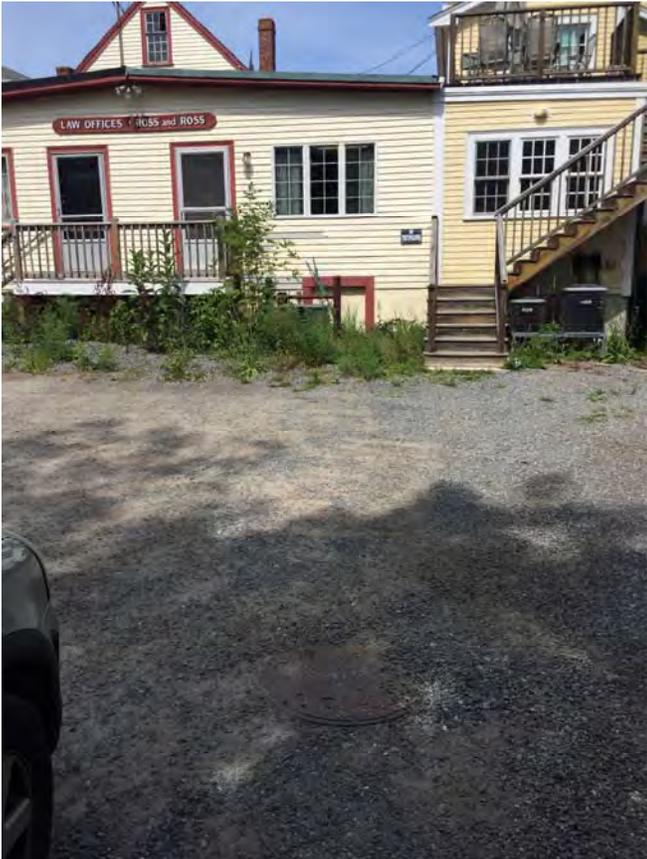
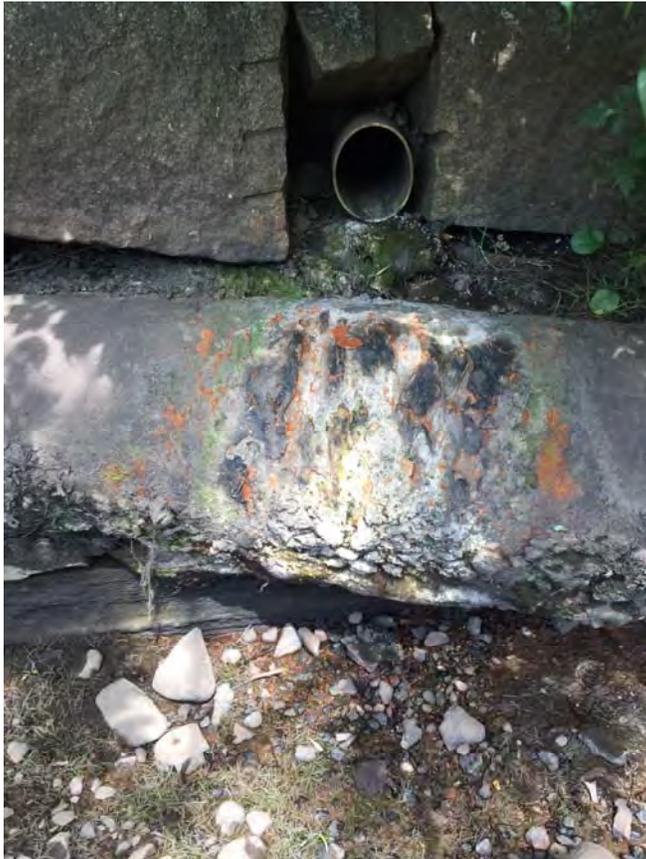
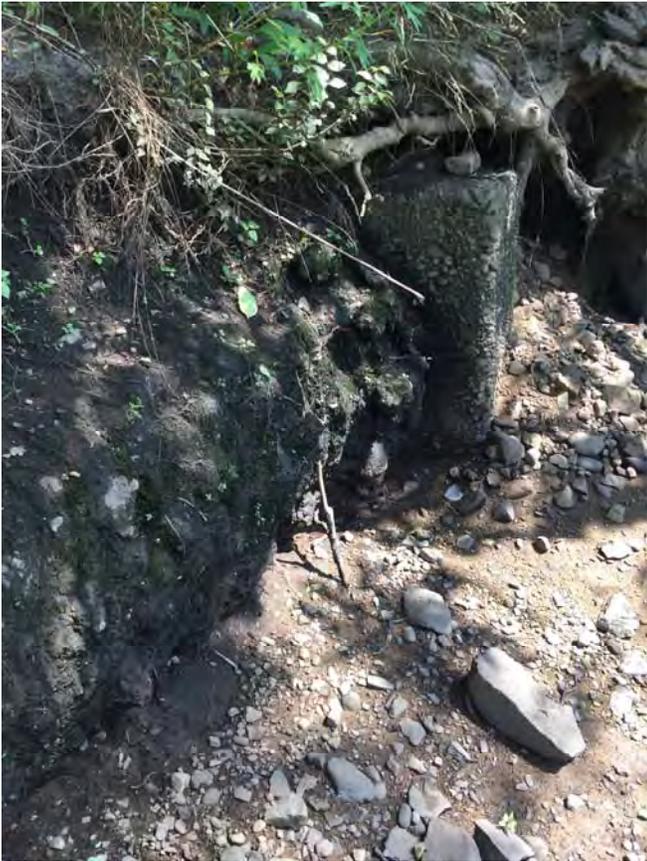
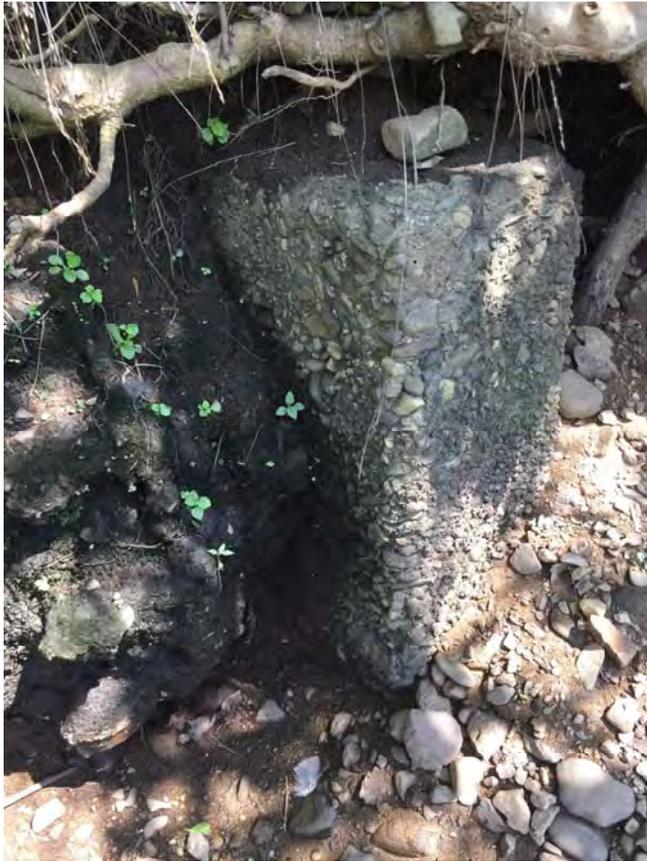
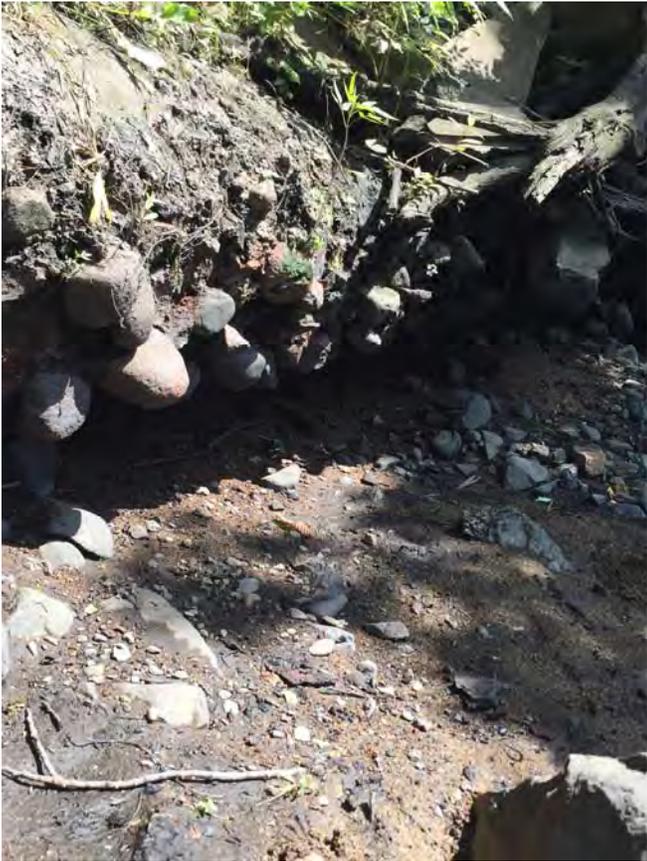
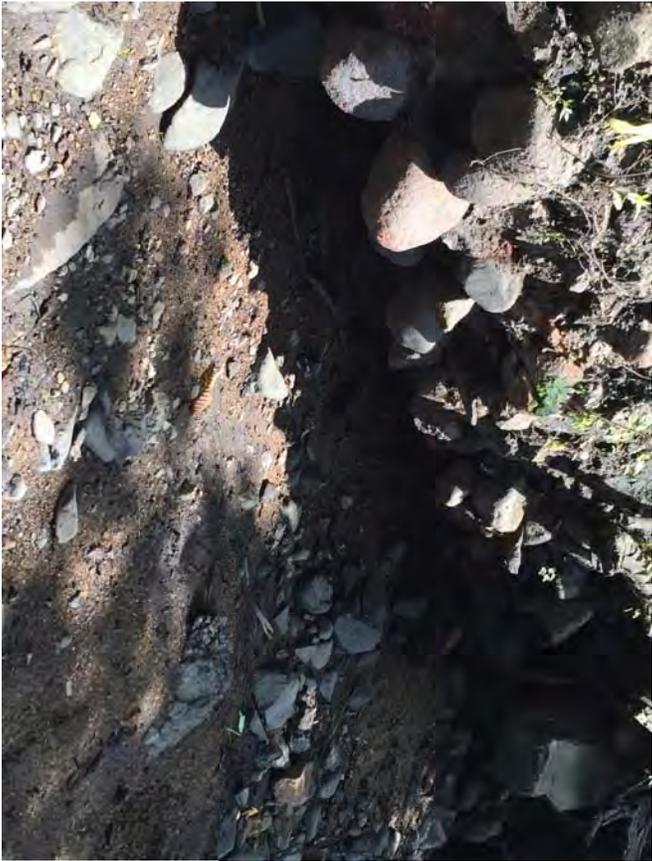
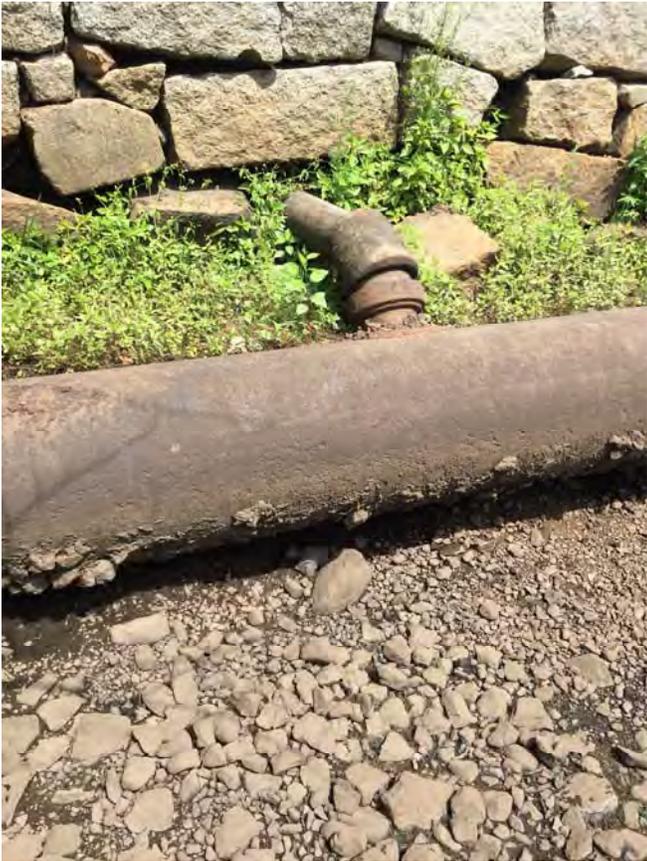
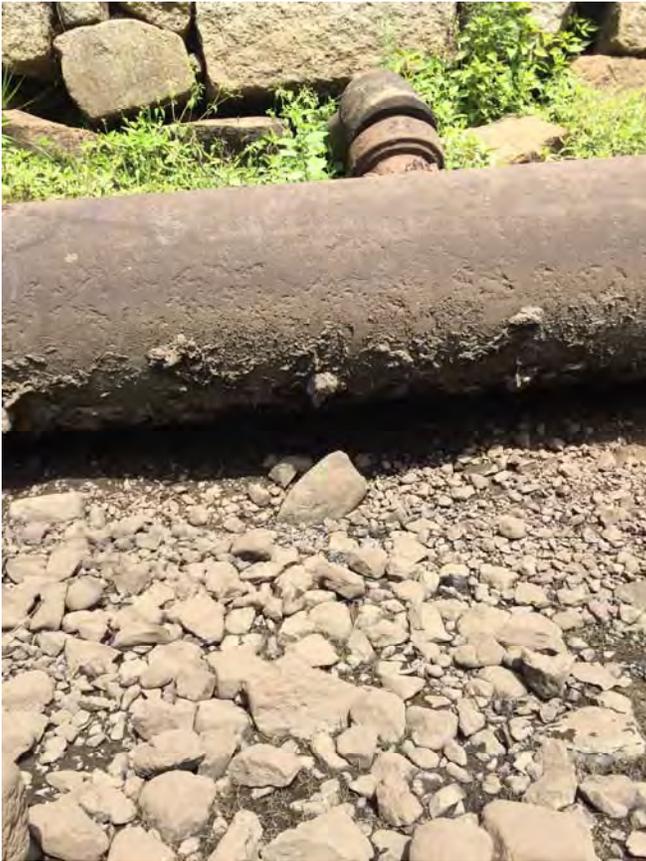
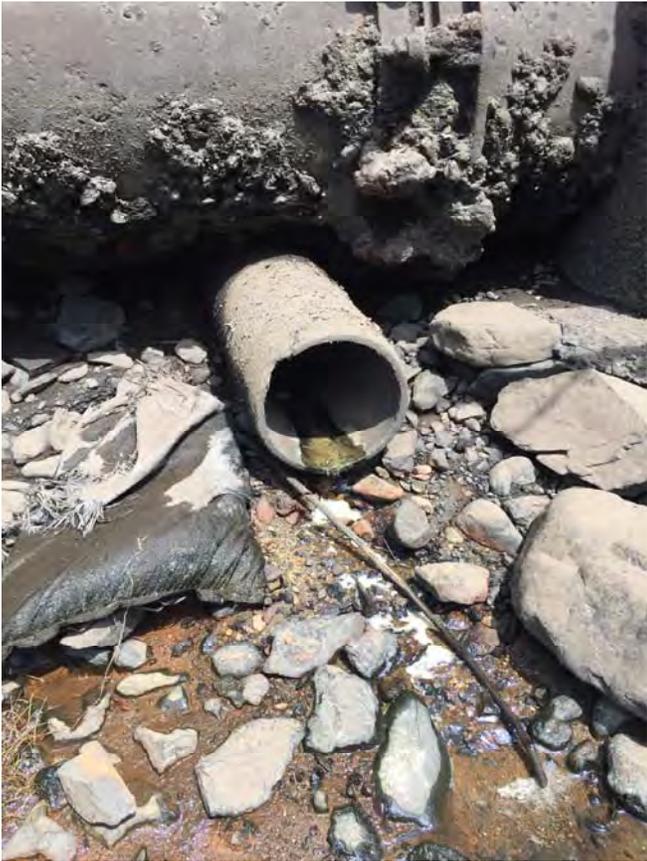
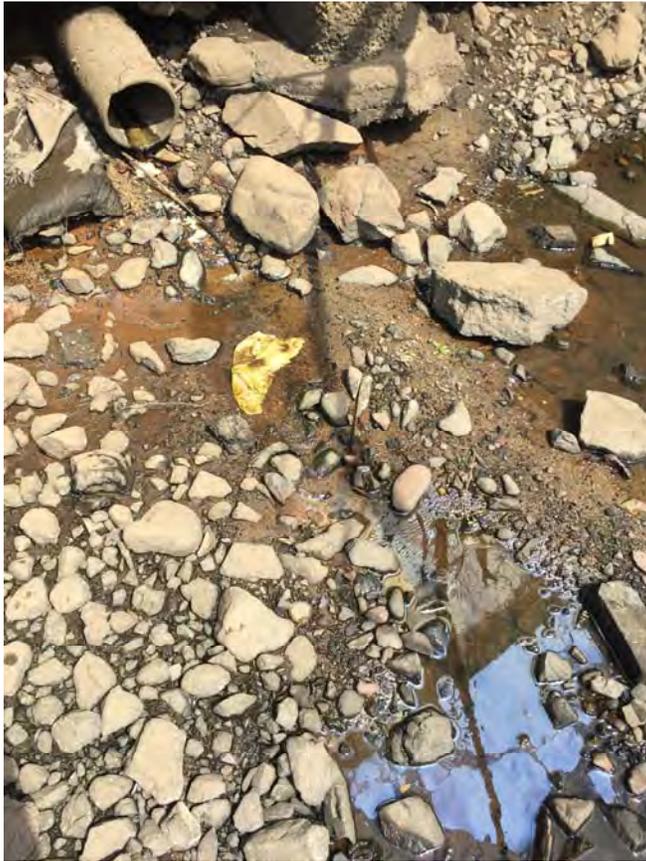
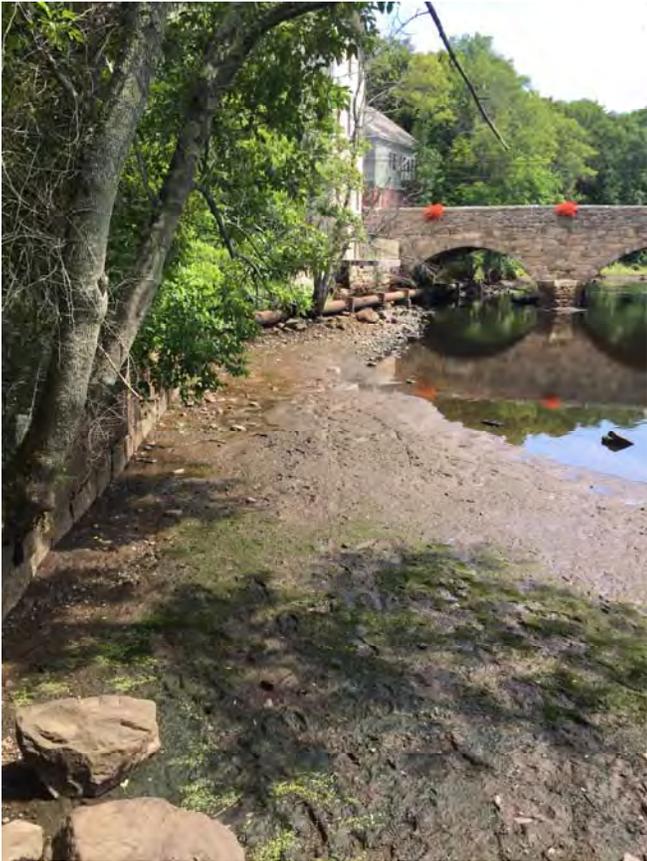
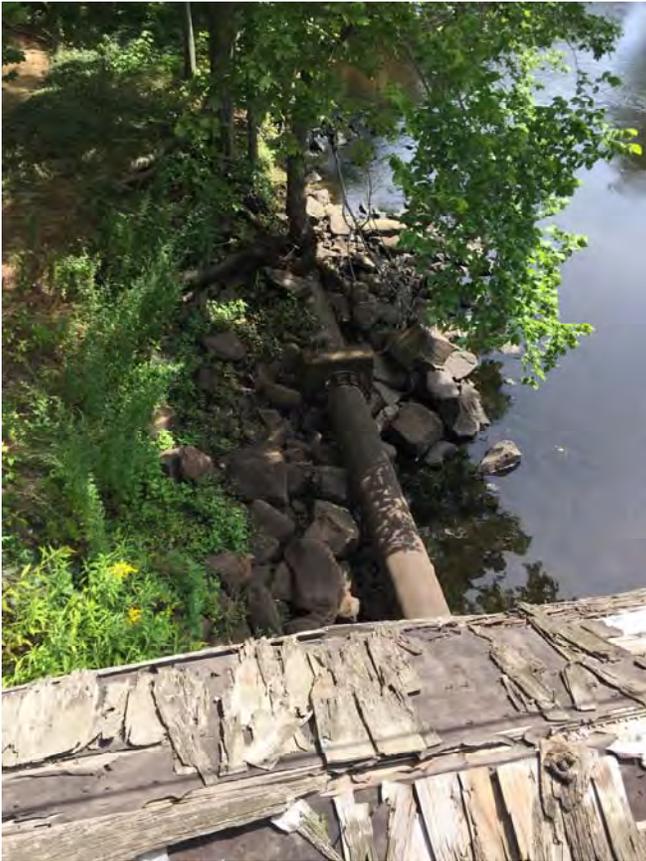
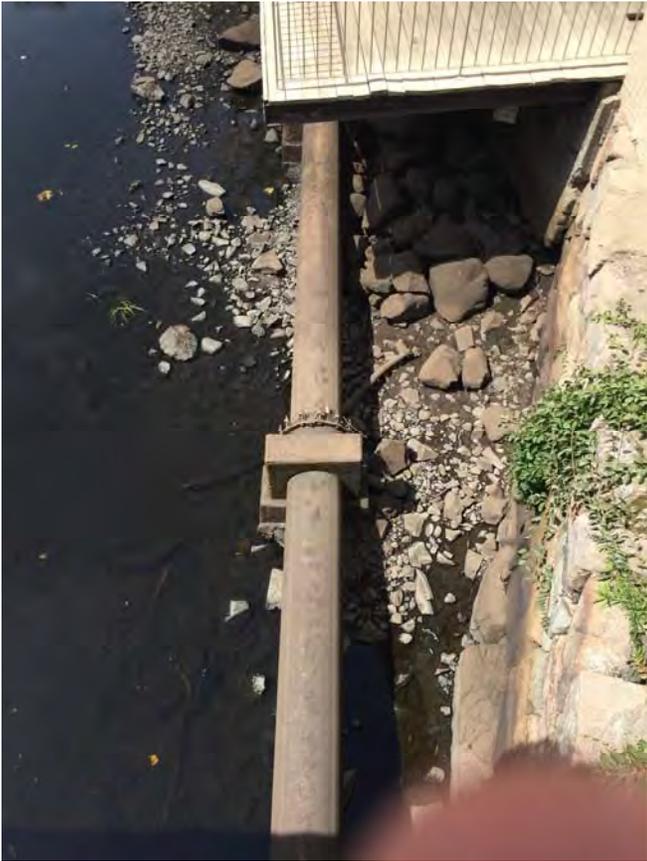
August 2017 Union Street / Market Street Interceptor Sewer - Photos

The sewer is constructed with concrete pile supports, cast-in-place around the pipe near each pipe joint. Cast iron fittings at pipe joints are not encased in the concrete piles and are exposed to the elements and have evidence of corrosion on the bolts and hardware.

The section of sewer main partially encompassed by the Northern river embankment downstream of the Choate Bridge has experienced erosion beneath the exposed pipe. The pipe is exposed to the elements and river flow and appears to be bearing the weight of the river bank where the pipe and bank have been undermined by erosion, creating the risk of pipe failure in the event continued erosion causes bank slippage. There are also large trees growing in the vicinity of the pipe and river bank, adding to the potential risk to the pipe caused by future erosion and bank slippage.

- Inspect pipe and joint fittings along Northern River bank for corrosion and evidence of leakage.
- Remove large trees in vicinity of sewer in Northern embankment, and evaluate alternatives to backfill and stabilize soil beneath pipe, and to stabilize the river bank along exposed sewer length between the Choate Bridge and SMH 673 to protect against erosion, bank slippage, and potential resulting pipe failure.

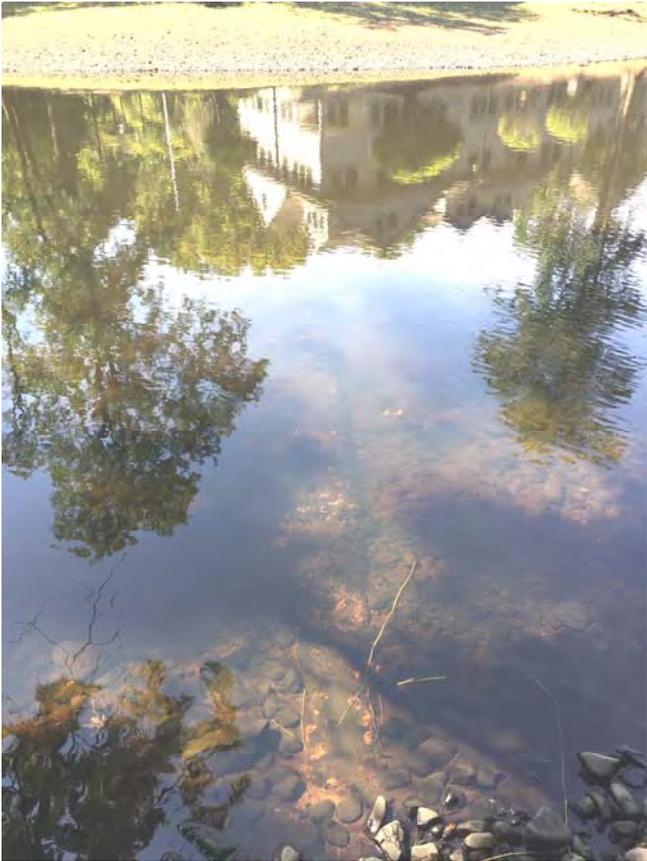
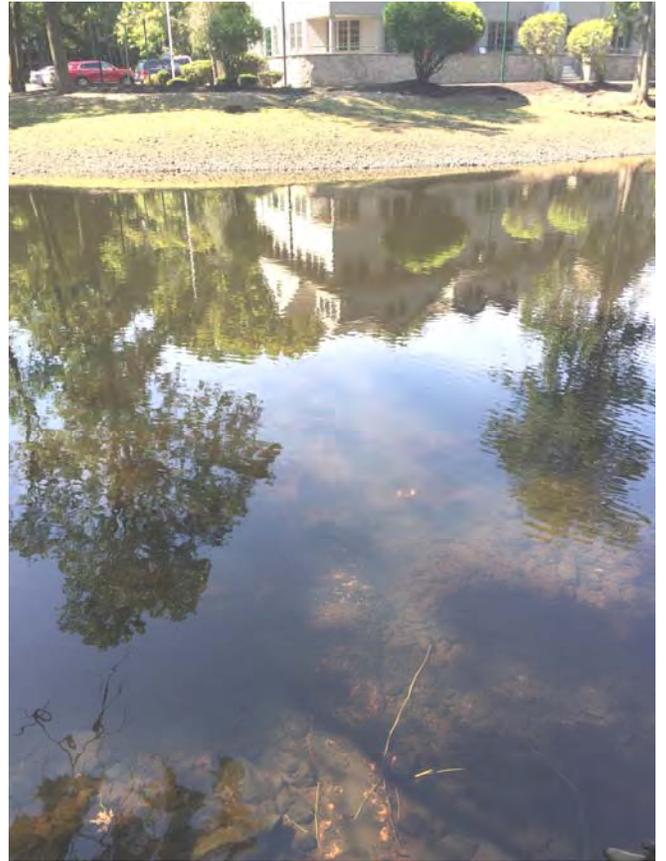
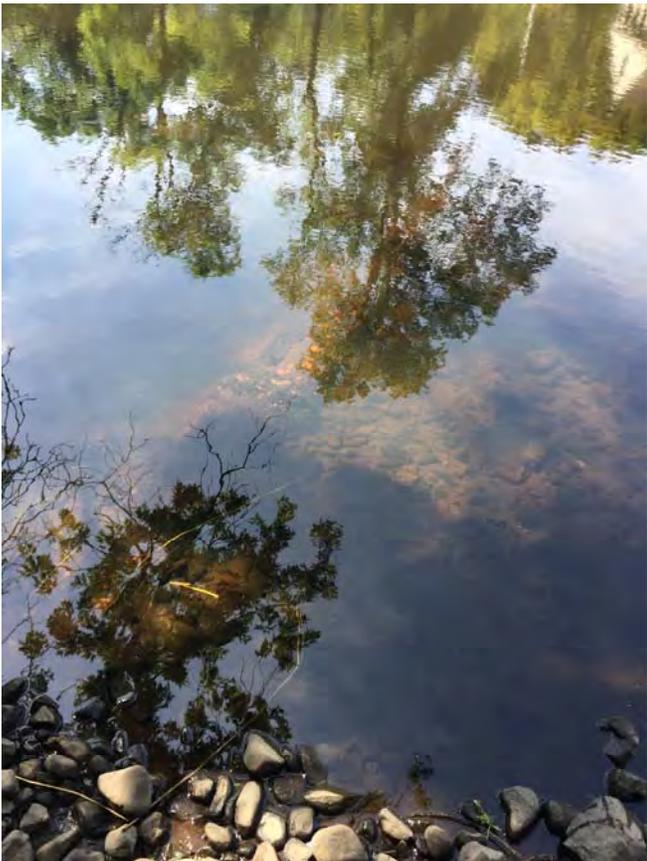
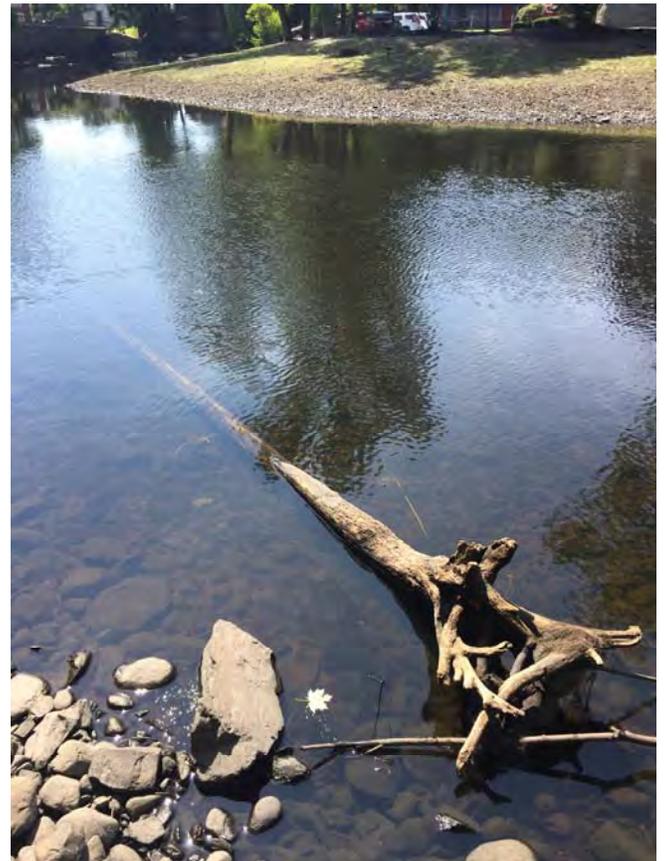
August 2017 Choate Bridge Sewer Siphon - Photos

Sewer Siphon - The sewer siphon crossing under the river is currently exposed and visible in the river bed. Record drawings identify the siphon as being buried under river bed with 2-feet of minimum cover, if the record drawings accurately represent the installed siphon configuration it appears that erosion of the river bed has significantly changed the cross-section of the river bed and exposed the pipe. The pipe is approximately half exposed to river flow (buried to the spring line) and is exposed to river flow and potential damage from boats or river born debris.

(As an example of river born debris, a large tree was observed in the river bed upstream of the siphon that presumably was washed downstream during high flows.)

- Consider conducting soil borings along route of sewer siphon in river to evaluate alternatives to replace sewer siphon at deeper depth.
- Consider installing structural pipe liners to extend the life of the interceptor sewer and/or sewer siphon and provide some protection from failure.
